Boundary survey. Milton C Forster Estate
Brentsville May. District.
Ross + Frame. engr.

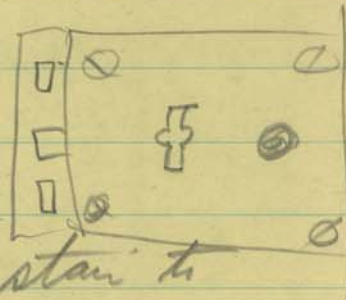
old floor
mantel

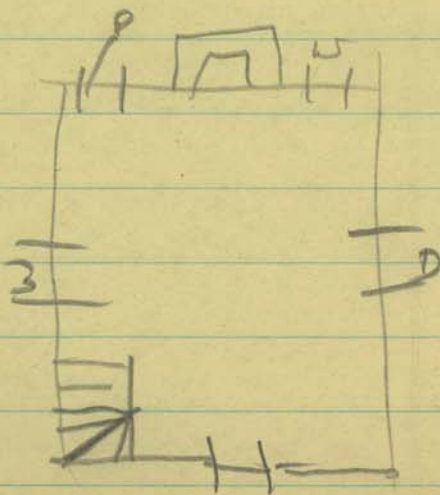
mantel
moulded shelf.

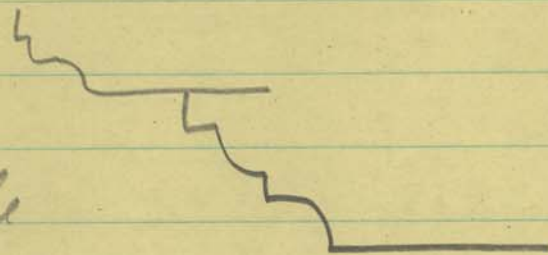
beaded plain wide
jambs

plain wide frieze w/ bead on lower edge

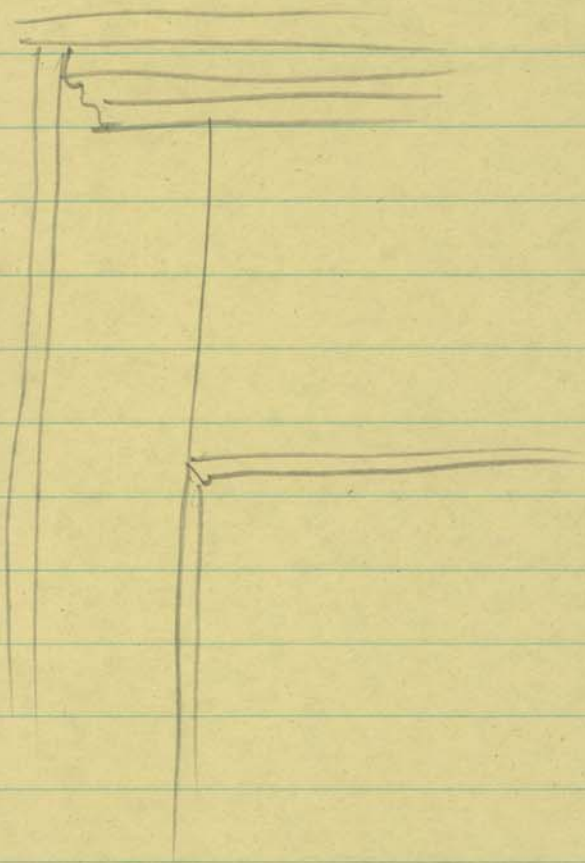
stone lintel.

brick firebox. repointed or
rebuilt.

flaystone hearth.

Room B has upper joints c36" center to center
 beaded, one plastered. now white washed.

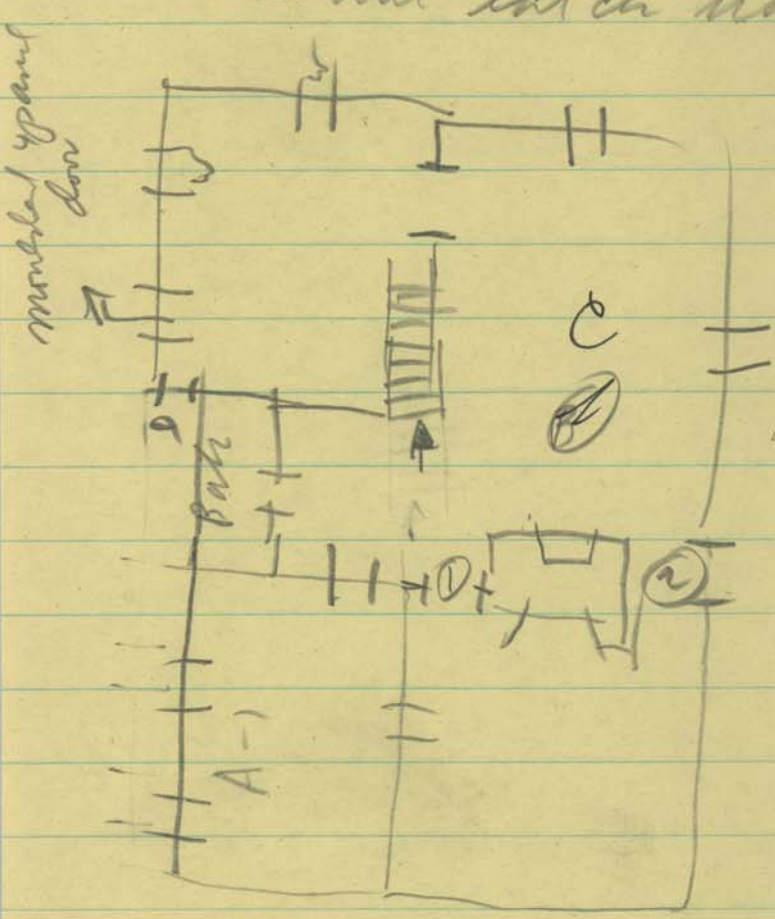
mantel in (2) is
 modern.

door at (1) is 4 panel
 moulded.

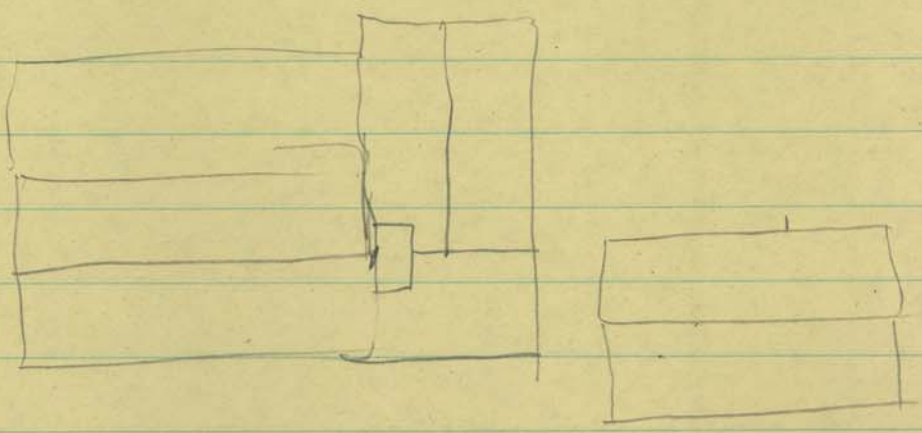
2 Cornices at south end

sawtooth cornice
