VIRGINIA
DIVISION OF HISTORIC LANDMARKS
HISTORIC DISTRICT/BRIEF
SURVEY FORM

City/Town/Village/Hamlet 8221 Hickory County _____
 Street address or route number 8231 U.S.G.S. Quad _____
 Historic name _____ Common name Walter Alpaugh
 Present use Dwelling Building Style Log cabin
 Original use Summer log cabin at Lake Jackson Building Date(s) 1930's

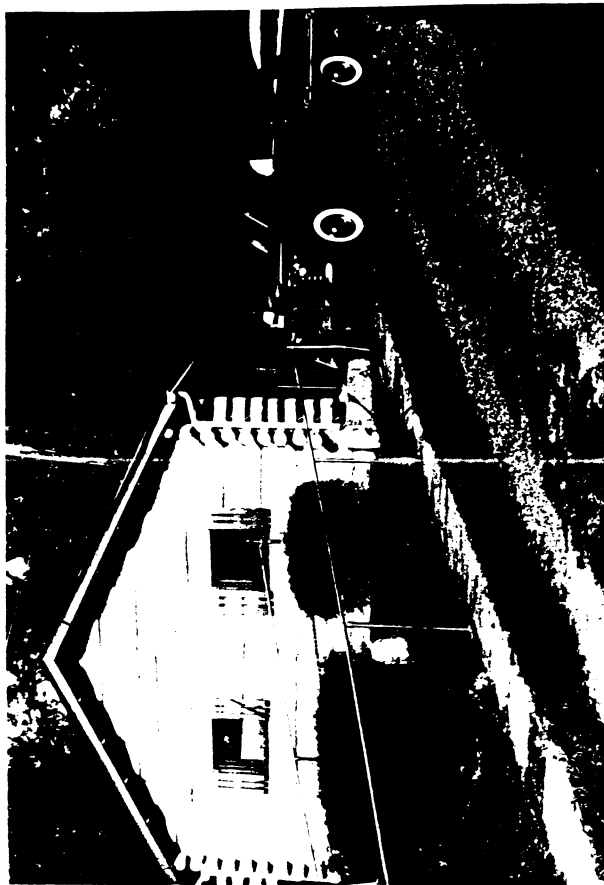
10. Major additions and alterations:
2 additions - 1 on either side.

11. Outbuildings:
wooden toolhouse and log cabin garage with good integrity.

13. Significance:
the cabin has lost its integrity; however, the log garage has good integrity.
