HISTORIC STRUCTURE REPORT

THE BARNES HOUSE

Independent Hill vicinity
Prince William County, Virginia

OCTOBER 2004

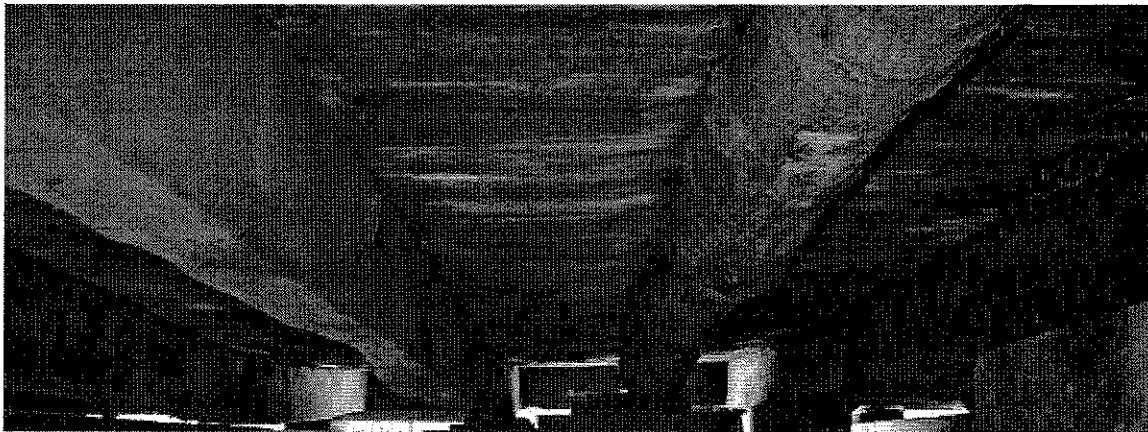
Others show considerable evidence of powderpost beetle damage. (It is probable that the insect damage—both from termites and beetles—occurred many years ago). At least two or three of the joists are seriously warped and have dropped as much as two or three inches at the lowest point.

Figure 9: The joists, though similar in size, vary from hewn members to round "log" joists.

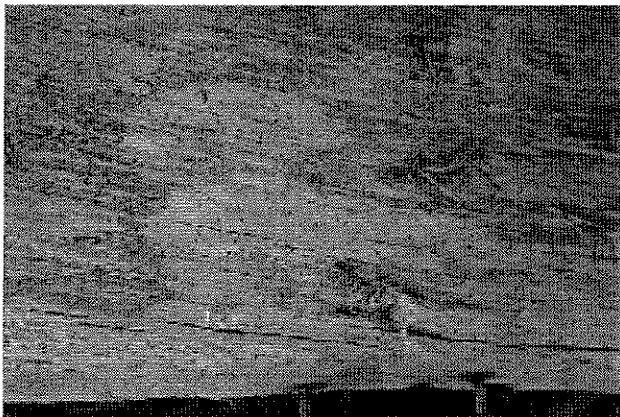
Figure 10: The round "log" joist on the left has evidence of powderpost beetle damage—a scattered pattern of tiny holes, about 1/16 inch in diameter. The beetle primarily attacks the sapwood of wood that has not had time to dry completely. Damage from powderpost beetles can result in the sapwood (outer 2 inches or so of each log) being largely hollow, reducing the structural capacity of the member from that of the profile that appears to be represented.

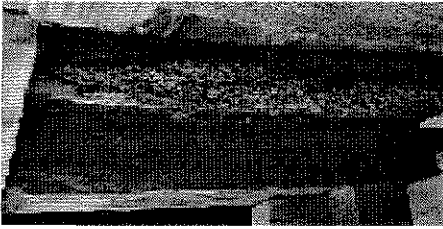
There is also evidence of shear failure in a couple of the joists. Some of this may have occurred many years ago, as there are indications in a few places that they have generally been out of level for many years.

Figure 11: The joist on the left has substantial damage from wood rot, possibly also caused by termite infestation. The effective structural capacity of the member is greatly reduced, and to the degree that it is rotted, the structural capacity should be considered to be zero. The member will need to be either replaced or substantially reinforced.

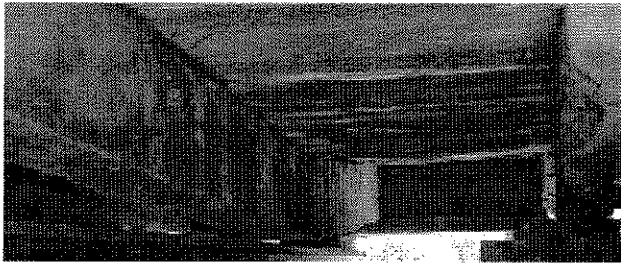
Figure 12: Two or three of the joists represent extreme examples of warping, as seen on the left. Depending upon how the building is to be used, it may be necessary or desired to replace this joist or shore up the flooring to create a level floor surface.

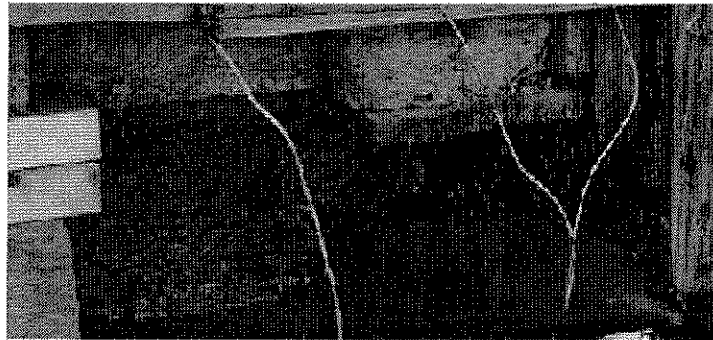
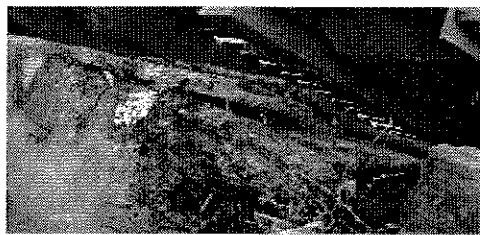
Figures 13 & 14: The building's worst structural condition is rotting and/or termite damage at the corners of the sill plate. Although the sills (bottom horizontal member of each wall) along most of the two long walls are generally in good condition, the corner sections of the sills, along the short walls between each corner of the house and the nearest chimney, are missing.

The sills are in place along a large portion of the house's perimeter, and this appears to be one of the reasons that the joinery of the exterior remains tight and the walls remain relatively plumb in spite of considerable problems with the floor joists. Like the joists, the sills are hewn members pegged together at the corners, with mortises to accept each joist and stud. They are a little heftier than the joists, generally about eight inches tall and about twelve inches deep. However, at the end walls, the sills were interrupted by the fireplaces, resulting in a lesser degree of integrity at the bottom edge of these two walls. The openings left in the framing by the removal of the chimneys were closed in with wood studs and plywood when the house was moved. This may have preserved the integrity of the exterior framing. However, in the course of the move, sections of the end wall sills broke away in areas where there had apparently been some rotting or insect damage. Additionally, a section of one of the long sills is currently missing (rotted away),

at the joint where it met the sill of one of the end walls. A few pieces, a foot or so in length, that had broken away from the framing members at the corners were found lying near the house at the landfill site. They had broken away because they had been completely destroyed by termites, to the point where there was no solid wood left, though the original shape of the wood was still apparent.

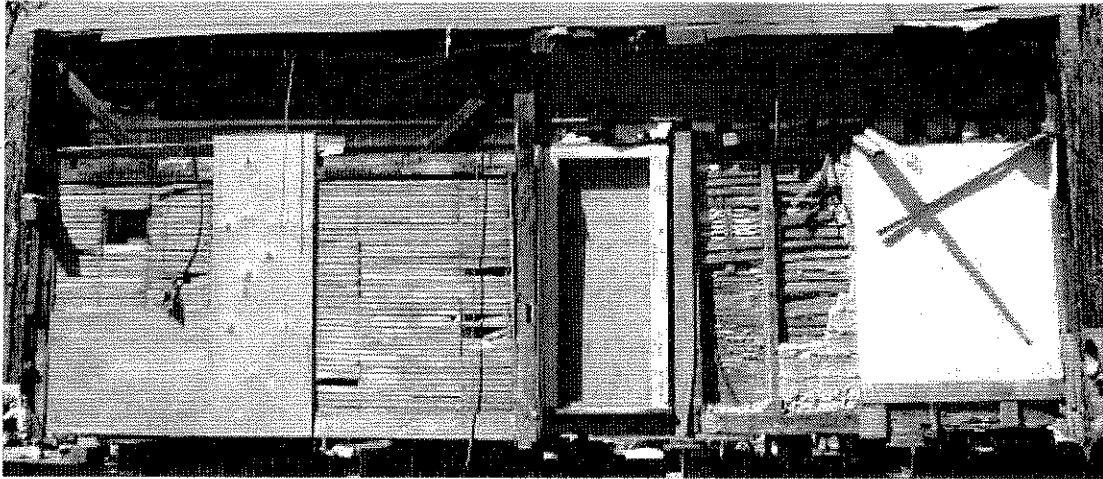
Figure 15: The rear wall of the house, as exposed when the catslide kitchen and bathroom additions were removed, shows layers of materials and construction techniques from several different periods. The main studs are visible in some areas, particularly in the right half of this view, where some of the clay nogging between the studs is also now exposed. Behind the nogging there are two layers of wood lath. The layer touching the nogging (and the not-quite parallel strips above it) is the riven lath from the original construction. Spanning from stud to stud, it is held in place by narrow ledgers nailed to the edges of the studs. Newer sawn lath is on the inside side of the studs, also visible in this photo (bottom half of the space between the studs just to the right of the door). It holds the plaster that was added to finish the interior at some point in the nineteenth century. In the left half of this view, the sawn lath is a remnant of the interior finish of the now-demolished kitchen. The heavy framing and diagonal bracing were the wall of the kitchen wing, framed independently from the presumably older wall of the original house, just beyond it. In the sandwiched materials where these walls come together are some of the remnants of the original beaded weatherboarding. The weatherboarding is visible (in shadow) across the top of the wall in this view.

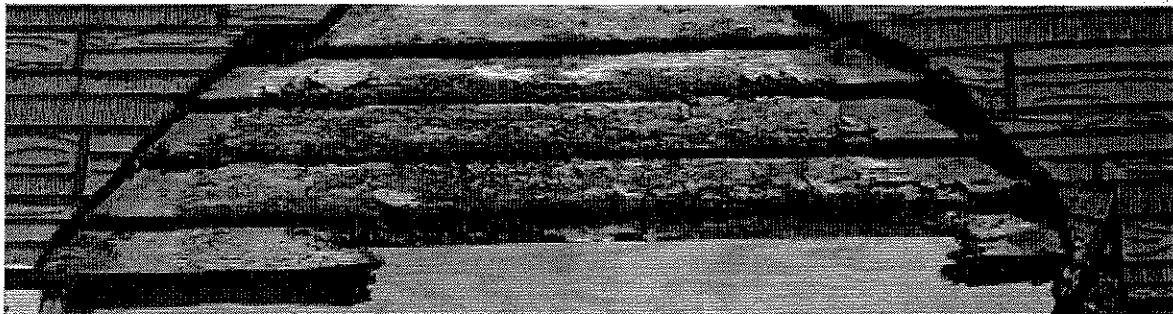
Figure 20: Plain lap siding used when the built was re-sided about 1900, as seen at the top of the area where the chimney has been removed. Note the deterioration from water trapped behind the masonry.

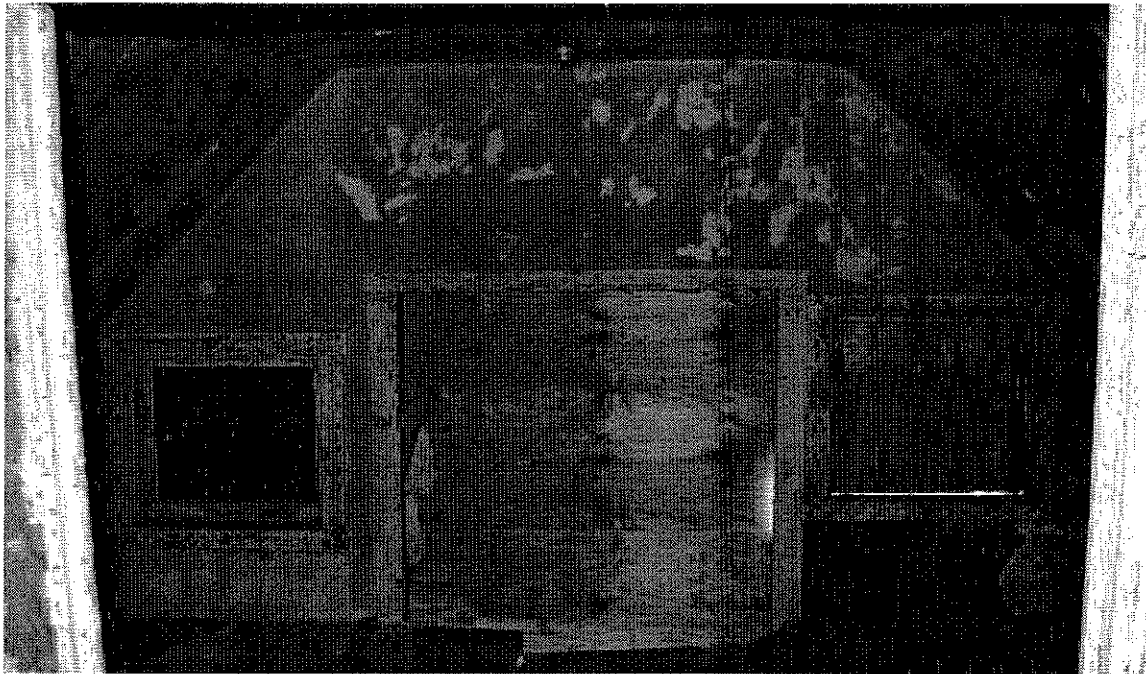
Figure 25: The second story (or attic) consists of two large rooms shaped by the roofline, knee-walls, and a narrow ceiling. Beneath twentieth century plaster on expanded metal lath, the original wall treatment of horizontal bands of beaded interior sheathing appears to be intact.

The second story plaster was applied wet over metal mesh lath. It is most likely composed mainly of gypsum. It was installed at some point between about 1920 and about 1950. The metal mesh lath was nailed directly on to beaded horizontal wall boards. The earlier boards appear to be relatively intact under the plaster. The second story plaster is intact in some areas and damaged by water in others, with some large sections missing. However, it would be appropriate to remove it to expose and restore the earlier wall treatment design, the beaded boards (see Recommendations).

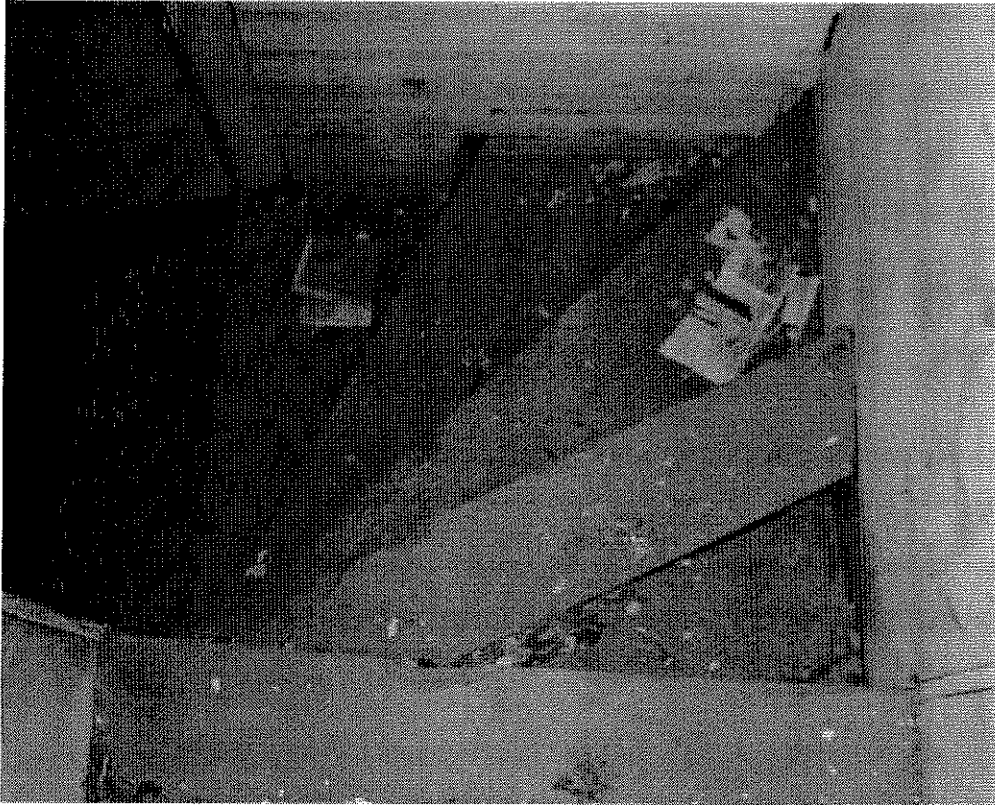
Some sections of the stairs are in good condition, while others are not. One wedge-shaped tread is completely broken and needs to be replaced. There is also some unevenness in the riser heights, which could be a problem if the building is restored for a use that involves allowing the public to go to the second story.

Figure 28: Some of the stair treads, particularly in the winding section, are broken.

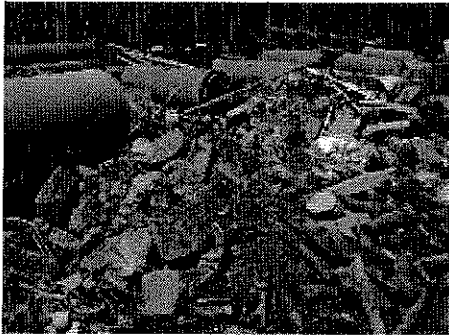
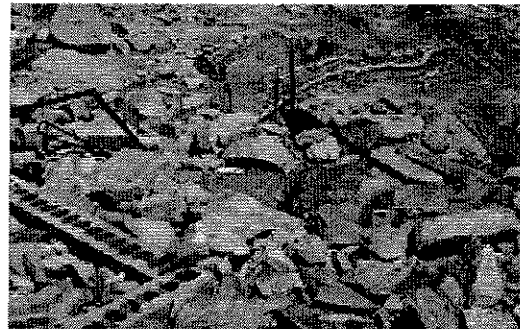
Figures 29 & 30: Some of the stone from the Barnes House chimneys was moved to the temporary site at the Prince William County Landfill (left) and some is still to be found at the house's original site (view on right).
