Chapman Mill ~~75~~ 30 -

36-37' x 41.6 -

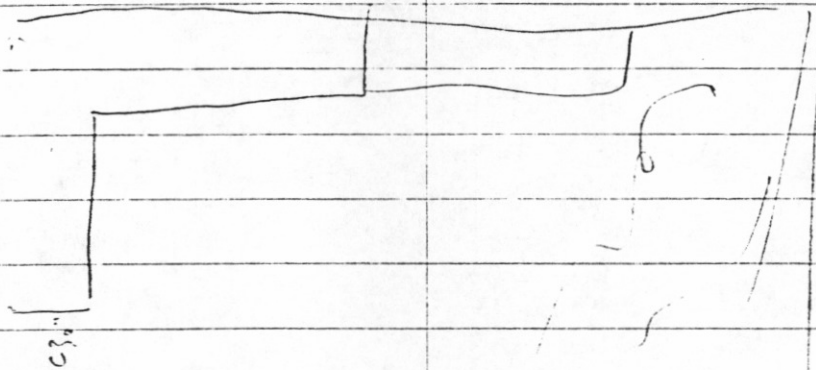
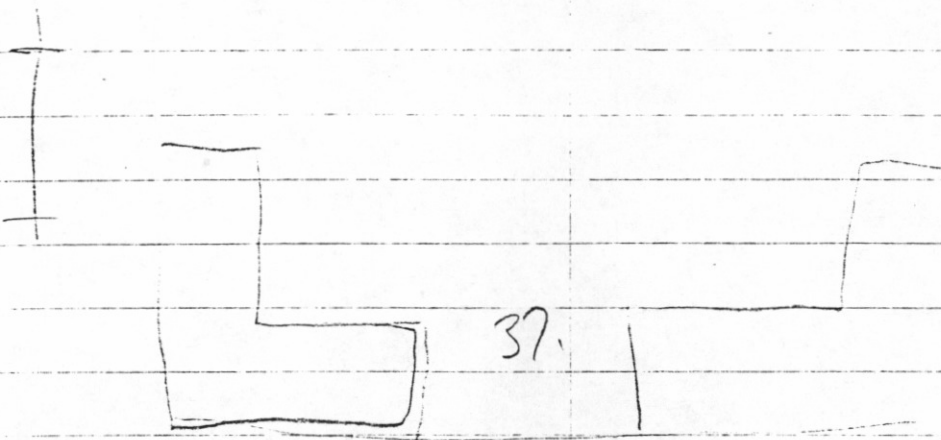
walls of mill have collapsed in
on middle.

Mill ruin debris and go trash
litters the site.

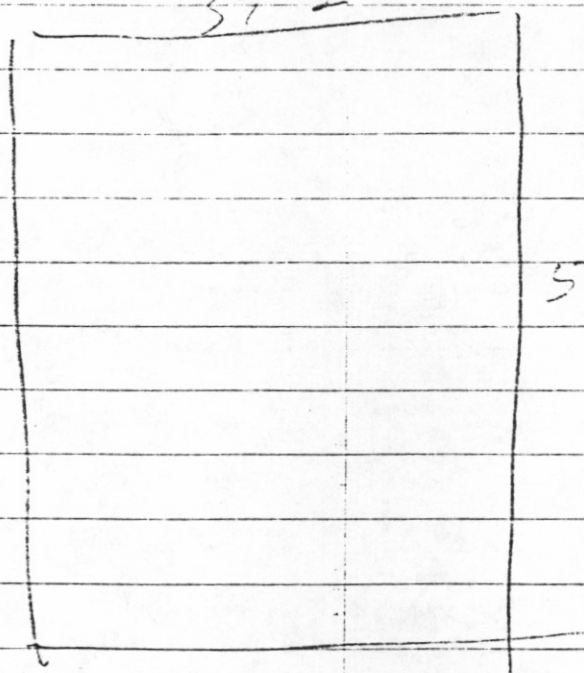
wooden window frame most is +
tenoned + pegged lying on
ground to east of mill.

Frame is nailed with cut nails.

Frame is 5" deep x $3\frac{1}{4}$

interior frame
that has been
moulding.

opening (possible) - 55 x 41
