The purpose of this report is to provide an addendum to the Historic Structures Report Architectural Data Section on the Brawner Farm House, or Douglas Hall, at Manassas National Battlefield Park, Manassas, Virginia. This work was completed at the request of the Planning Division of the National Capital Regional Office. The principal goal of the research was to develop information on the condition and evolution of the structure as it relates to the Park legislative mandate to interpret the events of the 1st and 2nd battles of Manassas, and to provide this information to the Development Concept Plan (DCP) Team for the Brawner Farm.

Subject: Results of Fabric Investigation and  
Alternative Preservation Treatments of Douglas Hall,  
Manassas NBP

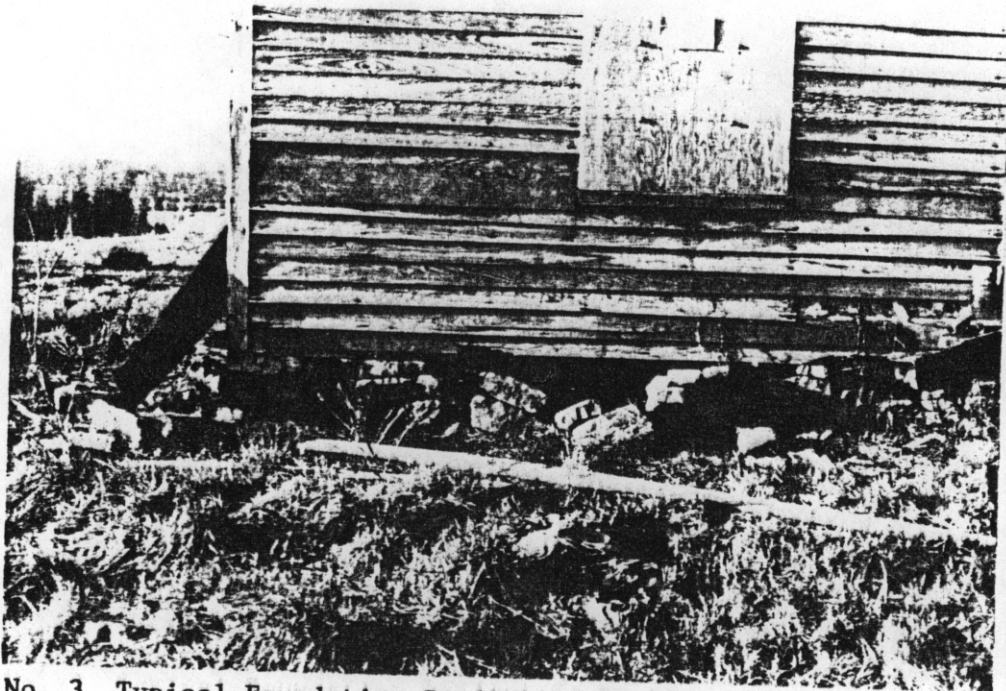
The foundation of Section A is constructed of random coursed, dry laid field stone. It is continuous with the perimeter of the Section A structure and shows no evidence of significant alterations.

No. 3 Typical Foundation Condition, Section A

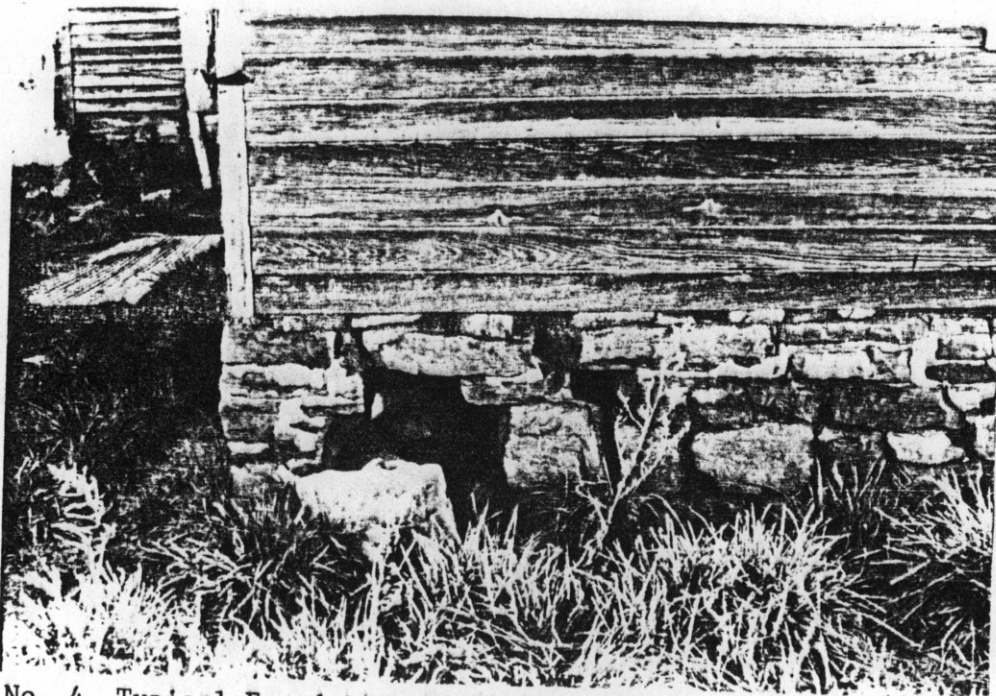
The foundation under Section B, is constructed of mortared field stone, and is butted against the foundation of Section A. A partial basement exists under Section B. The basement extends the full width and approximately 2/3 the length of the wing. A date "1916" with the initials "J.P.A." is scratched into the pargeted concrete wall. The excavation of the basement may post-date construction of the wing.

No. 4 Typical Foundation Condition, Section B

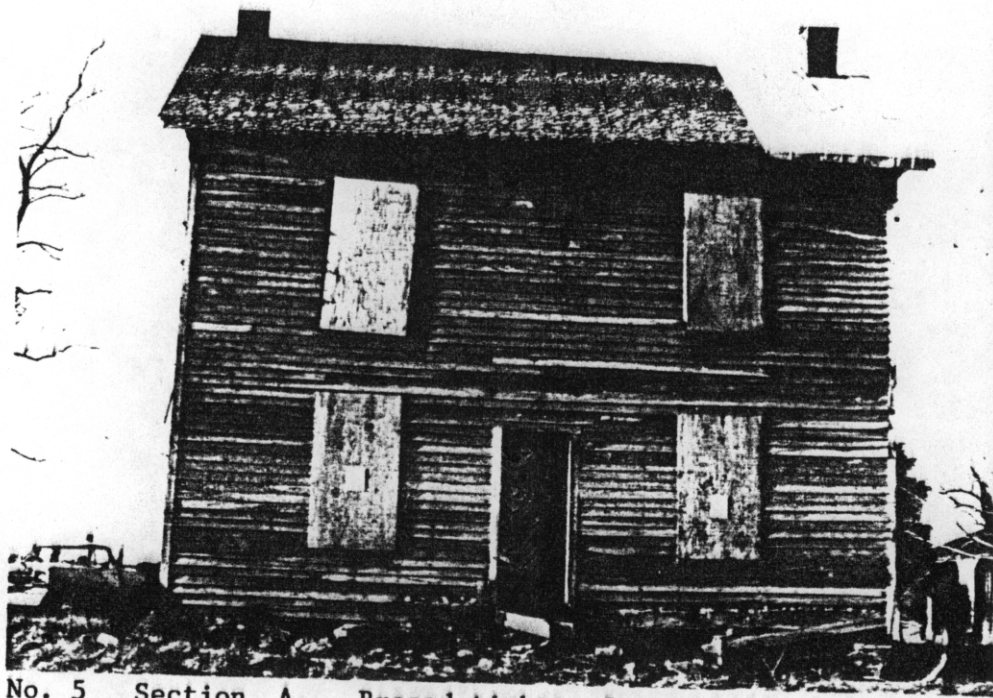
The construction of Section A represents two distinct phases of building activity, and incorporates isolated, nonstructural elements from a third, distinctly earlier, building period. From the second floor plate down, the structure is a braced timber frame characterized by hand hewn sill plates and corner posts, with vertically sawn studs, joists, and knee braces, mortise and tenoned at framed joints. Water or steam powered vertical saw mills were the predominate method of manufacture of framing lumber from c.1830-1870, before the general use of circular sawn material, however, vertical saw mills continued to operate in many areas through the end of the 19th century. Nailed connections throughout the structural frame employ machine made cut nails of a type generally used after 1835. The voids between the studs contain remnants of mud and straw infill used as insulation.

No. 5 Section A, Braced timber frame, sill plate and second floor plate visible

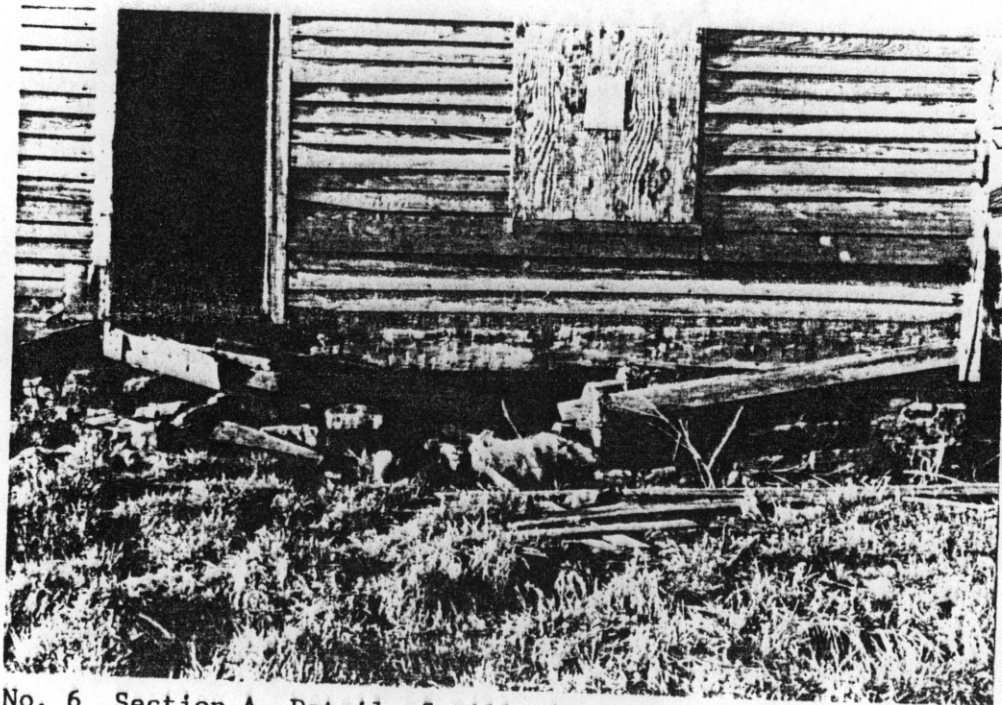
Several unusual and/or noncontextual features are evident in the braced timber frame. The west elevation was constructed without knee braces at the corner posts. A single through dovetail mortise is cut into the south elevation second floor plate, with no evident reference to another member. At the east and west elevations the sill plates are joined at midspan with a half lap joint. This suggests possible reuse of materials.

No. 6 Section A, Detail of sill plate
