Buckland Mill.

Notes 11/8

Buckland Mill. 1900?

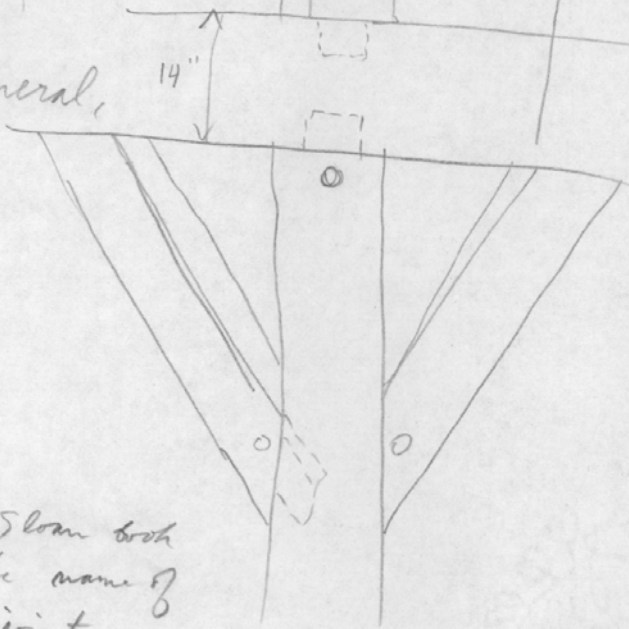
3d floor, scarf joint on long side of beams.  
hewn beams + sawed beams + uprights.

ends of  
tenon  
project  
part  
the post.

joint

clean sawed - circular saw marks.

14"

See Eric Sloan book  
for the name of  
this joint.
