STATE Virginia  
 COUNTY Prince William  
 TOWN OR VICINITY Woolsey  
 STREET NO.  
 HABS SURVEY NO.  
 AIA

2. NAME The Retreat  
 SEE SPACE BELOW FOR MAP OR DIRECTIONS

HISTORICAL SIGNIFICANCE & DESCRIPTION  
 The Retreat is one of the very  
 earliest houses in this area,  
 it has received no care in the  
 last 75 years - poor condition,  
 CONTINUE IN SPACE BELOW

14. NAME, ADDRESS AND TITLE OF RECORDER  
 W.B. Morton III  
 213 S. Pitt Street  
 Alexandria, Virginia  
 DATE OF RECORD August 5, '50

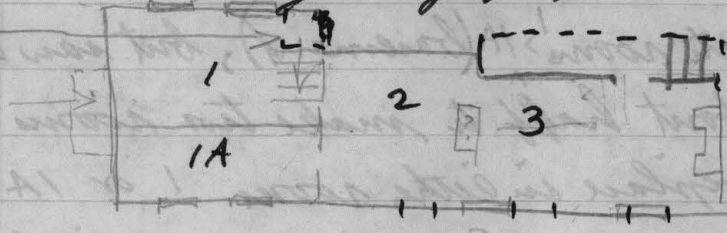
Basement House has a full basement. Room 3 has blackened ceiling + large fireplace. Roof over 3 protects entrance.

missing  
S.C.

to room 3: down 3 wide steps + turn left.  
Basem. is well lighted w/ windows →

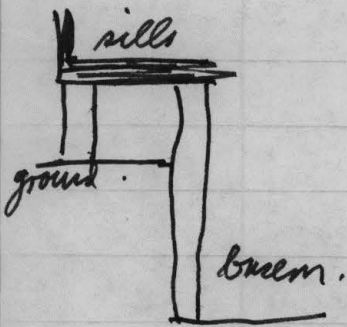
Foundation at rear of 2-story section:

at the back and east side of the newest portion of the house there appears to be a double thickness foundation. It seems that the outermost foundation extends from ground to sill only, a matter of c 2 feet. Behind that, about a foot or so back, is the 2d foundation, which extends from the ~~sill~~ bottom of the house (joists rest on it) to the lowest level of the basement. Could be that newest part was built on found. of east room of older house? What about the chimney? Could it have been rebuilt later and ~~is~~ a little further E than it originally was?

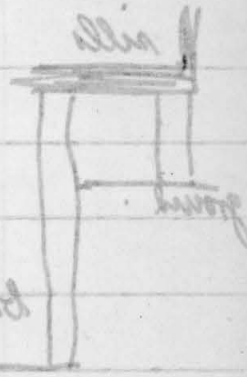
the sketch 10/28

Entrance to the basement. is a mystery. not the entrance but the fact that it is well protected by ~~an~~ a projecting <sup>and</sup> ledge, and steps down to basem. are wide - c 42" and low (3 of them). Could cooking + food prep. have been done down there, then the food carried upstairs to the dining room. Which room was the dining room?

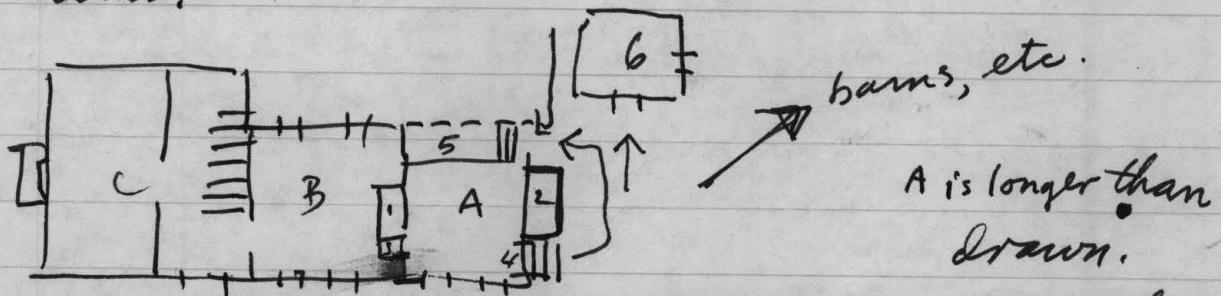
1. is a fireplace in the center portion of the house possibly the west parlor, or possibly the dining room.
2. is fireplace in <sup>quite</sup> a winter kitchen, final food preparation room, or dining room. b.p. is rather small.
3. is a pantry beside f.p. ① but it opened onto room A.
4. is a missing stair case to rear entrance of portion A of house.
5. is the entrance to the basement.
6. a small stone house w/ pent roof.
