Monroe 5-3

## Condition

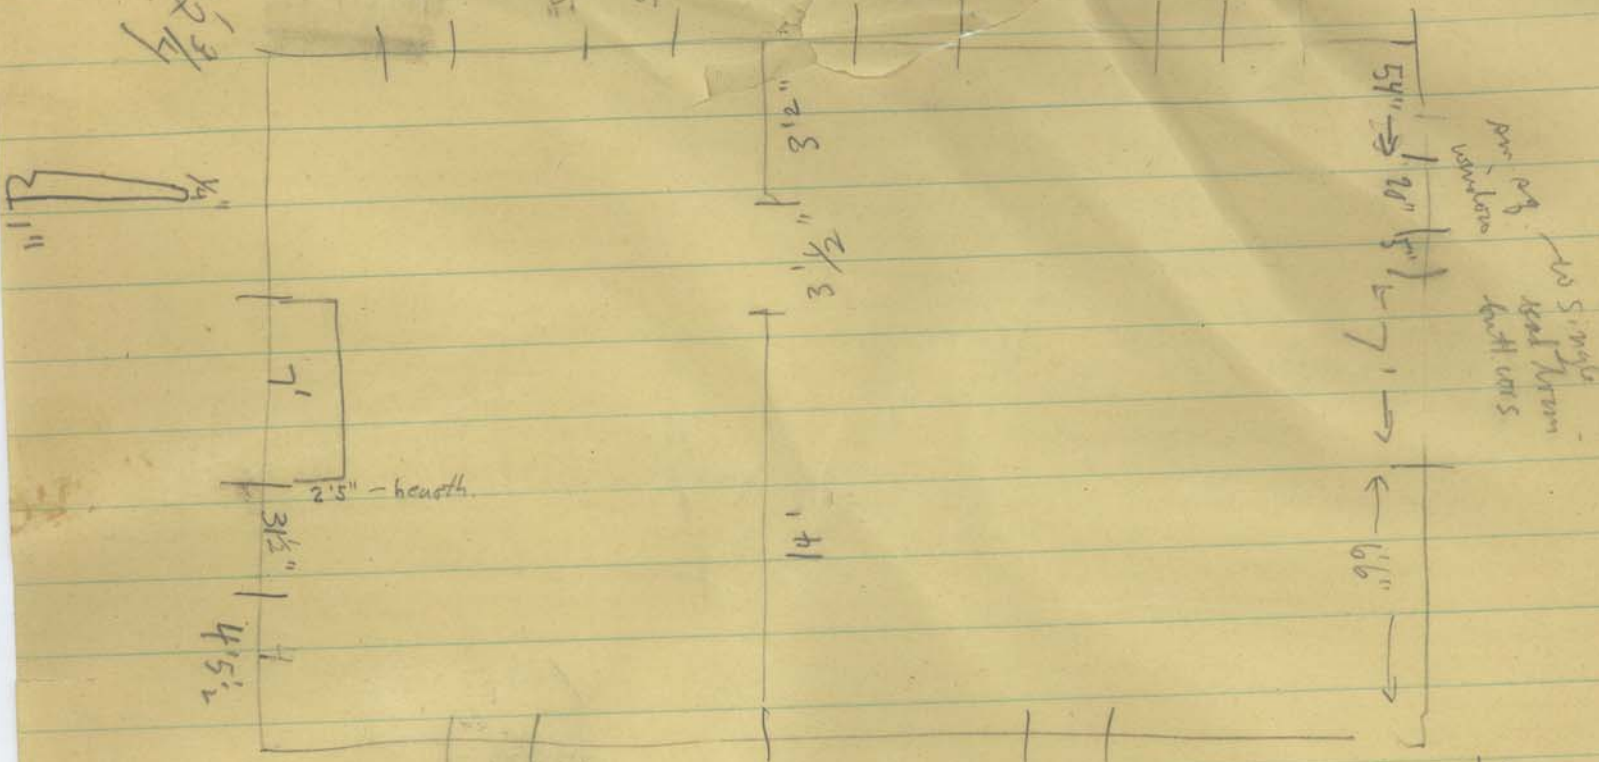
Measure 5-3

Window  
base for  
6'6" 8'10"

per  
window  
to 5' high  
head from  
floor to top

3'1" 5'4" 12'6" 17'2 1/2 20'2"

join  
between  
2 rooms.

3'1" 5'5 3/4

30'2 1/2 to  
end of logs  
30'3 1/2 to end  
of wall  
incl siding

width  
window  
frame  
outside dim

2'11" 5'6"

foundation 5' high  
height sleepers to sill 7'9"
