VIRGINIA
HISTORIC LANDMARKS COMMISSION

SURVEY FORM

Historic name Brentsville Union Church	Common name AKA Brentsville Pentecostal Church
County/Town/City Brentsville, Prince William County	
Street address or route number vic. 12249 Bristow Road, Bristow, VA 22013

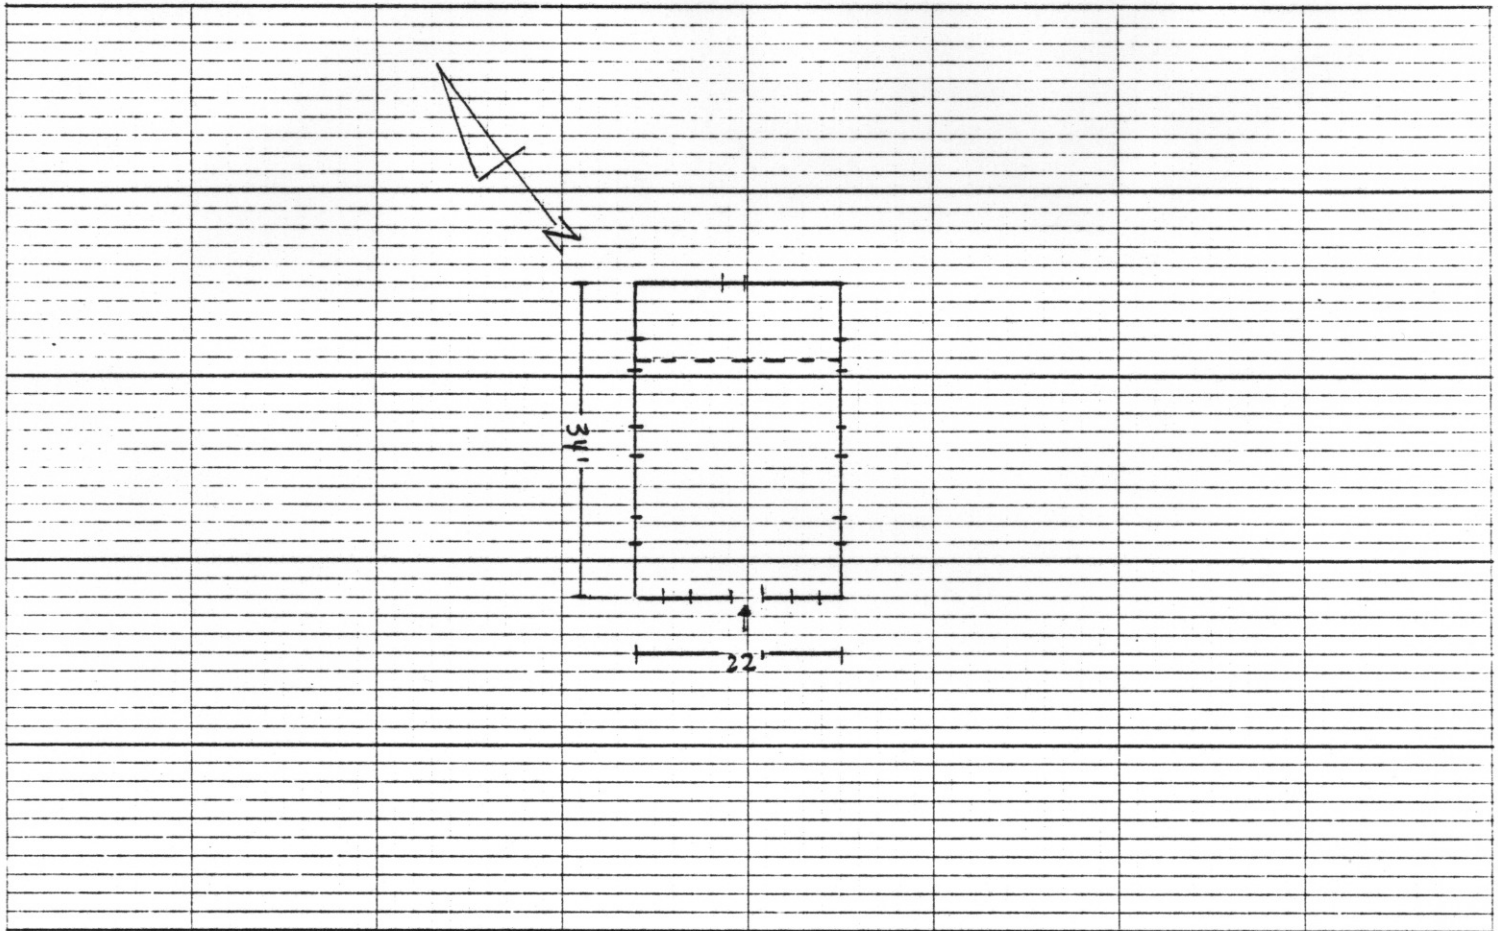
Plan (Indicate locations of rooms, doorways, windows, alterations, etc.)

The 22' x 34' wooden frame church rests on a stone foundation. It is covered in 5 1/2-inch lap weatherboards previously painted white, and has a moulded cornice, a plain wide frieze, cornerboards, and gable returns. Atop the roof is a frame-built gable roofed-belfry having bracketed corners but possibly having lost some of its ornamentation. The large 2/2 sliding sash windows across the front and along each side have bracketed hoods and are flanked by green-painted shutters. The front entrance likewise has a moulded, bracketed cornice, or hood on brackets. The double door has two moulded panels per door, the upper panel with a circular arch. There is a three-light overhead above the door. The door has mortice locks, a metal knob and metal faceplate.

Inside is a large, high-ceilinged room with plaster walls painted blue-green and wide, plain, box trim with a single bead, painted brown. Four drop light fixtures hang from the ceiling. There is a hole in the east wall for a stovepipe. The wide baseboards show the former locations of the pews which have all been removed. Some, if not all, (14 total) of the brown-painted, crudely-made, simply-decorated pews are piled onto the 8 1/2-foot wide platform at the rear. The remains of an old, 3-foot-high, 14-foot-long moulded rail with a square, moulded post and turned balusters are stored at the front of the church. The floors are rather wide tongue-and-groove pine, needing some repair. The plaster walls are cracked as is the ceiling. Some of the floor joists may be damaged. Some of the window panes are missing.

The grounds need some work, and the building should be made weather and vandal-safe.

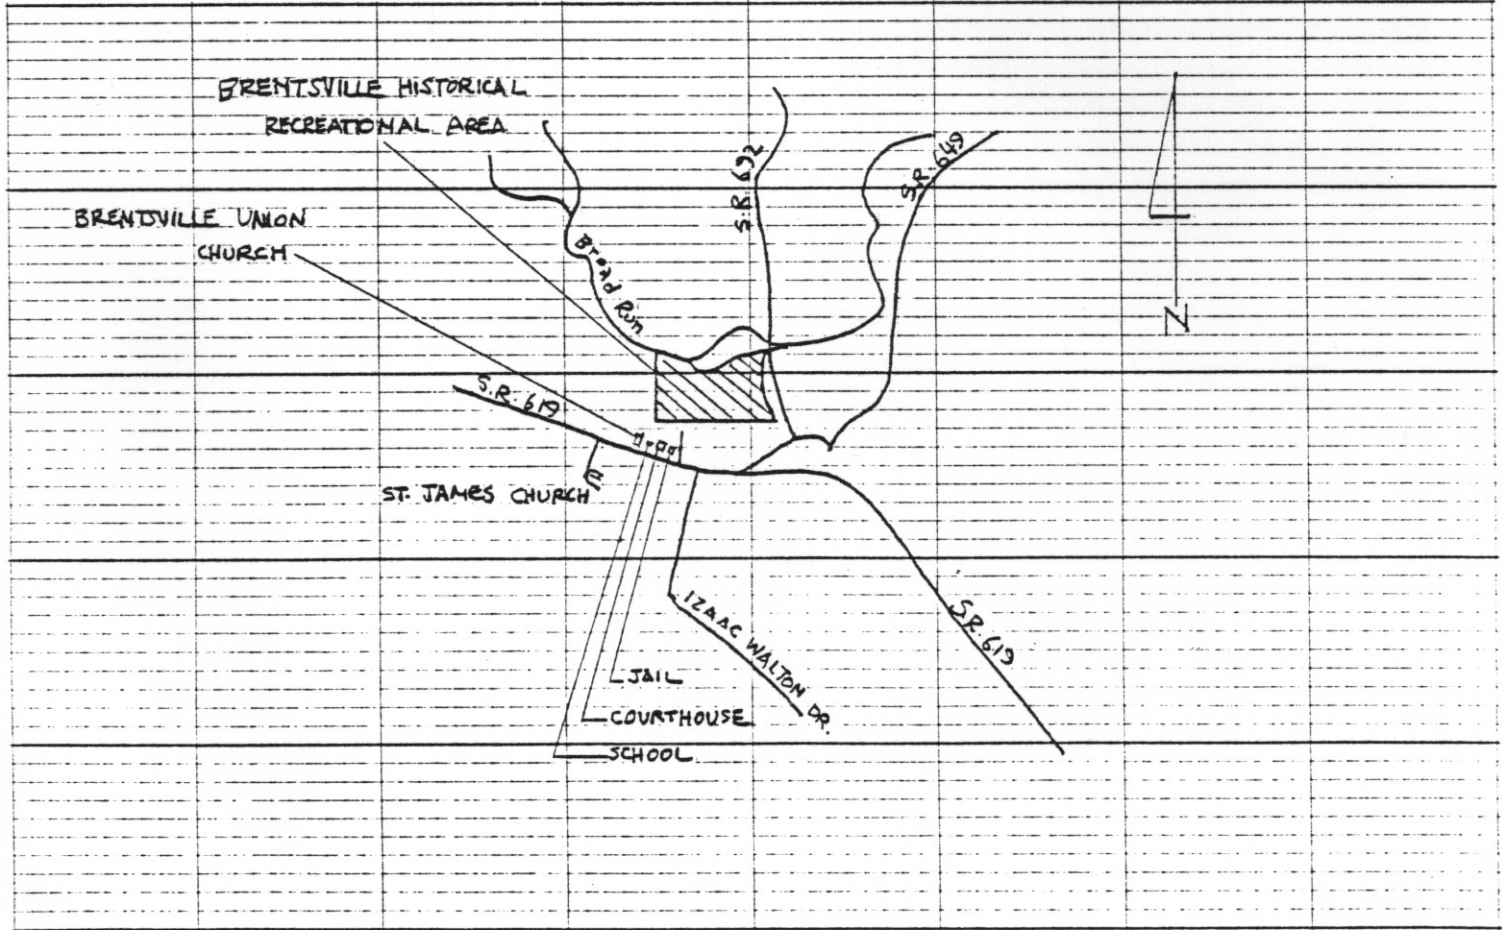
Site plan (Locate and identify outbuildings, dependencies and significant topographical features.)

Brentsville Union, Pentecostal, Church is located on a 50' x 50' part of the "old tavern lot," a 3-acre parcel set aside when the town of Brentsville was laid out in 1820.
