Grayson Family Tomb Stabilization Project

Prince William County, Virginia

January 2017

Prepared by
Justin S. Patton
Prince William County Archaeologist

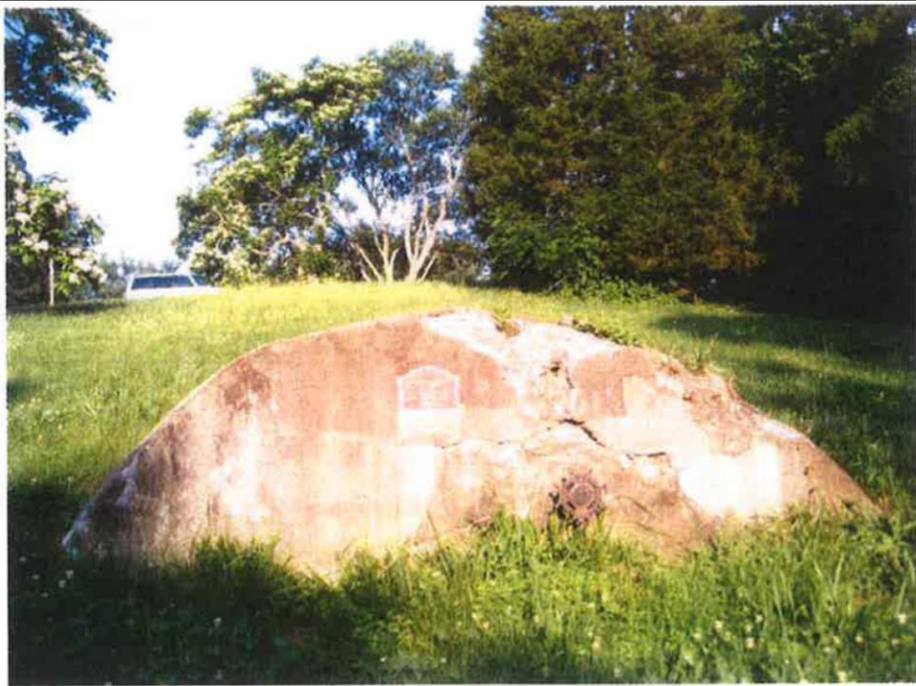
Figure 3-2. Plate 3 and 4 Showing Condition of Tomb Prior to the Cemetery Delineation (from Jirikowic 2005)

PLATE 3
Grayson's Tomb, View to West

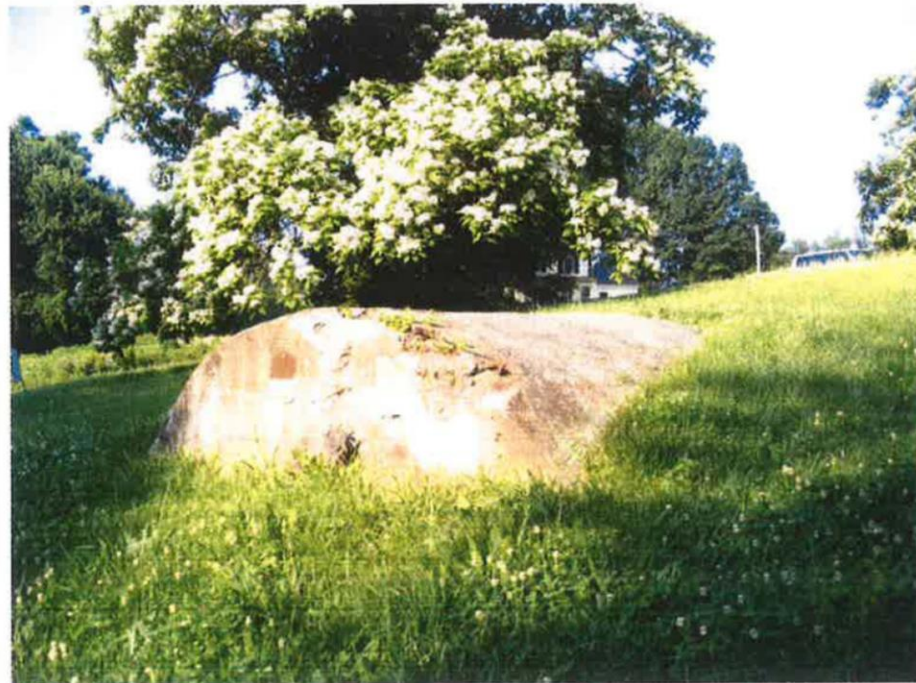
PLATE 4
Grayson's Tomb with Stonnell House in Background, View to Southwest

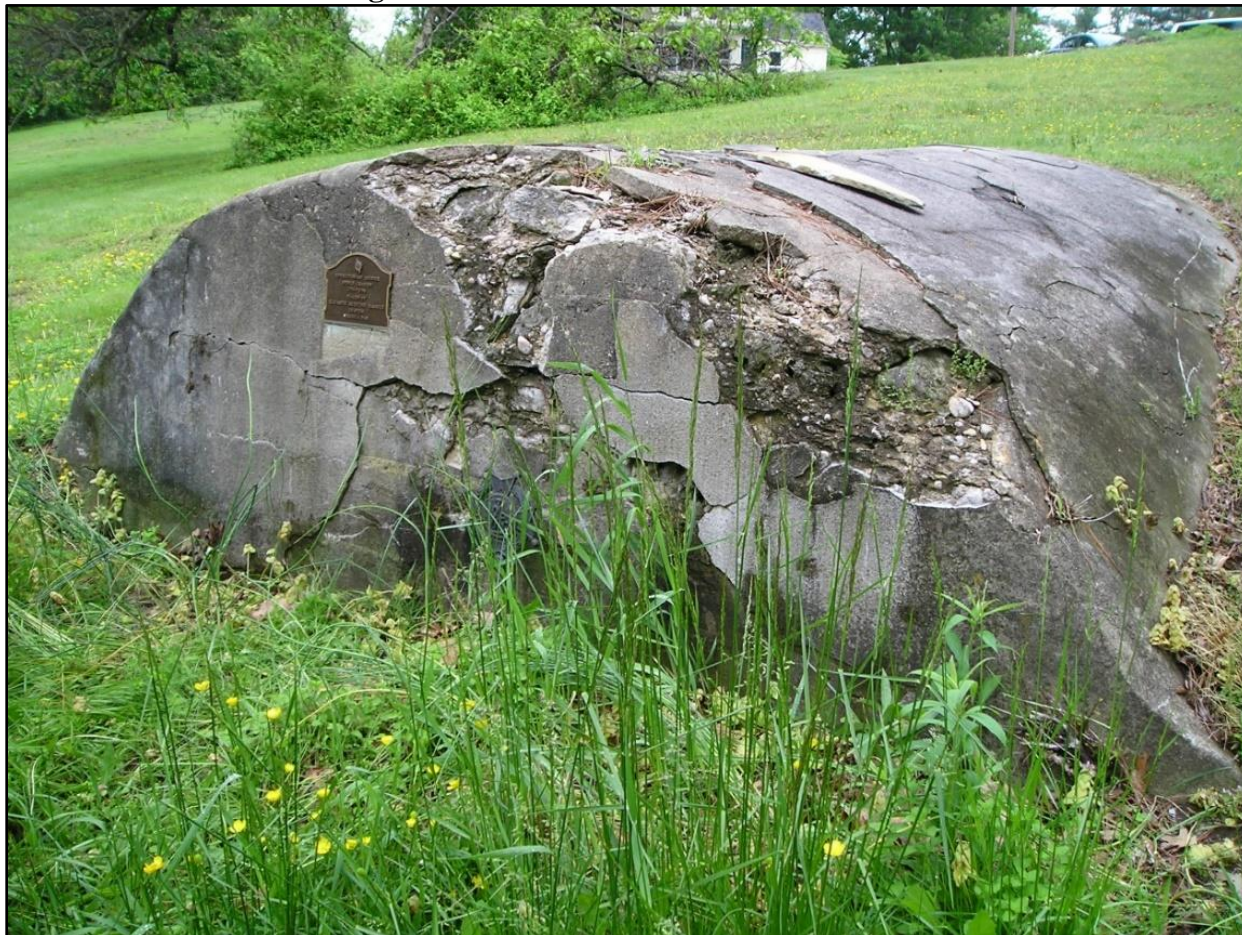
The Tomb is a semi-barrel shaped vault cut into the hillside. It measures 3.10 meters (10 feet) south to north and 4 meters (13.1 feet) east to west. It is covered in multiple skim coats of mortar. Holes or breaches in the very top of the east wall show the arch is made of irregular shaped rock, joined with mortar with a high content of Portland cement. The skim coats are spalling.

Plate 3-1. 2013 Facing Southwest at the East Face of the Tomb. Notice extensive spalling of skim coats and holes through the Tomb

Chris Robinson and Moss Rudley from the National Park Services, Historic Preservation Training Center, visited the Tomb on June 5, 2013. They observed, it was not a nicely constructed arched tomb and the south wall appeared misshapen. They recommended additional archival research, core sampling of the Tomb's walls to determine its composition and to obtain a cross-section of the wall, and video borescope the Tomb's interior. Identification of the Tomb's materials might help date the structure. A primary goal of the restoration effort should be to stop water infiltration into the Tomb.

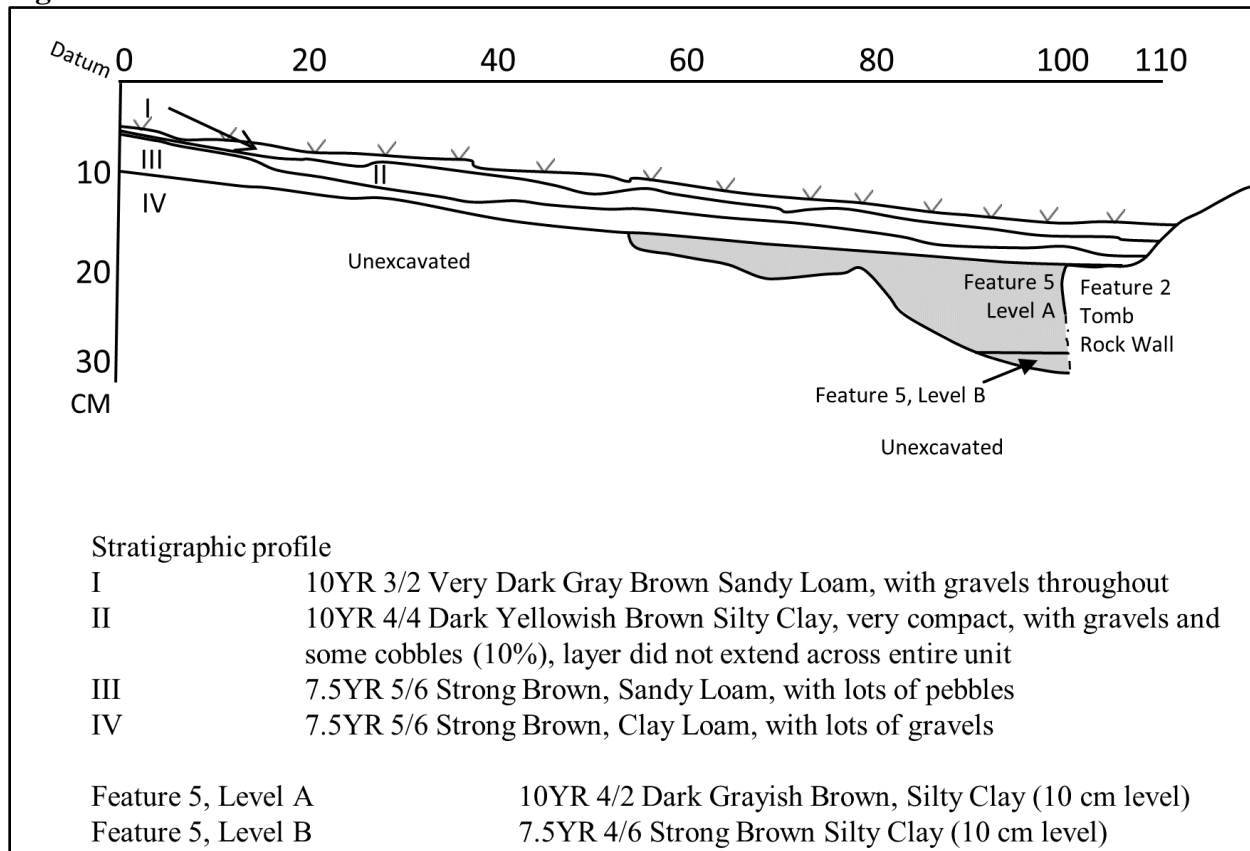
Figure 4-3. North Wall Profile Test Unit 2.

Feature 5 was found in the east third of Test Unit 2, adjacent Feature 2, the Tomb (Figure 4-3). At its farthest from Feature 2, it extended 32 centimeters but narrowed as the depth increased. Two levels were observed. Level A soil consisted of a 10YR 4/2 Dark Grayish Brown, Silty Clay and was approximately 10 centimeters in depth. Artifacts recovered included wire nail, unidentified nails, pieces of slate, clinker, flat glass (not window glass) and pieces of ironstone (Table 4-10). Level B soil consisted of a 7.5YR 4/6 Strong Brown Silty Clay packed tightly around rock (Figure 4-3 and Plates 4-6, 4-7). Excavation was terminated at 6 centimeters although the level continued to extend and narrow. No cultural material was recovered in Level B. Level A appears to be fill from the twentieth century and is likely a result from application of a skim coat over Feature 2. Feature 5, Level B, appears to be a builder’s trench. Excavation was terminated due to the interpretation that further removal of rock might damage the Tomb’s west wall.

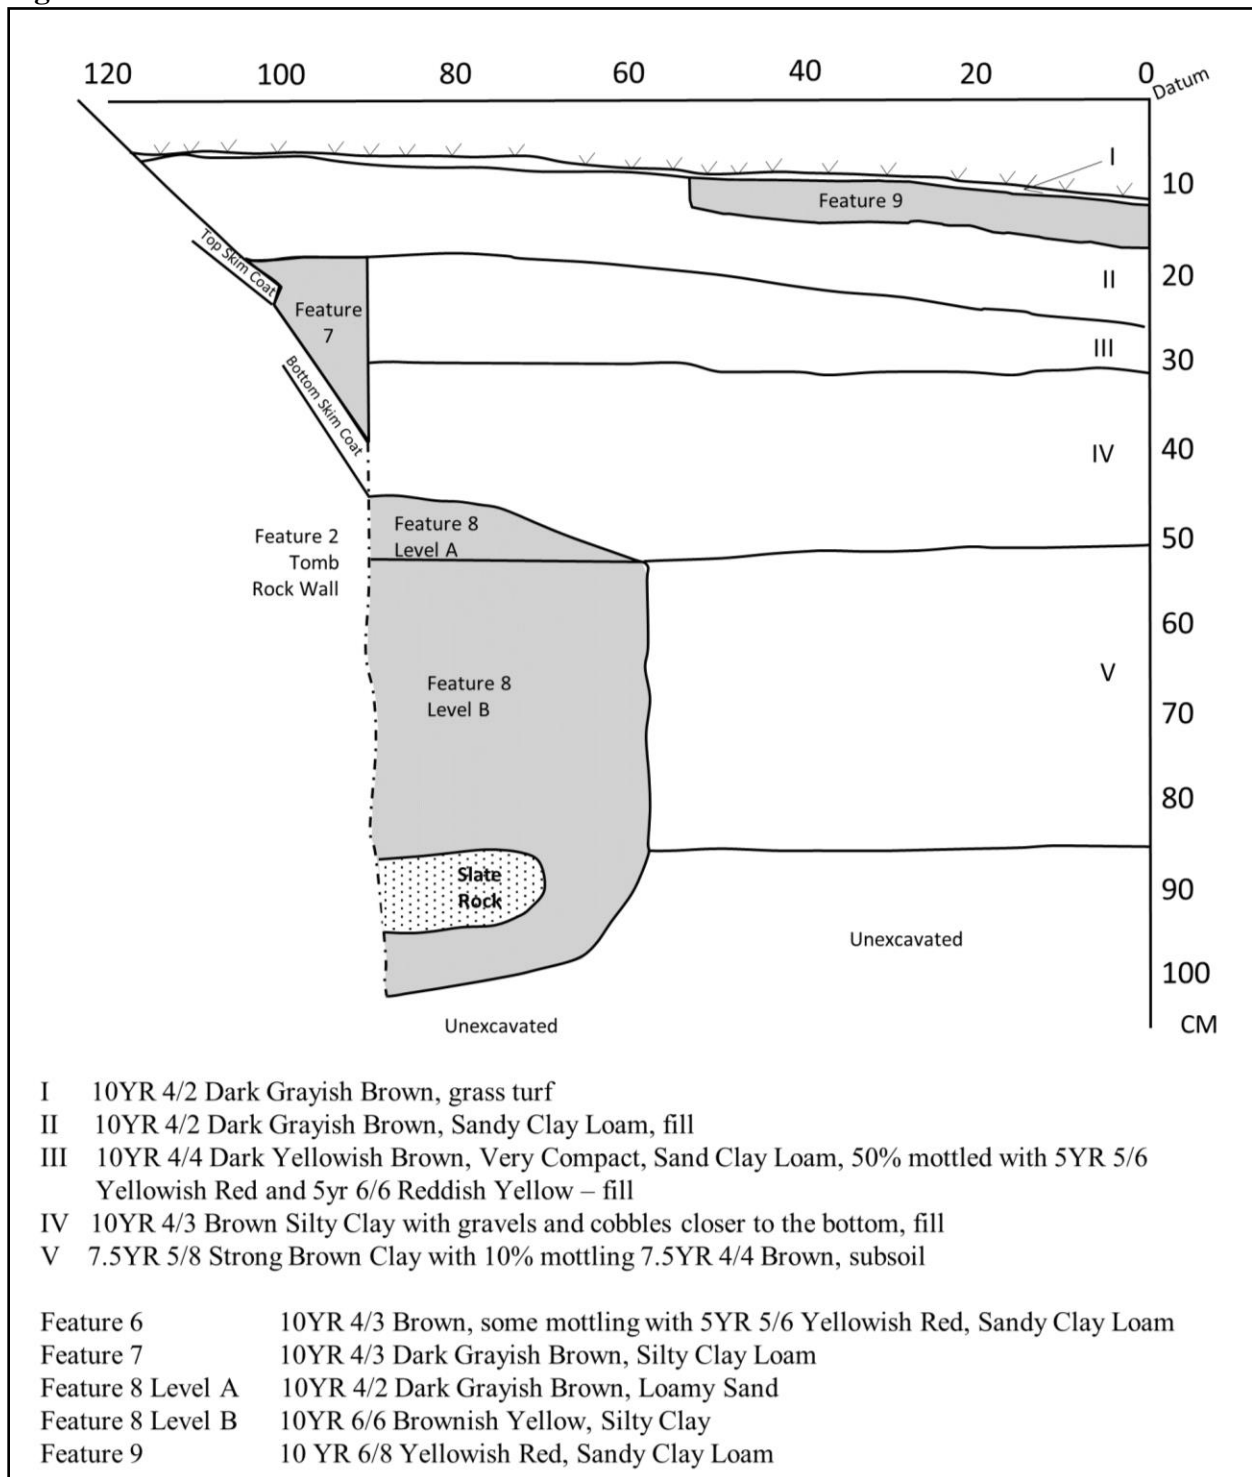
Figure 4-4. Test Unit 3 West Wall Profile

Feature 7 was found in Test Units 3 and 4, adjacent Feature 2, the Tomb (Figure 4-4). It was a band of dark soil extending 7 centimeters from Feature 2 and was 20 centimeters deep. It consisted of a single level of 10YR 4/3 Dark Grayish Brown, Silty Clay Loam. Artifacts recovered included the following: asphalt shingle, mortar, unidentified nails, lamp glass, melted container glass and a small steel plate. Feature 7 appears to be backfill from a builders or repair trench excavated when the top skim coat was applied to Feature 2. Based on the artifacts this might have occurred during the mid-to-late-twentieth century. See Figures 4-4 and Plate 4-2 to review the relation of the top skim coat to Feature 2.

Feature 9 was found in Test Units 3 and 4 beneath Stratum I (Figure 4-4). It extended from the north wall in both test units on average 20 centimeters and at a maximum 52 centimeters. It was approximately 5 centimeters in depth. Soil consisted of a 10 YR 6/8 Yellowish Red, Sandy Clay Loam. No cultural material was recovered from Feature 9. It was determined during excavation this was overburden from backfill operations from the 2005 cemetery delineation.

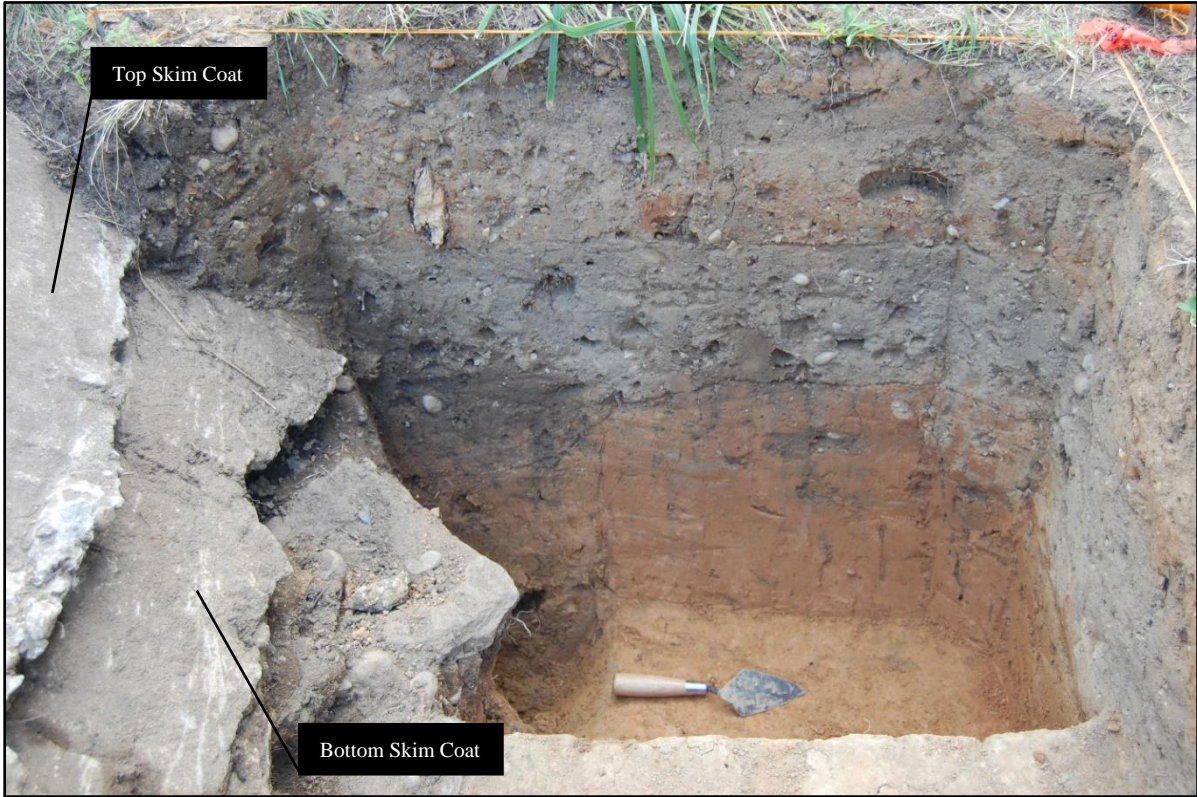
Plate 4-2. Test Unit 3, West Wall showing Feature 2, excavated Features 7, 8 and 9

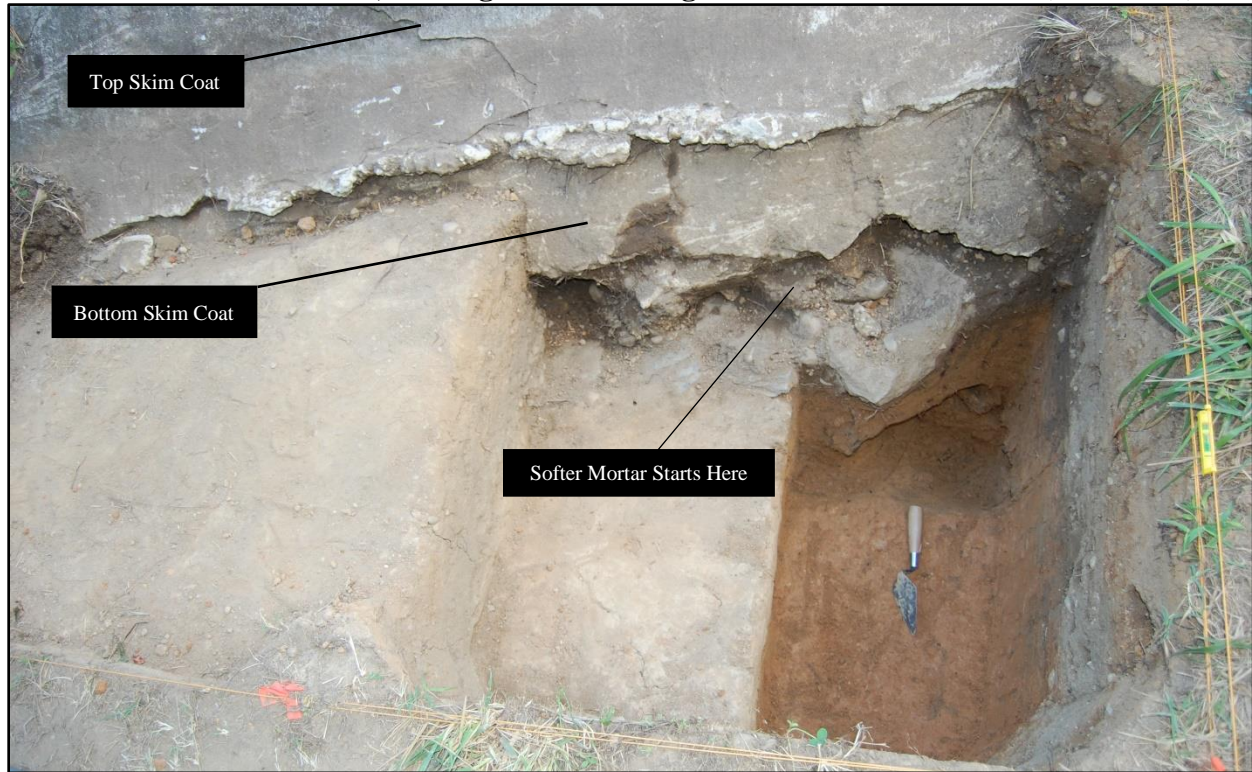
Plate 4-5. Test Unit 3 and 4, looking south showing Feature 2 and Feature 8 (excavated)

Feature 8 was found in Test Unit 3 and adjacent Feature 2 (Figures 4-4 and 4-8, Plate 4-5). It was a band of dark soil extending north from Feature 2 for 31 centimeters and extended into the east and west walls. Its maximum depth was 52 centimeters. As excavation deepened the feature narrowed. It consisted of 2 levels. Soil in Level A consisted of a 10YR 4/2 Dark Grayish Brown, Loamy Sand. Level A was 9 centimeters deep. Artifacts recovered from Level A included the following: window glass, mortar, cut nail, slate, bike chain, unidentified metal object, and a quartz flake. Soil in Level B was 42 centimeters deep and consisted of a 10YR 6/6 Brownish Yellow, Silty Clay. Artifacts recovered from Level B included the following: cut nails, unidentified nails, pieces of slate and a large slate cobble (discarded in the field) near the termination of excavation (Table 4-13).

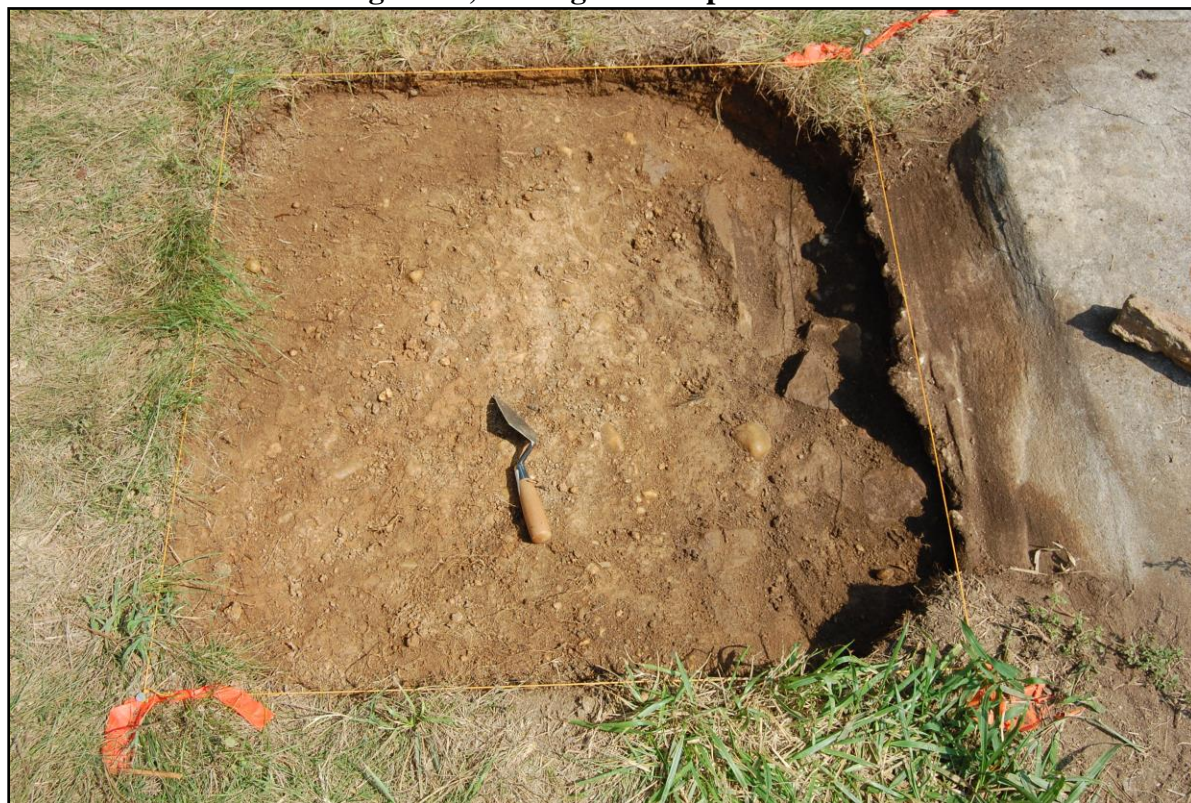
Plate 4-6. Test Unit 2 facing north, looking at the top of Feature 5 and Feature 2

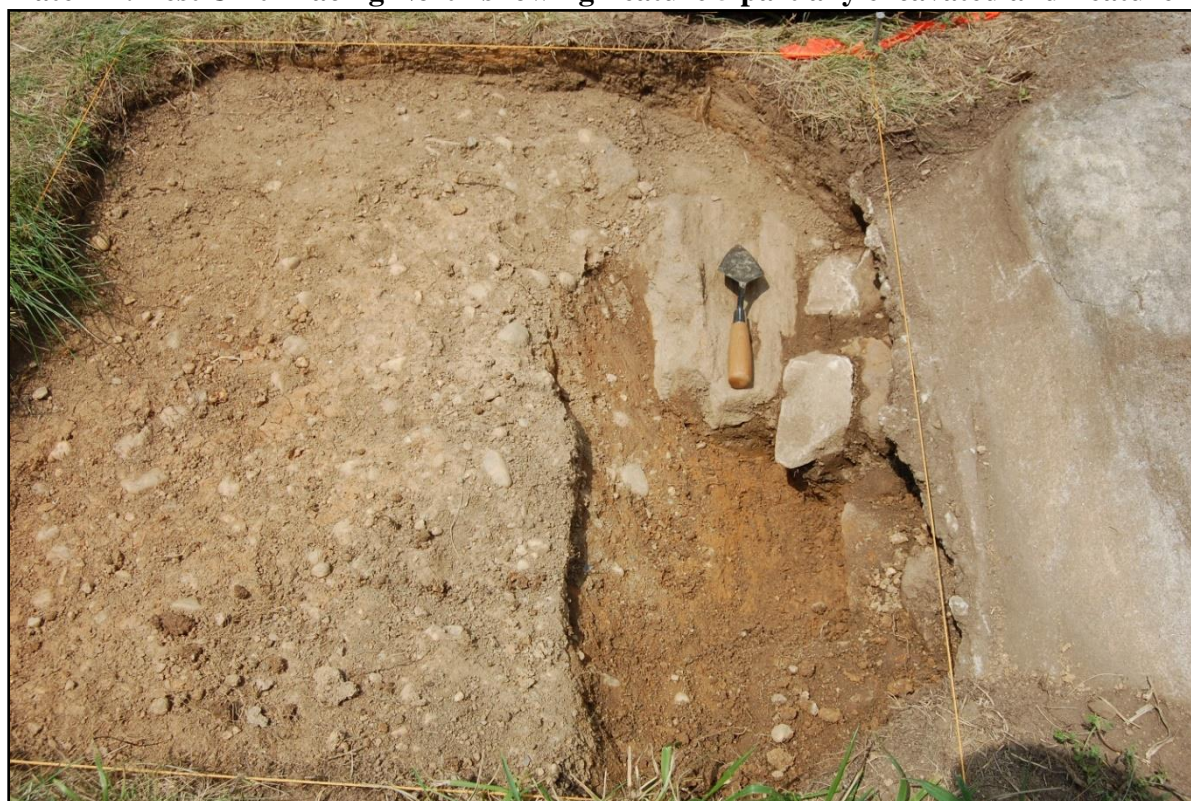
Plate 4-7. Test Unit 2 facing North showing Feature 5 partially excavated and Feature 2

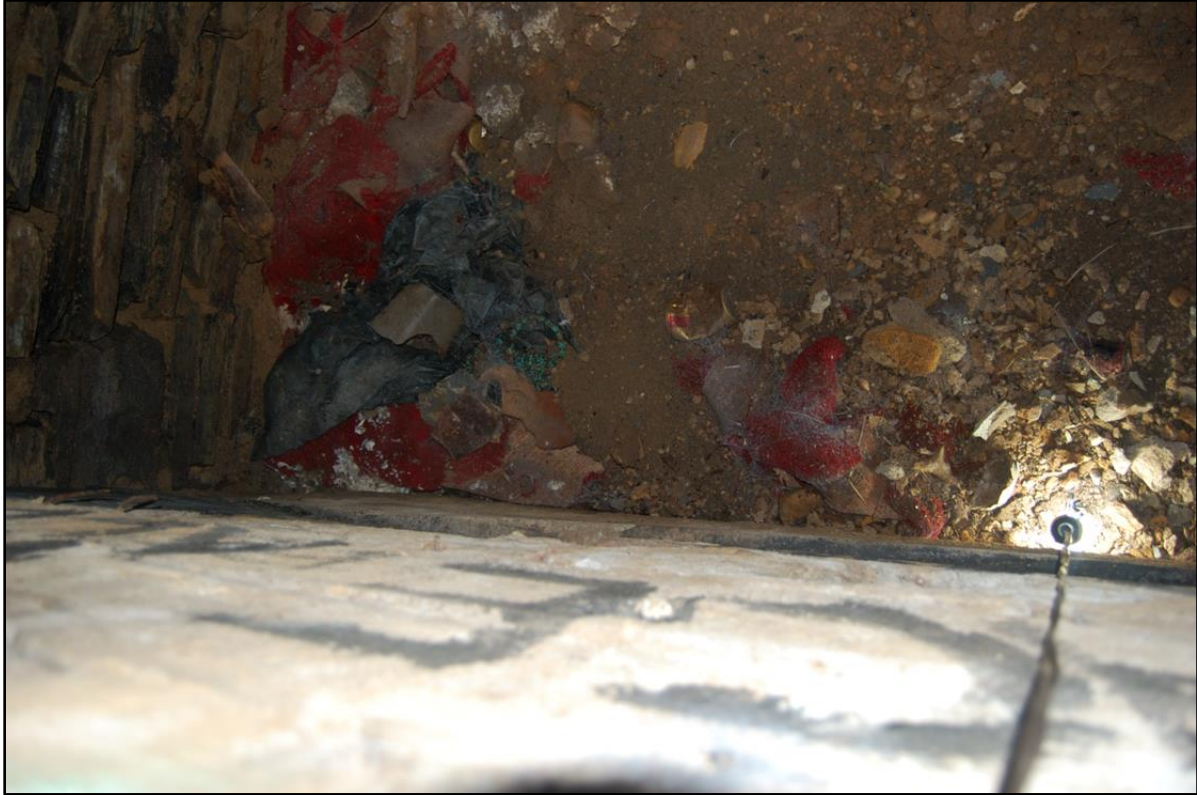
The combination of digital photography, video and stills taken of the video revealed a number of interesting data points. No evidence of human burial skeletal remains was observed. Graffiti on the interior of the Tomb's east wall and detritus on the ground surface inside the tomb (plastic beads, pieces of red shag carpeting, aluminum Michelob beer can [unknown if this is pull tab or stay tab enclosure) confirms people entered the tomb as late as the 1970s and maybe the early 1980s.

Plate 5-3. Tomb's Interior Floor Adjacent the East Wall (note red carpet and beer can)

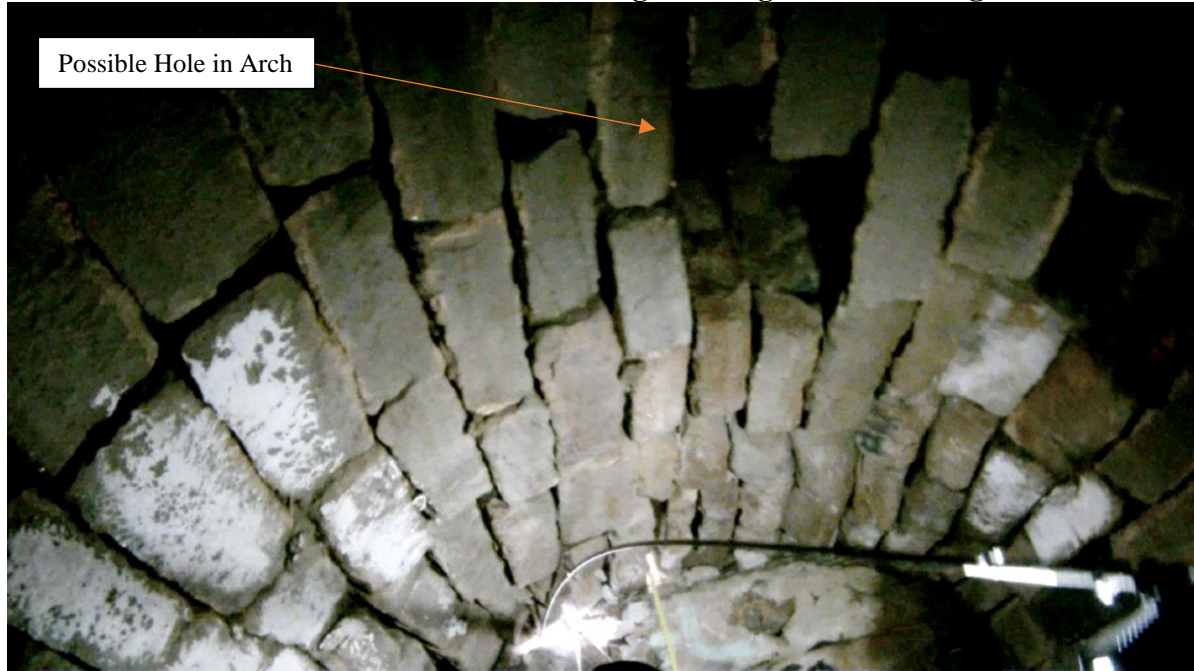
In regard to the existing structural integrity of the Tomb and episodes of repair and reconstruction, Mr. Korzendorfer and Mr. Patton made the following observations: 1) there is presently little or no mortar in between rock comprising the arched ceiling, 2) some chinking was used in the arched ceiling, 3) there is missing stone (hole) near center on the arched ceiling's long axis, and 4) there appears to be a repaired hole in the south wall of the arch. Based on this information, we became very concerned about the stability and structural integrity of the arched ceiling if the top and bottom skim coats over the Tomb's arch were removed. See Plates 5-6, 5-7 and 5-8.

Plate 5-6. Video Still of Tomb's Arched Ceiling Showing Hole – Missing Stone

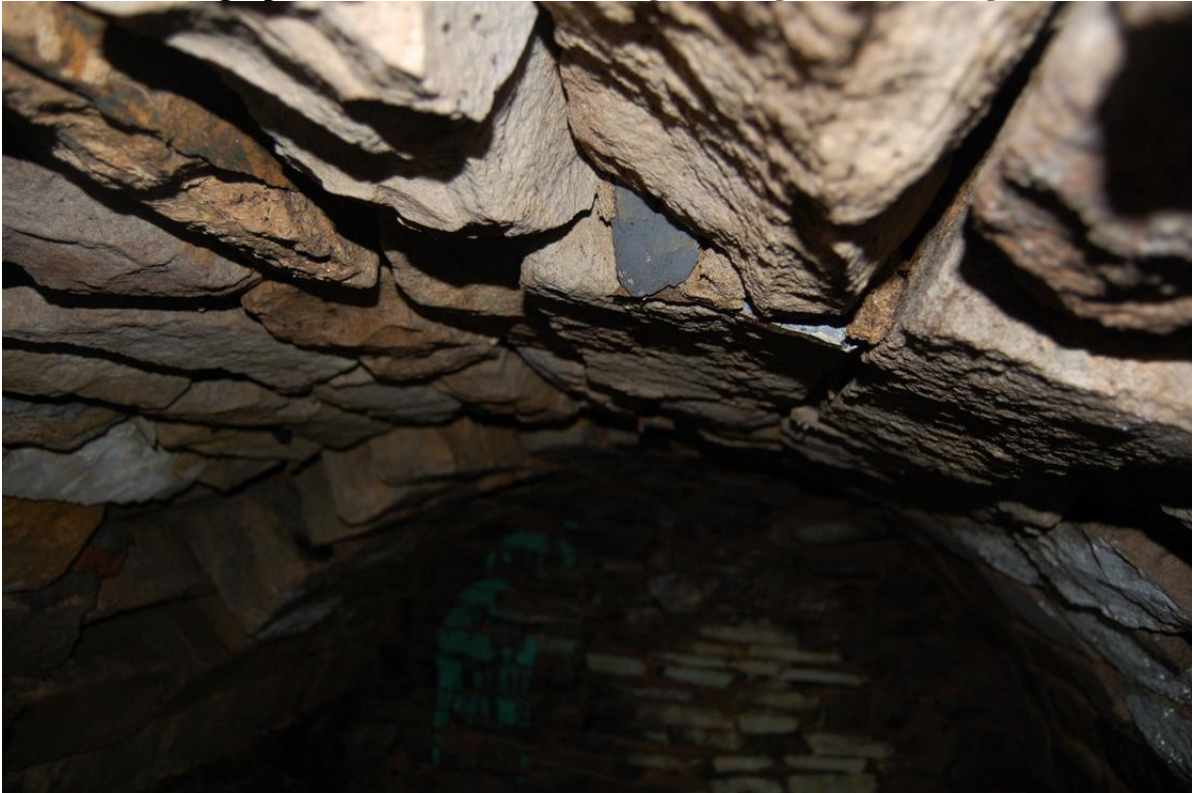
Plate 5-7. Photograph of Tomb's Arched Ceiling Showing Slate Chinking

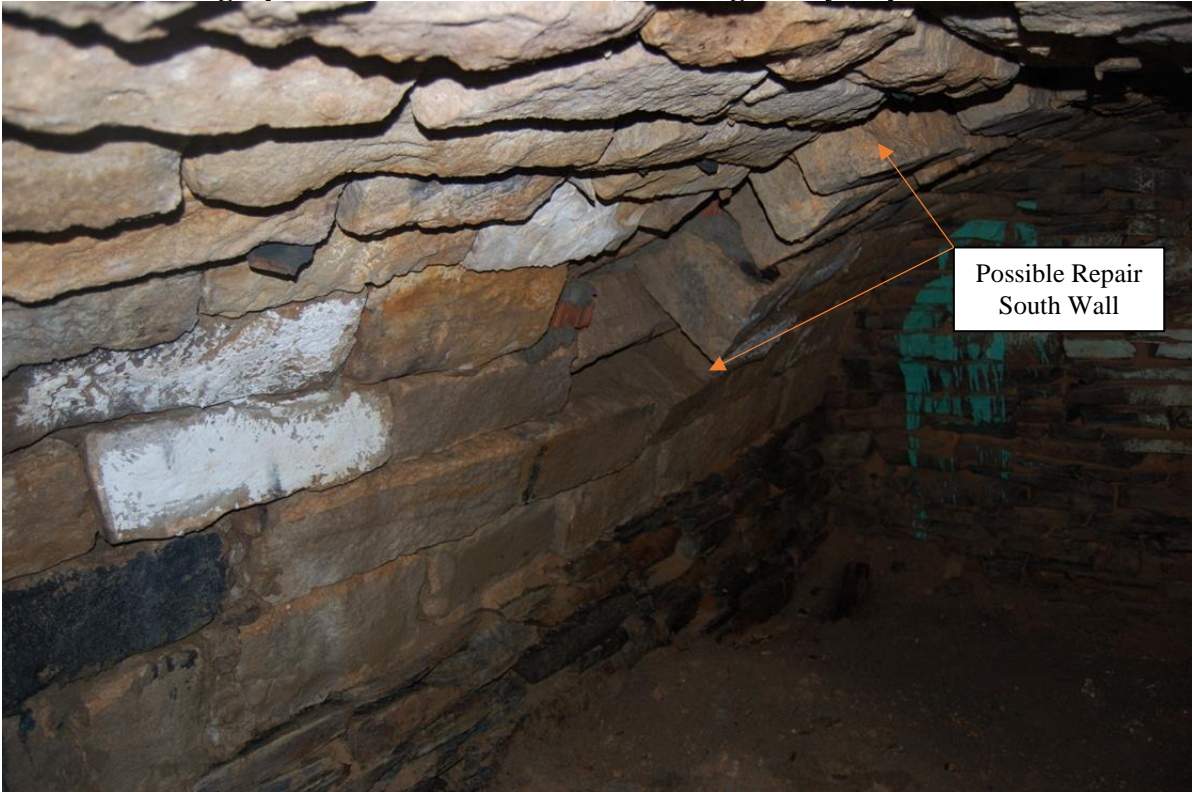
Plate 5-8. Photograph of South Interior Wall, Showing Likely Repair to Tomb's Arch

In the left of the picture is the south wall. At this location the brown fieldstone is estimated to also be 60-70 centimeters above grade in the interior of the tomb. Above the brown fieldstone are large blocks of cut and faced stone and they also extend across the Tomb's arch as described in the north wall. Also in the south wall there appears to be a filled-in hole, and it is speculated this was the result of a repair to the south wall from a breach. See Plate 5-8 for close up of the breach in the south wall.

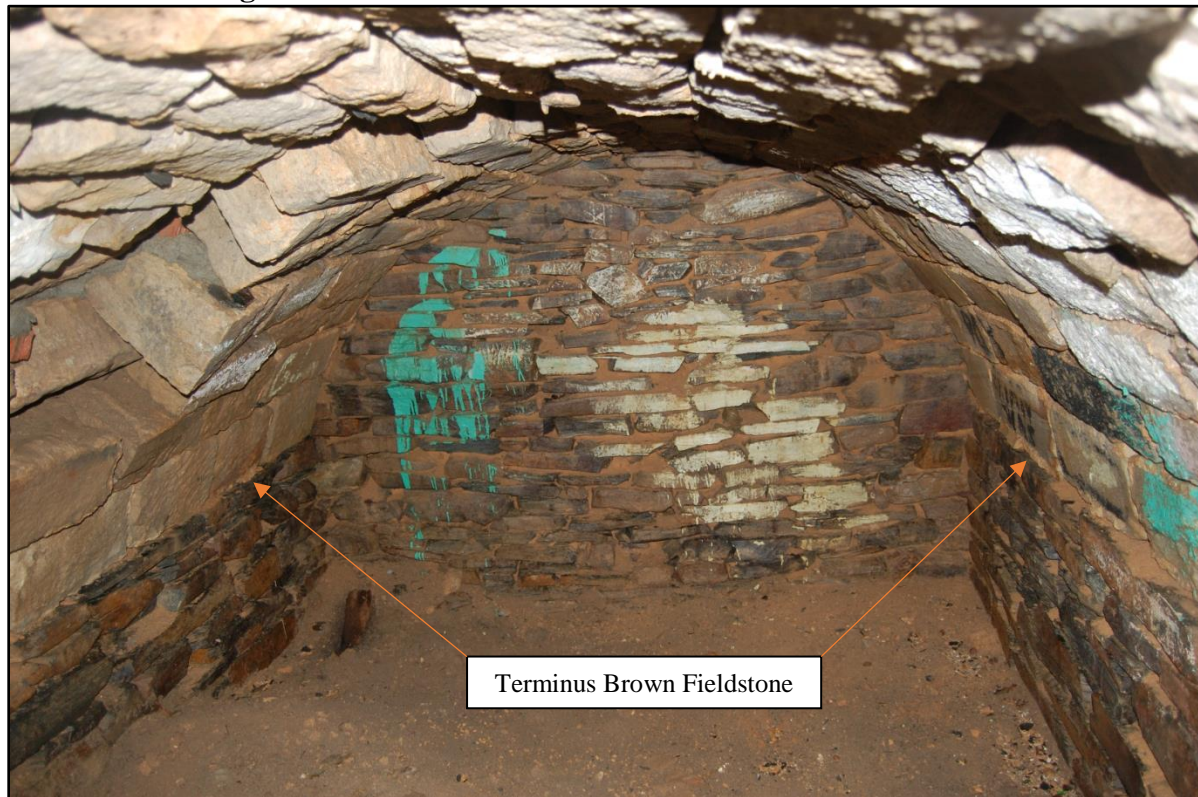
Plate 5-9 is the best example showing evidence of the Tomb's original construction materials and materials used to rebuild and repair the Tomb. In Plate 5-9, notice the brown fieldstone on the west wall (the wall facing you). This brown fieldstone extends from the bottom to the top of the wall. Some of this stone appears to retain whitewash. Others have been vandalized with green paint. On the right of the picture is the north wall. At this location the brown fieldstone was estimated to be 60-70 centimeters above grade in the interior of the tomb. Above the brown fieldstone are large blocks of cut and faced stone. These cut stones are different than the brown fieldstone. Some of the cut stone appear to retain whitewash. They extend across the Tomb's arch to the south wall, in some areas. In other areas it appears a different type of stone is used, with a face not dressed as neatly.

Plate 5-9. Looking at the Interior West Wall from the Breach in the East Wall

In summary, it appears the brown fieldstone was the material first used to build the Tomb. It comprises the lowest elevations of the south and north walls. It also comprises all of the west wall. During archaeological testing of the Tomb's exterior, the west wall exhibited the highest degree of integrity. The cut stone used to make the arched ceiling was very different than the

brown fieldstone and represents a reconstruction. This might be the reconstruction conducted by Stonnell in the late nineteenth century. Finally, there appears to be a repair to the south wall.
