MILLOMA DIVISION OF HISTORIC LANDMARKS

SURVEY FORM

Braymer Fouse

Historic name "Douglas Hall"

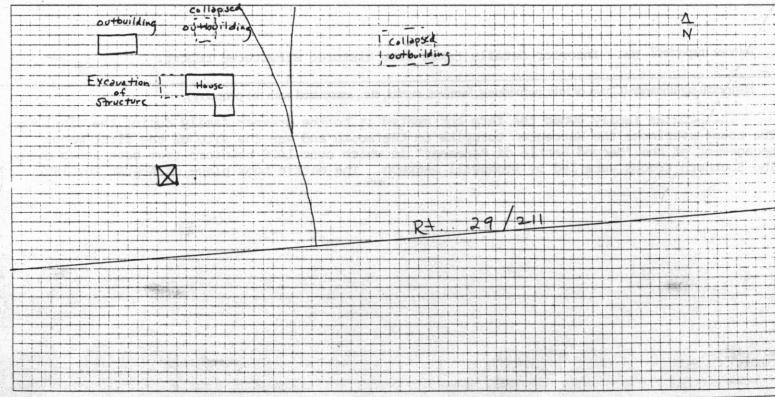
Site plan (Locate and identify outbuildings, dependencies and significant topographical features.)

The side has a garage, an outbuilding, and the sites of two collapsed outbuildings. An earlier structure of wing has been excavated by the National Park Service directly behind the west wing.

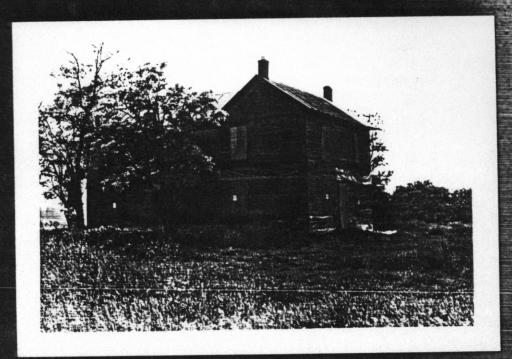
North Facade

The existing structure at "Douglas Hall" is the result of a circa 1904 remodeling which encased the earlier post-and-beam farmhouse. Standing today is a 3 bay, 2 story, L-shaped structure with a metal gable roof, plain weatherboards, a simple cornice with returns, 2/2 sashes and plain cornerboards. There is a central flu in the south wing, and two end, interior flus in the north wing. The entry hall has a cellar beneath it.
