VIRGINIA HISTORIC LANDMARKS COMMISSION

SURVEY FORM

Historic name Brentsville Schoolhouse Common name Schoolhouse in Brentsville
County/Town/City Brentsville, Prince William County
Street address or route number vic. 1 Bristow Road, Bristow, VA 22013
USGS Quad Nokesville Date or period c1910
Original owner Prince William County School Architect/builder/craftsmen
Original use School Board?
Present owner Prince William County Park Source of name
Present owner address 1 Bristow Authority Source of date Architectural evidence
Bristow, VA 22013 Rd. Stories 1 story
Present use Recreation center, conference Foundation and wall const'n Brick foundation; frame walls
Acreage included in Courthouse room
acreage. Roof type Metal-covered gable roof. Shed-roof addition

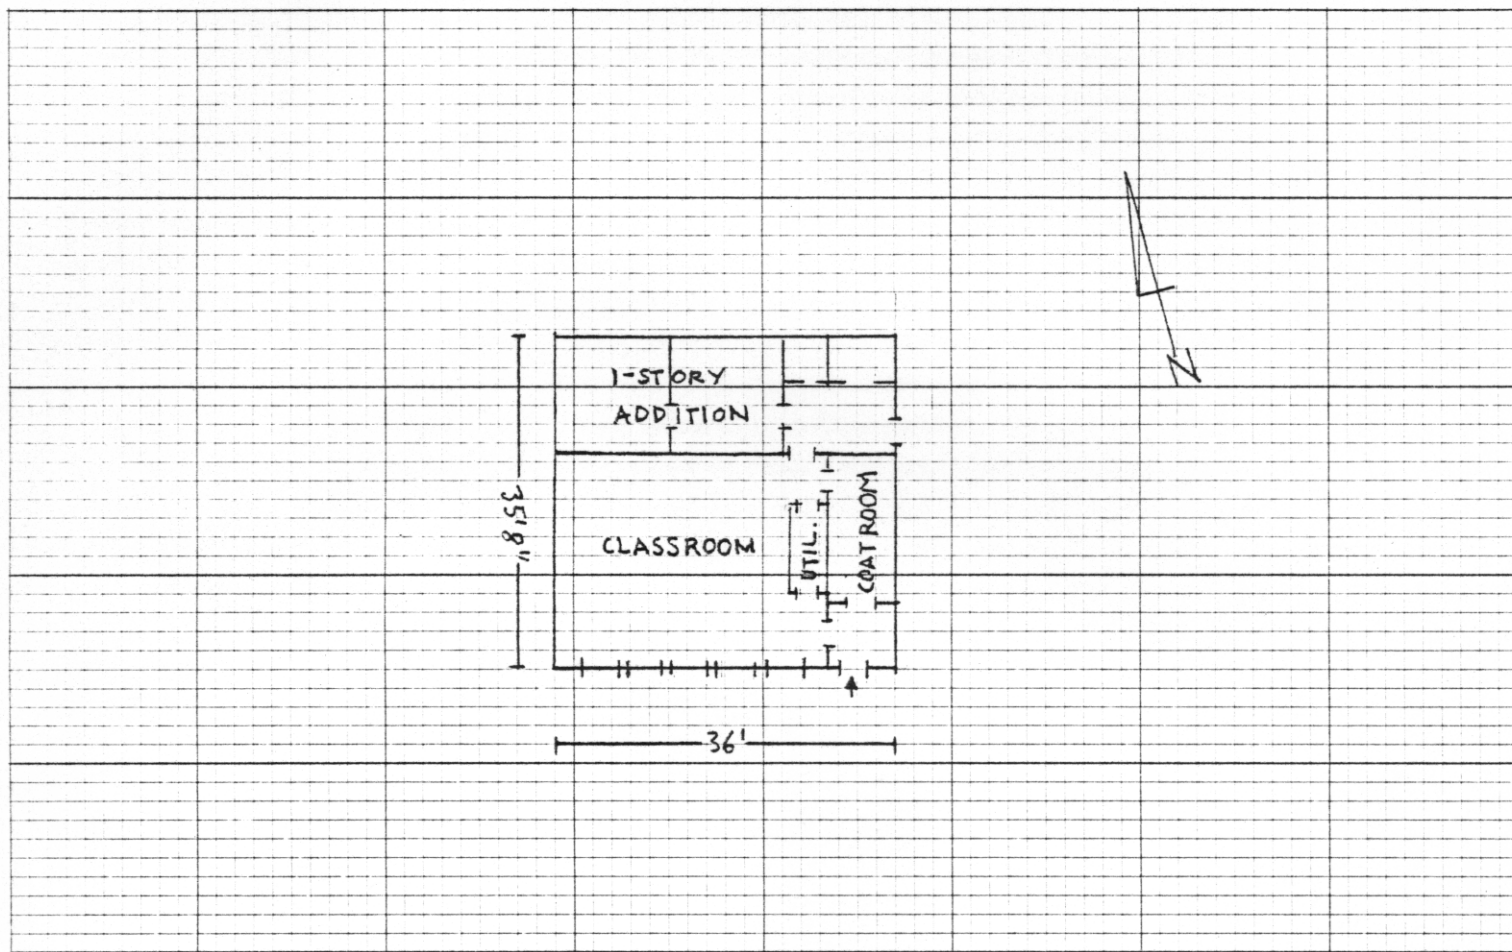
Plan (Indicate locations of rooms, doorways, windows, alterations, etc.)

This is a one-room schoolhouse with 4"-lap weatherboard exterior, plain trim, exposed rafters, deep eaves, and cornerboards. There is a hood on brackets sheltering the front entrance, a 5-panel 20th century door with a 3-light overhead. There is a one-story shed-roofed addition across the rear of the schoolhouse, probably constructed in the 1960's. Five large $\frac{6}{6}$ sliding sash windows on the front light the classroom.

Inside there is a classroom complete with blackboards to the left of the side passage. Behind the lobby is a cloak room which has been converted to a kitchen. There are two work-rooms or offices and two restrooms in the recent addition.

The ceiling of the old school is pressed tin. The electric lights are fluorescent now, but fixtures for the old, hanging lights still exist. An air conditioning and heating unit has been installed in a partitioned-off section on the classroom's east wall. The floors are narrow tongue and groove maple. The walls are covered with plaster and wallboard. There is waist-high wainscotting (matchboard) in the foyer and classroom, while the wainscotting in the former cloakroom is chest high. An entrance to the new addition has been made on the north wall of the classroom. Here it is possible to see where the wainscotting was cut, and the sill, door, and trim are new. The interior doors, except for the utility room and the above-mentioned are 5-panel doors similar to the front door. The interior trim is plain box trim with rounded edges. All woodwork inside is painted light green.

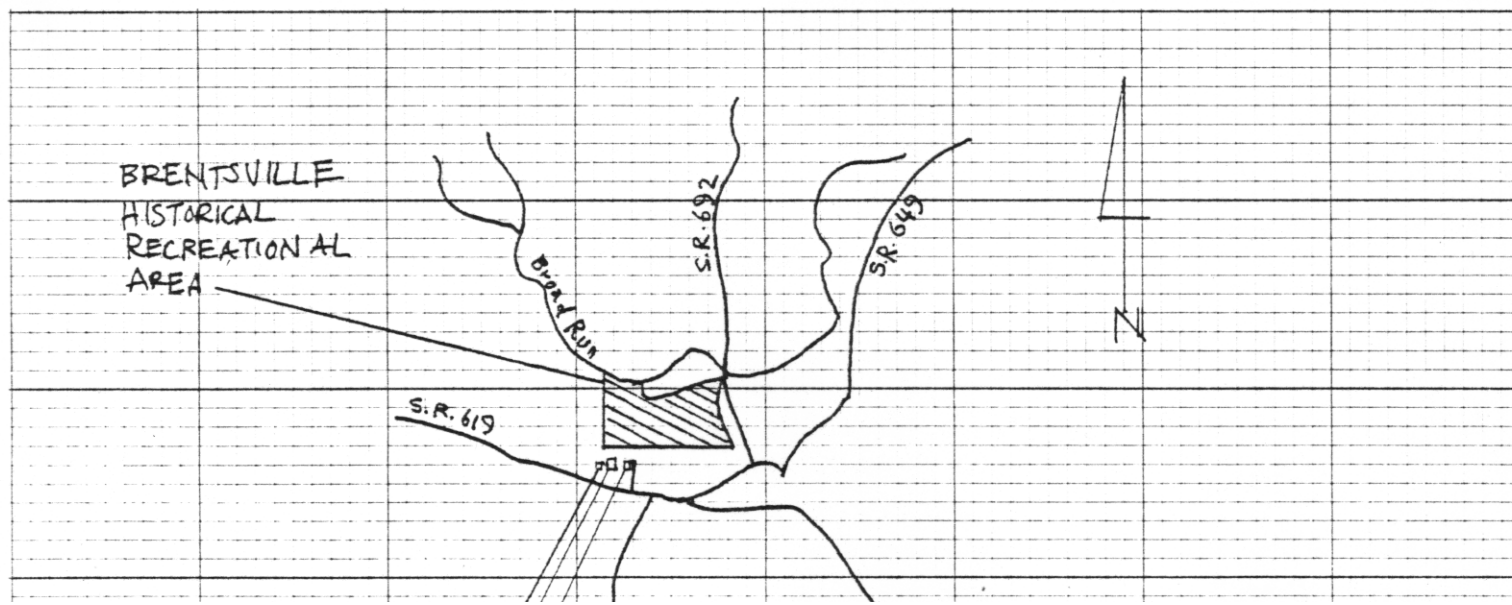
Site plan (Locate and identify outbuildings, dependencies and significant topographical features.)

Brentsville Schoolhouse, located beside the Brentsville Courthouse on the public square, was turned over to the Prince William County Park Authority in 1979. It is included in the 3-acre courthouse parcel, along with the jail. Behind the schoolhouse is the Brentsville Historical Recreational Area's ballfield. The Park Authority uses the building as a meeting place. The rear addition's classrooms are for classroom (arts and crafts) use.
