5-12-80

# Pentecostal (Main) Church Brentsville

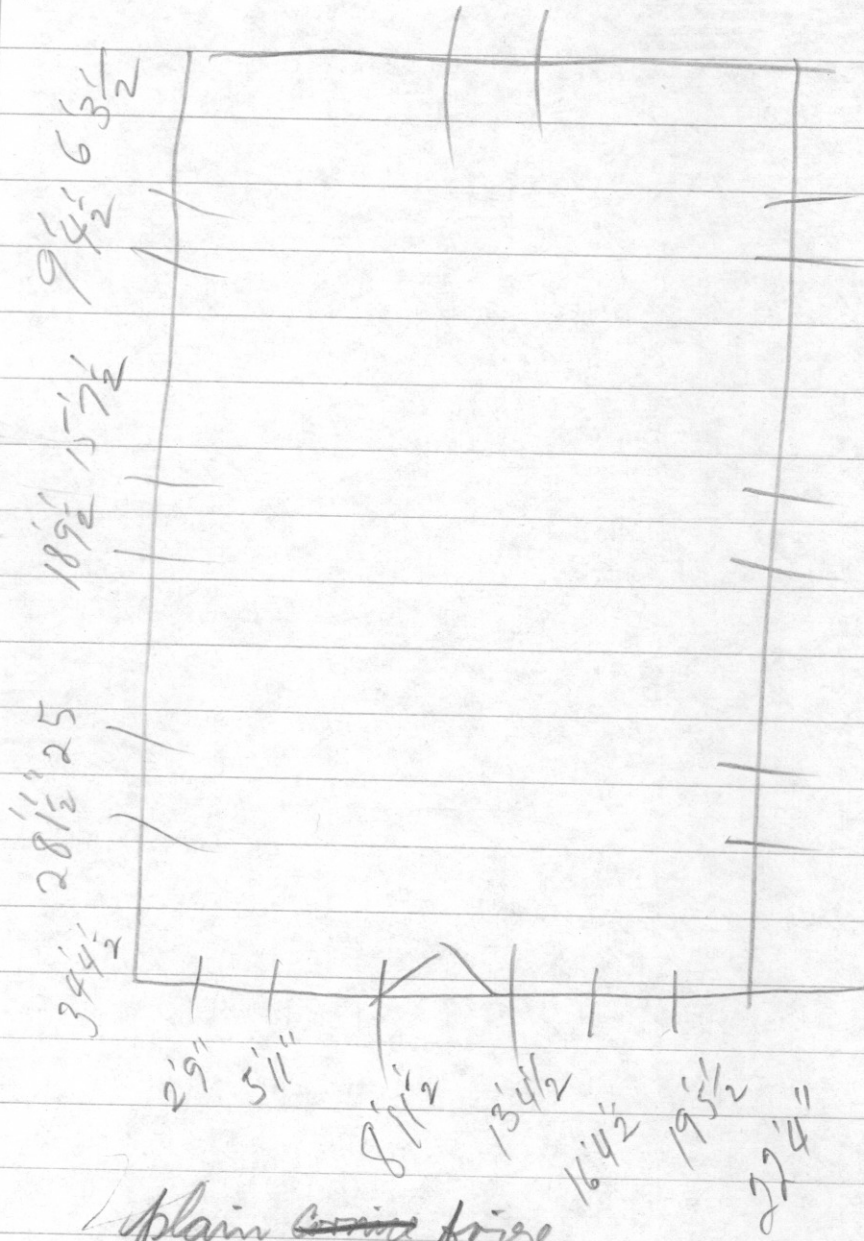
wide cornices w/ 3/4 round  
moulding.  
5 1/2 inch lap weatherboards  
windows 2/2 shuttered  
painted white w/ green shutter  
plain wide box trim with moulded  
hooks on scroll brackets

plain cornice frieze  
gable cuts.  
plain soffits. Simple  
moulded cornice.

stone found.  
belfry.

no cellar.

windows 4/4 sash \*

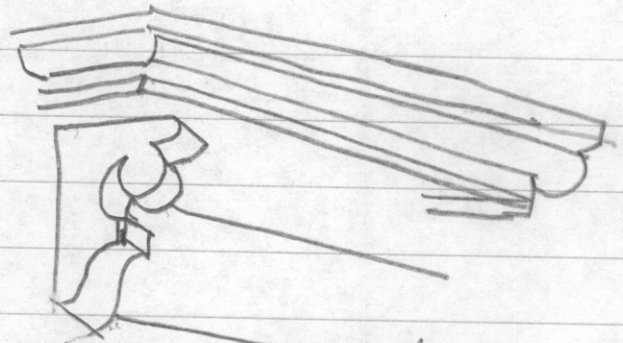
2 panels per door;  
double front door w/ semi-  
circular upper moulded  
panels

3-pane overhead.  
door has barked "hood" lintel.

mortise locks, metal knob + face plate

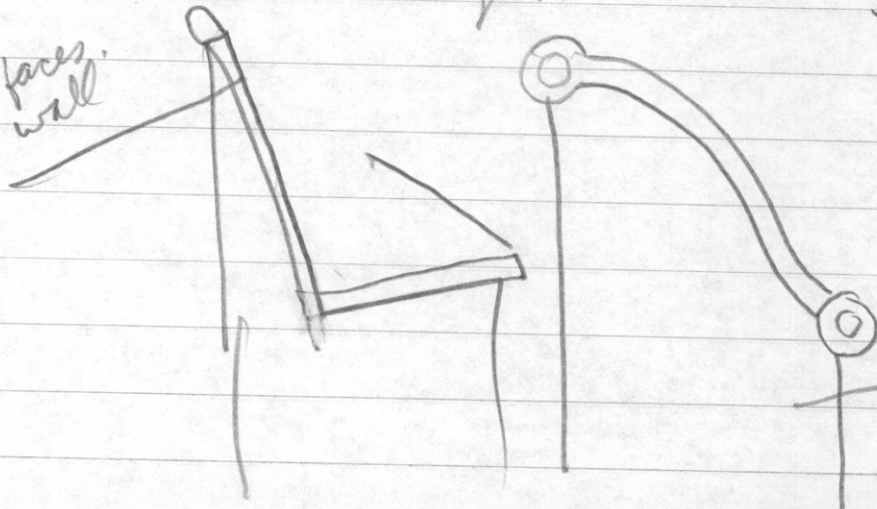
wide baseboards. - can see where pins were located  
not painted there. note on card,

← 14 Total.

Pens; plain slab pine benches  
seats set at an angle.

furn. practically all  
gone. some benches remain.  
Cubing is bad in places,  
some floor joists may be gone  
water damage on floor  
window panes may  
walls cracked.

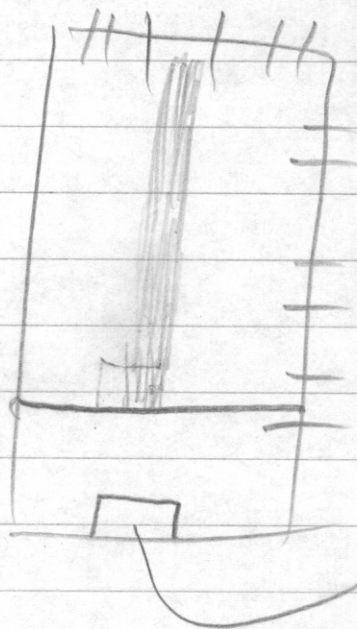
platform c 3/4 way back faced w/ pine paneling.

raised 8 1/2"

alter? 3 panel moulded

center of floor is raised — summer beam?

windows are large raised 2'2" off floor

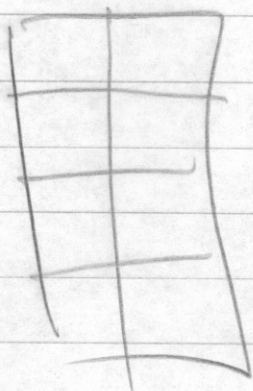
6'4" tall x 36 1/2" w

walls c 4 1/2 - 5" thick
