VIRGINIA
DIVISION OF HISTORIC LANDMARKS
HISTORIC DISTRICT/BRIEF
SURVEY FORM

City/Town/Village/Hamlet Buckland County Prince William
 Street address or route number 8110 Buckland Mill Rd. U.S.G.S. Quad Thoroughfare Gap
 Historic name Moss House Common name _____
 Present use Residence Building Style I-House, Late Federal
 Original use Residence Building Date(s) Ca. 1830

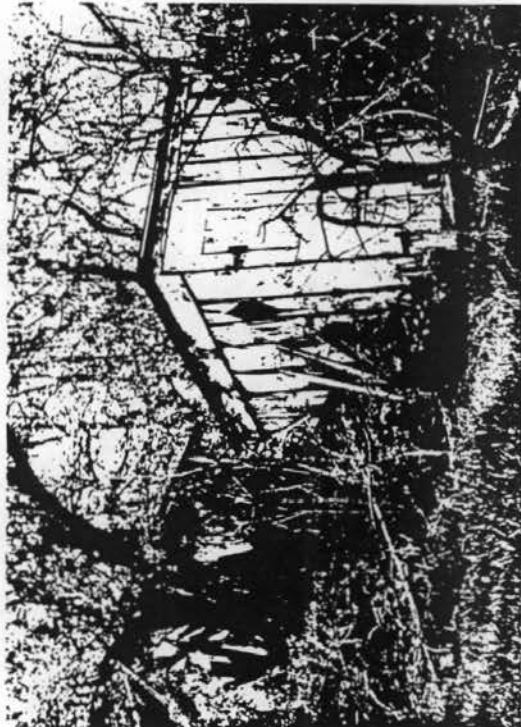
Sheds (non-contributing)
Neg. #9044 (25)
