VIRGINIA
DIVISION OF HISTORIC LANDMARKS
HISTORIC DISTRICT/BRIEF
SURVEY FORM

File no. 76-333
 Negative no(s). 8823

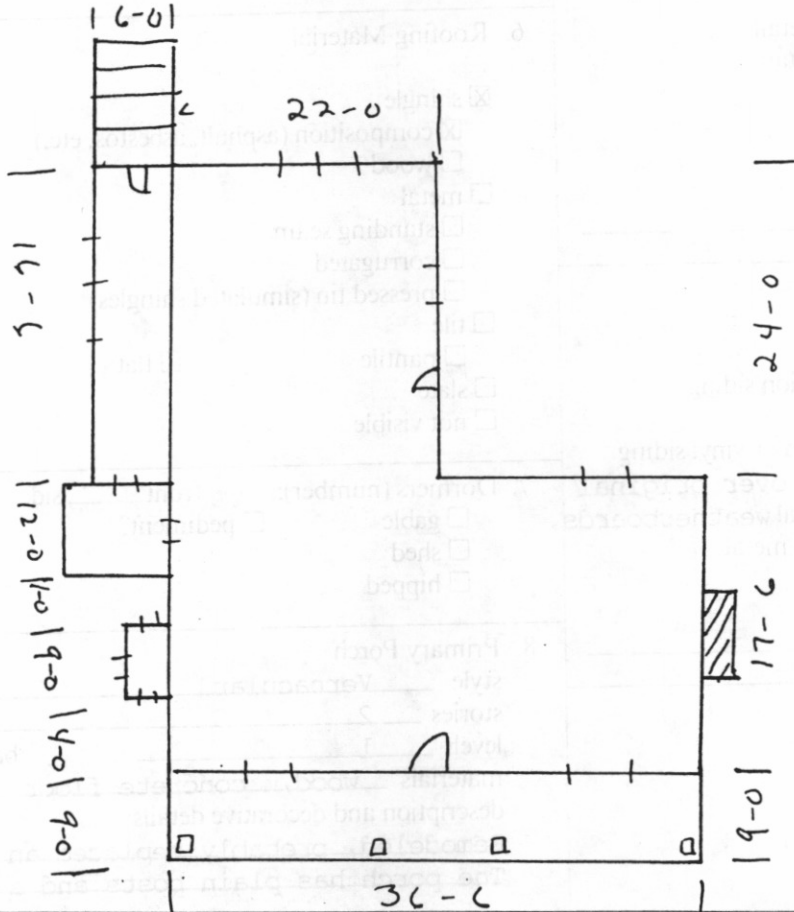
Drawing of Plan

The house has an L-shaped configuration on the exterior and a central hall plan in the front, 2 story wing of the interior. The central hall has a Victorian staircase with a turned newel post and balusters. The exterior is extensively remodeled including the addition of aluminum siding, replacement of some doors and windows, and the replacement of the front porch.

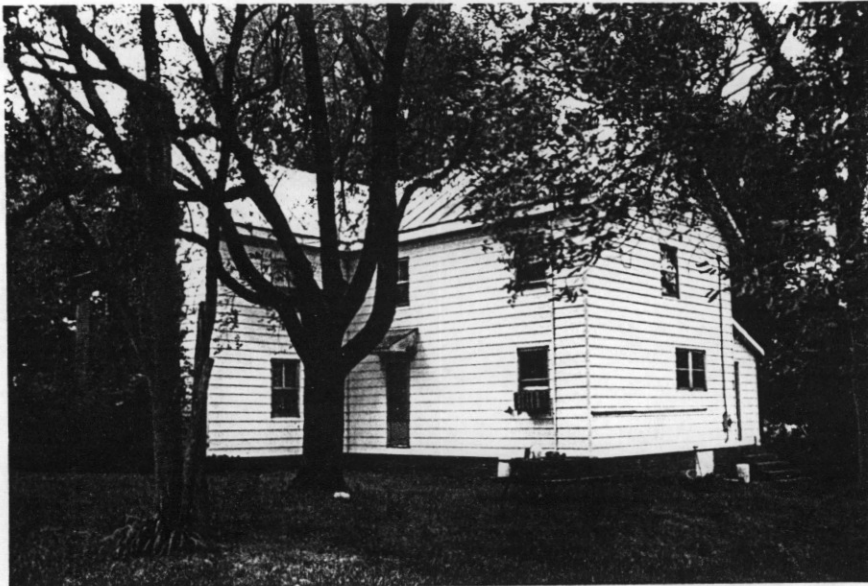
N.W. Corner

8. Primary Porch
 style Vernacular
 stories 2
 levels 1 bays 3
 materials wood, concrete floor
 description and decorative details
Remodeled, probably replaced an earlier porch.
The porch has plain posts and a shed roof.

9. General supplementary description and decoration:
Some old 2/2 windows. Stone end chimney.

10. Major additions and alterations:
There is a 2 story side bay window which is remodeled b probably original. An old, 2 story rear ell over a bri foundation extends off the rear of the house with a lat
 11. Outbuildings: shed roofed porch addition, now enclosed
Cinderblock barn and shed.
