## VIRGINIA DIVISION OF HISTORIC LANDMARKS

## HISTORIC DISTRICT/BRIEF SURVEY FORM

SURVEY FORM
City/Town/Village/Hamlet	County Prince William County
Street address or route number	Davis Ford Road U.S.U.S. Quad Occompany
Historic name Chinn House	Common name Chinn House
Present use Vacant	Building Style Late 19th cent. vernacular
Original use residence	Building Date(s) 1890–1895
	The state of the s

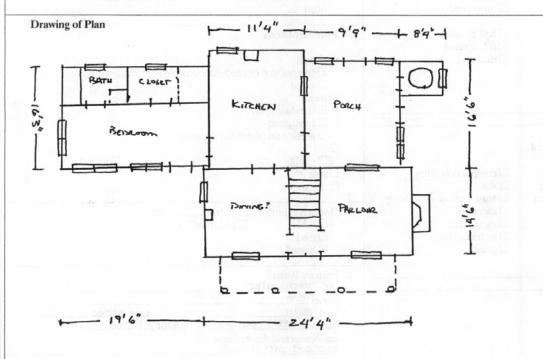
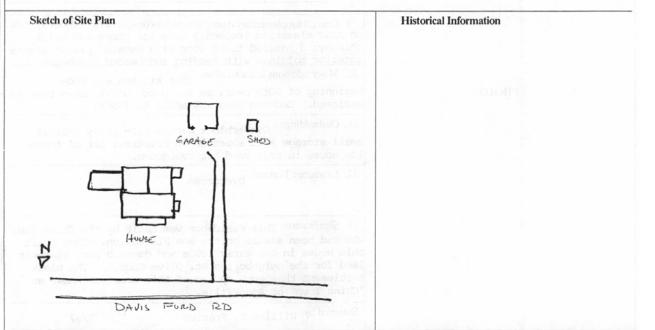
Plan and Massing (Note original features, additions, and alterations)

the original house is a 2 room plan with a staircase but no passage separating them. The kitchen ell was added in the early 20th century along with the enclosed back porch and well room in the 1950s a bedroom wing with a bathroom and closet was added to the hortheast side of the house off of the kitchen.
