VIKGINIA DIVISION 'F HISTORIC LANDMA KS

SURVEY FORM

Common name Davis House & Cemetery

Street address or route number 8000 Linton Hall Rd.

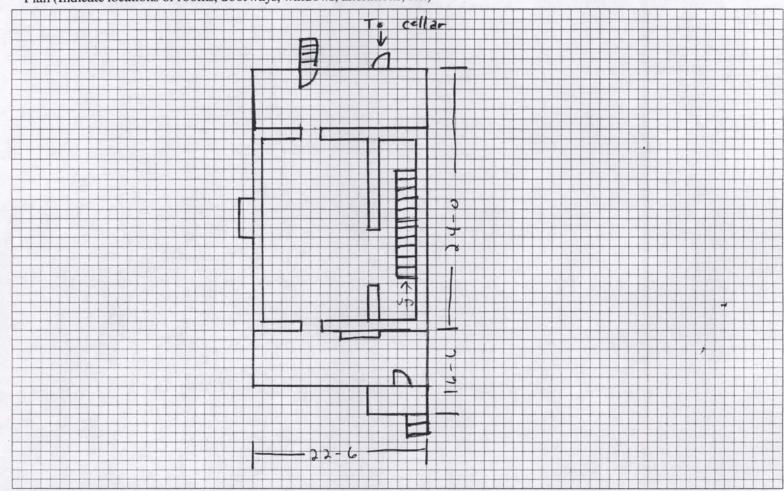
Plan (Indicate locations of rooms, doorways, windows, alterations, etc.)

The Davis house is a two story log structure set on a low rubblestone cellar. The interior and exterior have been extensively remodeled making it difficult to evaluate the age and evolution of the structure. The exterior is sheathed with plywood, covering earlier, plain weatherboards. The east and west porches, 1930's additions, are now enclosed. The 6/6 windows of these additions appear to be old and were possibly reused from the earlier part of the house. Single pane lights pierce the south gable wall on each side of the coursed stone chimney.

Entry to the house is now off the enclosed east porch. The simple Greek mantle with a carved date "1853" on the front frieze, located on the west wall of this addition was moved from the parlor. This could be the construction date or the date of an early remodeling. The original part of the house has a parlor with a side hall. A closed string stair with a turned newel leads to the two bedchambers with sloped ceilings. Floors throughout are carpeted and paneling covers much of the original fabric making an accurate evaluation of the interior almost impossible.

The basement, originally entered from a stair (now sealed off) underneath the main stair is now entered from the exterior through a low door in the west wall. The original entrance in the thick rubblestone walls is now covered by the west porch. The basement room was once used as a dining room and retains early plaster over sawn lathe with cut rails. The whitewashed ceiling joists suggests that the plaster was the result of an early remodeling. A simple Greek mantle is on the south wall but is now partially covered by shelving. The vertically sawn random pine floors can be seen through the holes in the ceiling. The dining room now has dirt floors but possibly had wood floors which have deteriorated.

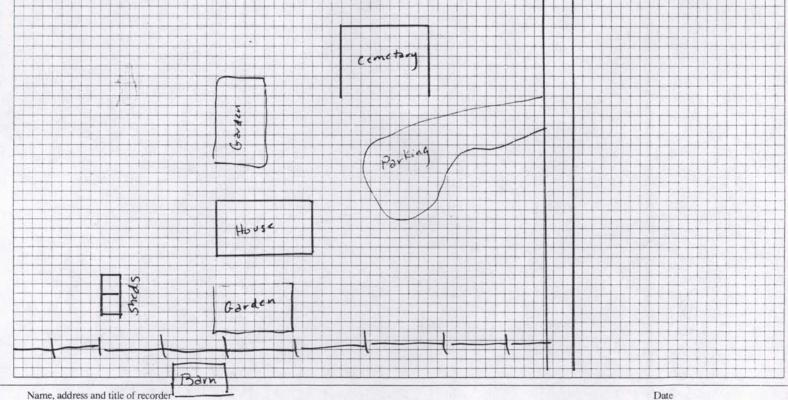
Site plan (Locate and identify outbuildings, dependencies and significant topographical features.)

A cemetery with an ornamental iron fence is located to the north of the house and contains graves from the Davis and the Brady families. Most of the outbuildings appear to be 20th century additions.
