file: Gossom-owned house behind Town Hall

VIRGINIA
HISTORIC LANDMARKS COMMISSION

SURVEY FORM

Historic name	Common name 6707 Fayette Street
County/Town/City Haymarket	
Street address or route number	
USGS Quad Thoroughfare Gap	Date or period c1875-80, with additions in c1900.
Original owner	Architect/builder/craftsmen
Original use Residence	
Present owner James R. Gossom	Source of name
Present owner address 15507 Thoroughfare Rd.	Source of date Architectural evidence.
Haymarket, VA 22067	Stories 2 stories
Present use Apts.	Foundation and wall const'n Stone foundation; frame walls.
Acreage cl.2 acres	
	Roof type Metal-covered gable roof.

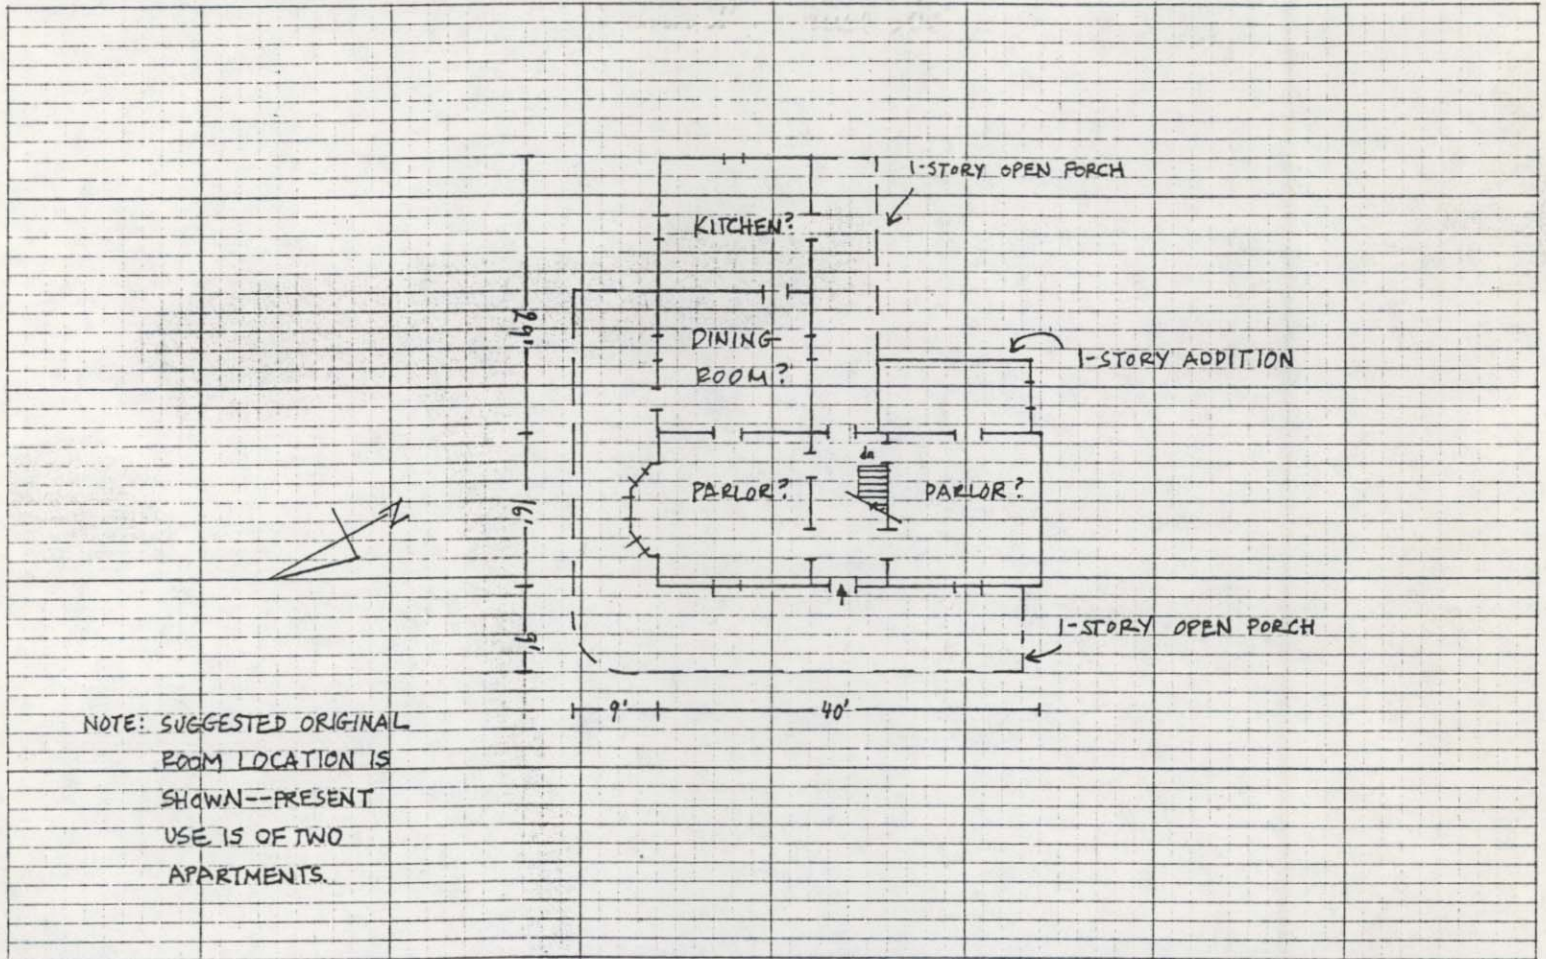
Plan (Indicate locations of rooms, doorways, windows, alterations, etc.)

This large, EL-plan, turn-of-the-century, two-story, weatherboarded frame house is urban in style, resembling quite a few houses in old Manassas. The front section is three bays wide with a central entrance. There is a one-story columned porch across the front which wraps around the northeast end. Though this porch is in bad repair, it is supported by tapering plain columns with Ionic capitals. There is a bay window on the northeast end. Both of these features may have been built in the early 1900's. The cornice is moulded; the exterior is covered with plain weatherboards; and there is a plain, wide frieze. The door and window trim is plain and has a moulded cornice. The moulded, four-panel front door has overhead and sidelights. The 2/2 sliding sash windows are shuttered.

The high-ceilinged interior is in poor condition. The straight-run, open-string, single-flight stair has been repaired. The original turned (oak probably) newel is missing. The slender balusters are turned, and the rail is moulded. The interior trim is both wide architrave trim and symmetrically-moulded trim with cornerblocks. The plan of one room on either side of the hall may have been altered by the addition of partitions. It is not known whether any mantels are remaining. There is a two-story addition attached to the house's rear EL.

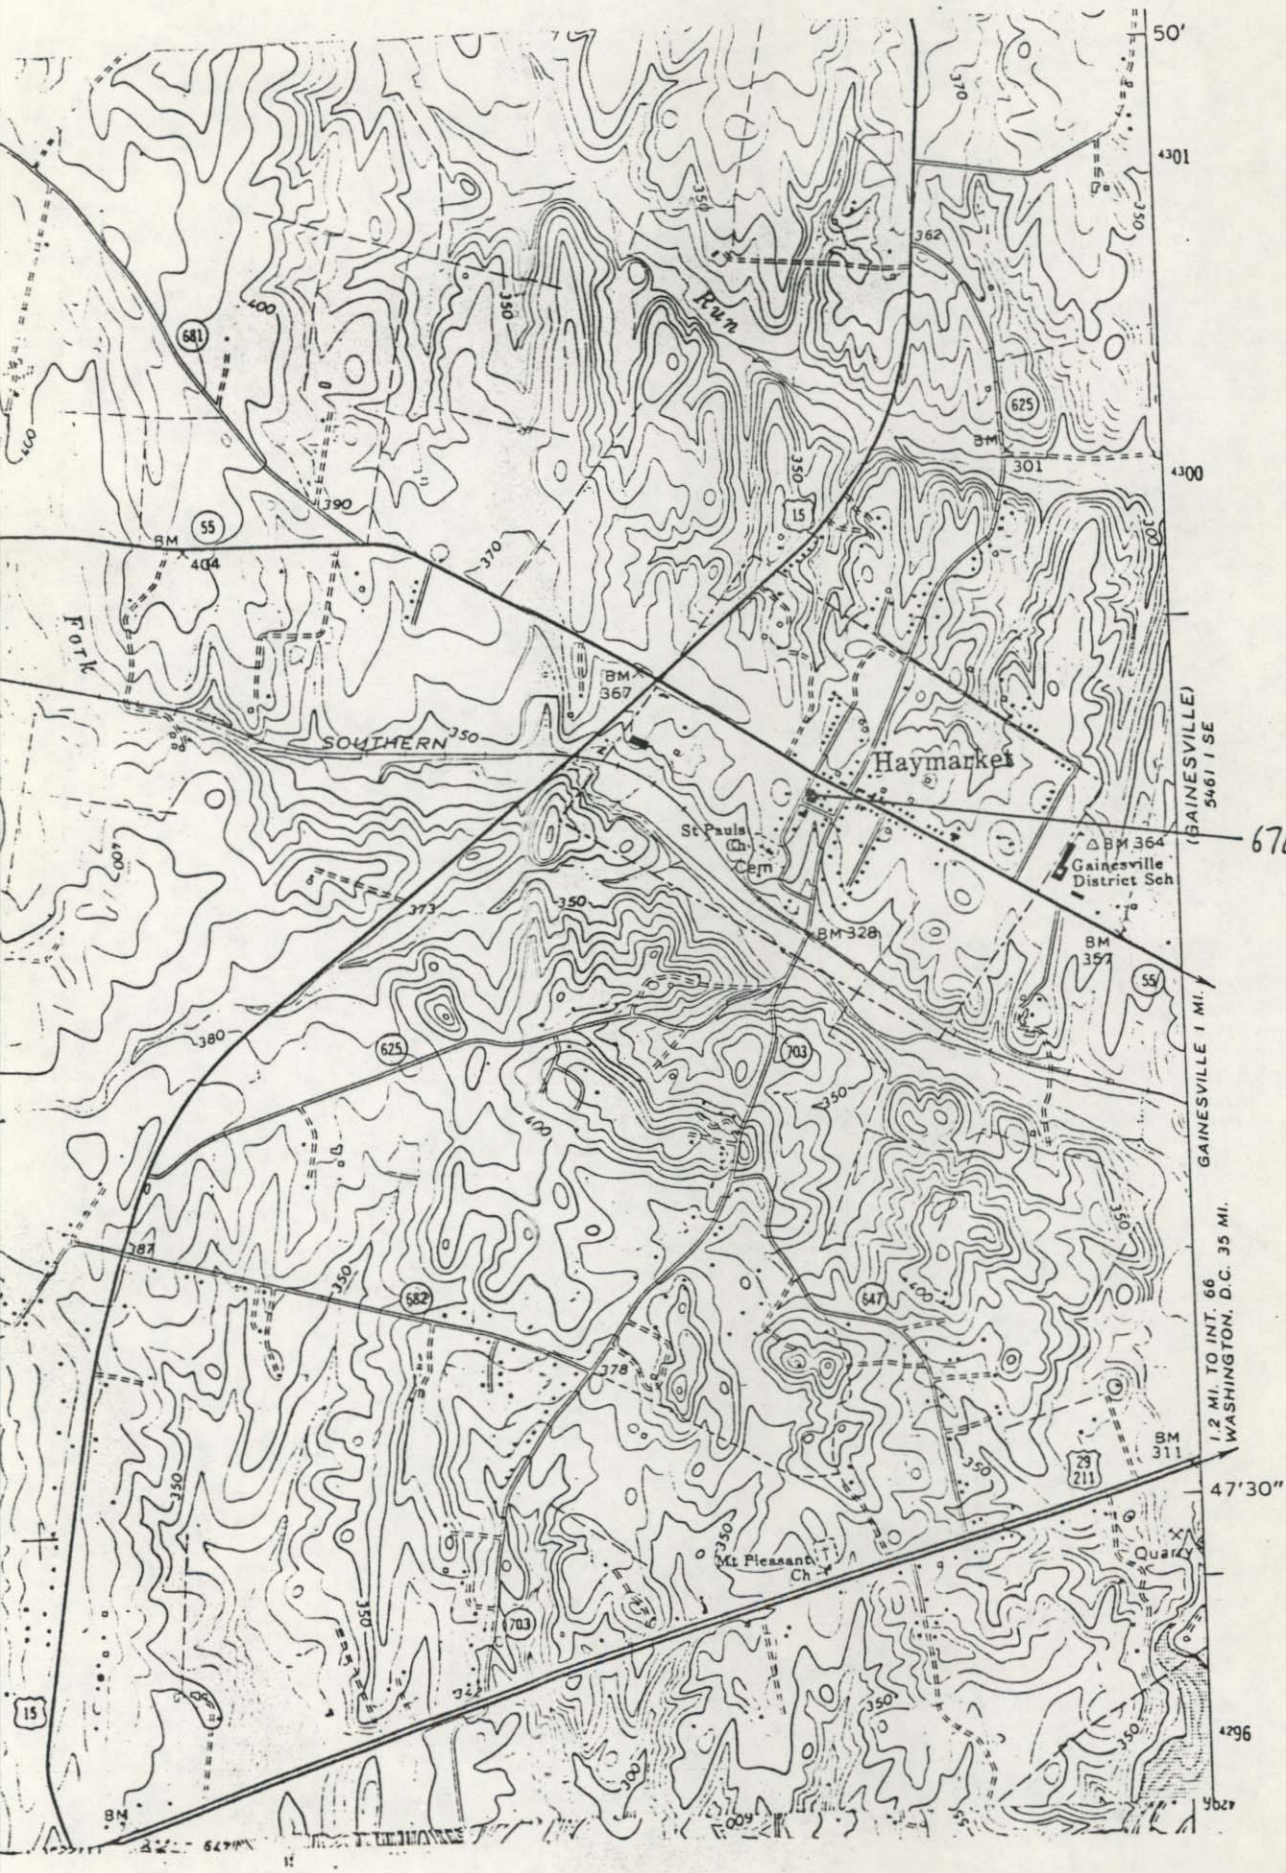
6707 FAYETTE ST.
233-7

State condition of structure and environs House and grounds in poor condition.

Absentee-owned, the house now contains three apartments. Though it is in deteriorating condition, this is one of Haymarket's most visible turn-of-the-century residences. It is located behind the Haymarket Town Hall and on the same street with the historic McCormick House and St. Paul's Church. This building is representative of the area's best late 19th century architecture, and should be preserved.
