# VIRGINIA HISTORIC LANDMARKS COMMISSION

## SURVEY FORM

Historic name	La Grange	Common name	
County/Town/City	Prince William County		
Street address or route number	5304 Antioch Road, Haymarket, VA		
USGS Quad	Thoroughfare Gap Quad.	Date or period	c1790
Original owner	George Green	Architect/builder/craftsmen	
Original use	Residence		
Present owner	D. Cecil & Nancy Culbertson,	Source of name	Unknown
Present owner address	Trustees	Source of date	Architectural evidence, published his- tories
5304 Antioch Rd., Haymarket, VA		Stories	2 stories, 1 1/2 stories
Present use	Residence	Foundation and wall const'n	Stone foundation, brick wall construction
Acreage	415.5 acres	Roof type	Asphalt shingle-covered gable roof.

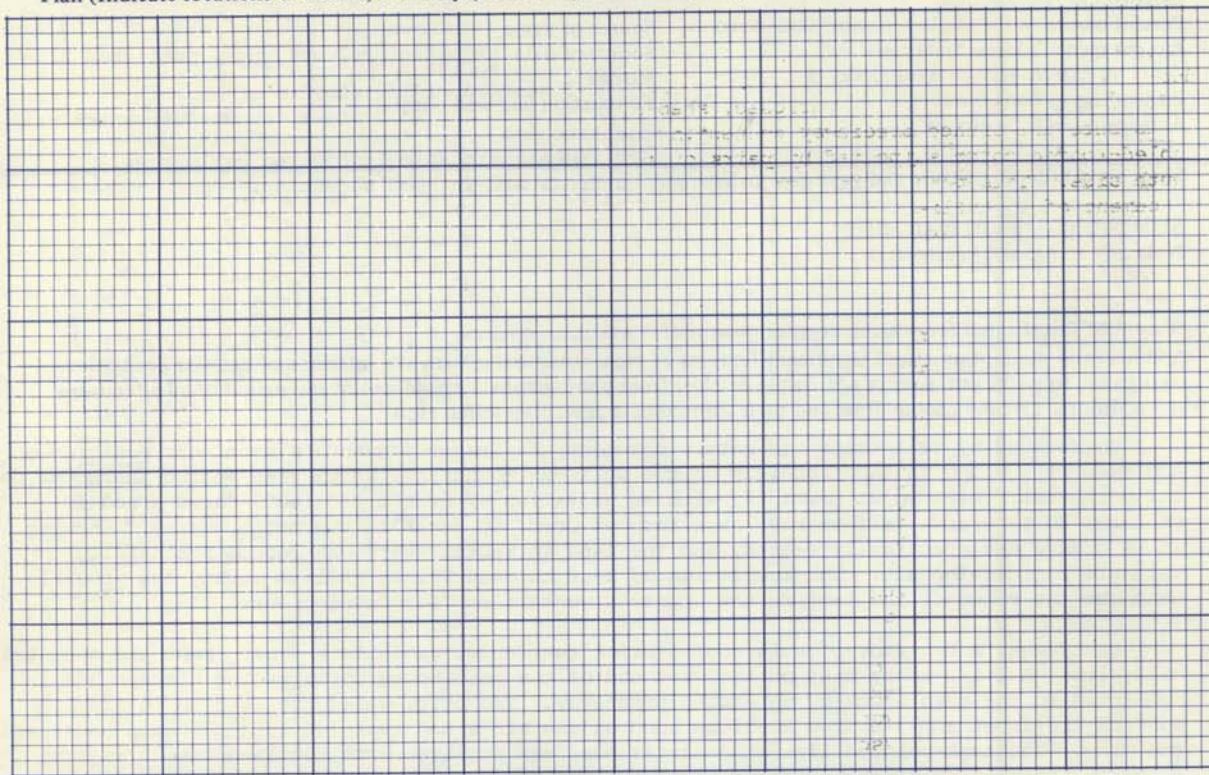
Plan (Indicate locations of rooms, doorways, windows, alterations, etc.)

La Grange, a two-story, gable-roofed brick residence, exhibits a 4-bay front and a central hall plan. A 1 1/2-story wing on the west end of the main house contains the kitchen and is connected to the main block by an arched breezeway. The brick walls are laid up in flemish bond on the front and 5-course American bond on the sides and rear (of both the main house and the wing). The tuck-pointed lime-sand mortar has been repaired with Portland cement in some places. Exterior decorative details include a moulded brick cornice, glazed headers in the brick walls, and jack arches over the windows. Three gable-roofed dormers project from the roof of both the front and rear facades of the main block. The kitchen wing has two dormers per side. There are three exterior, brick end chimneys on the main house, one on the east end to serve the sitting (living) room, and two on the west end serving the present dining room. The chimneys in the main block have tiled weatherings and corbelled caps. The kitchen wing has an interior chimney on its west end containing a formerly large cooking fireplace and bake oven. There is also a small stack for a corner chimney in the present family dining room. The replacement 6/6 sliding sash windows are flanked by reproduction paneled shutters. Architrave trim surrounds the exterior door and window openings. There is a 4-light overhead
