Notes. 17 Feb 1981

# Brentsville Courthouse

Court house.  
& School.

Brentsville.

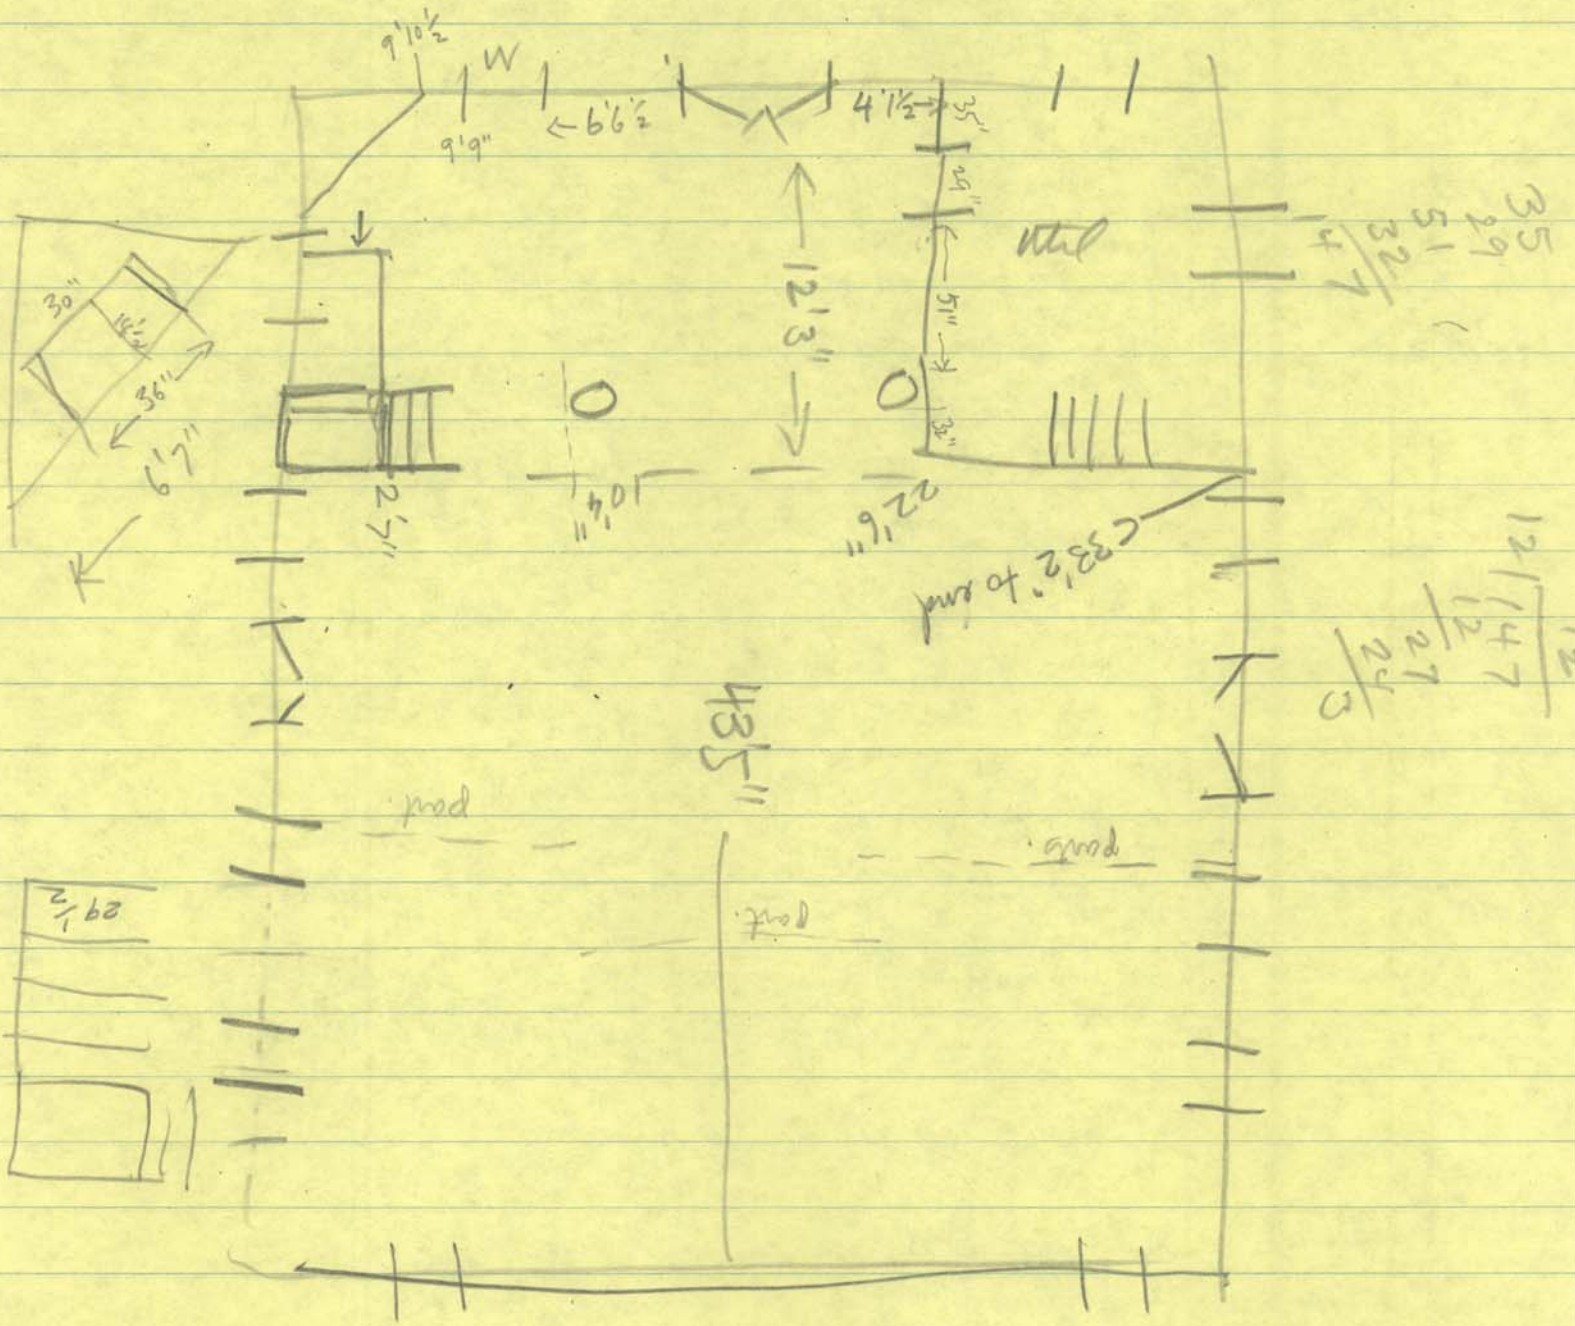
front elev. f

Windows 13" deep.

front door a repl.

trim is moulded, on both door + window.

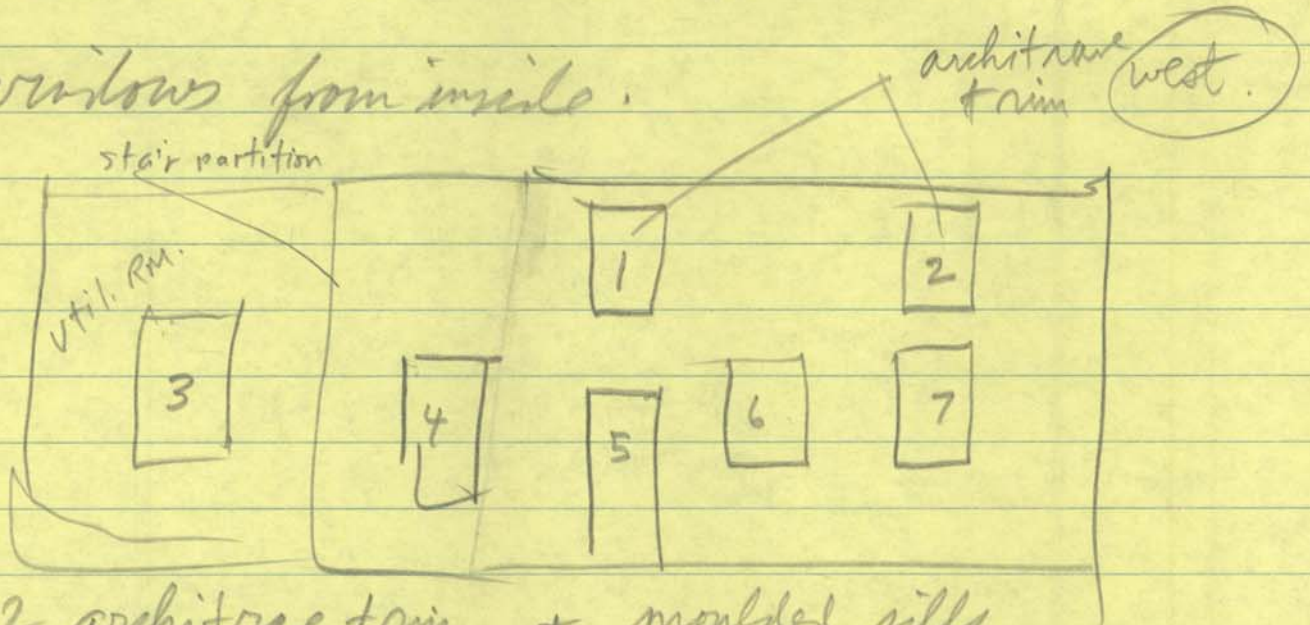
Windows from inside.

1 + 2 architrave trim + moulded sills,  
with plain <sup>paneled</sup> casements. 6/6

3 + 7 architrave trim with paneled + moulded  
casements. Trim is more ornate.

4 + 6 plain box trim, plain casements.

5 - door - architrave trim like 3 + 7  
door replacement.

flat, cyma, bead

walls plastered up to trim.

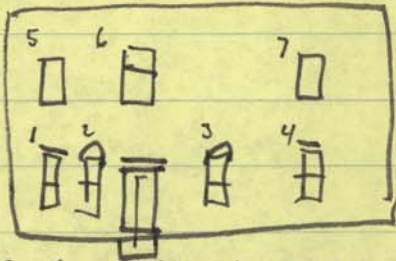
West side.

only two windows beside door line  
rounded arches, all others + door have  
flat arches.

Recessed double door flanked w/ moulded panels  
door is replacement. - knob may be old.

1/6 sl. stsh. "quarter round" moulding

Stone sill - chiseled to accept doorway

air vents at ground level may have been blocked up.

2 + 3 have wooden ~~br~~  
sills + applied

(cyma trim. +  
NO shutter pins

1, 4, 5-7 have  
shutter pins +  
quarter round mould,  
Stone sills

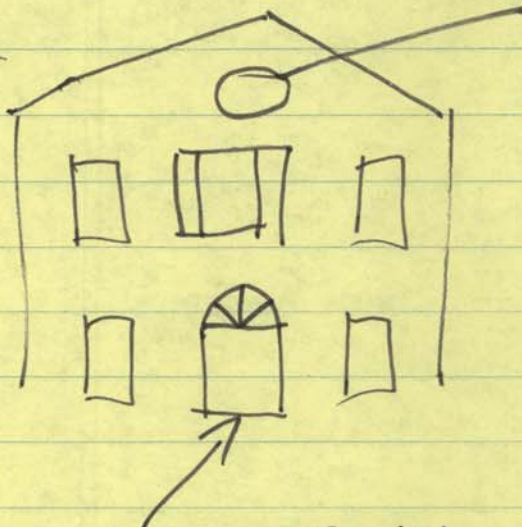
south side

prob. retouched - Looks like letters are  
painted on.

brick  
Keyed, semi-c. arch w  
fan light. double door,  
recessed mouldings. orig. sash?  
Windows have flat arches,  
Stone sills; quarter round moulding  
shutter pins

old worn stone sill  
but inserted in as a step.  
IS poured concrete.

replacement door  
prob 4 1/2" or so shorter  
than orig doorway

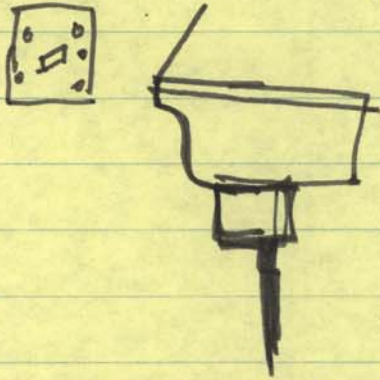
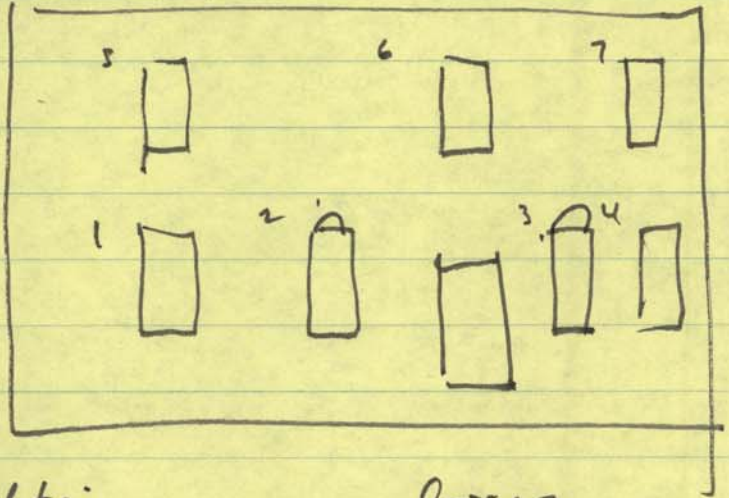
east wall courtyard.

bad crack been patched on south end below + above windows from top to bottom.

6/6 sash.

**TIE RODS**

2 iron or steel

joint plates run along wall ~~at~~ under cornice

1, 4, 5-7 windows - stone sills  
flat arches, shutter pins, quarter round trim.

2, 3 - brick sills, rounded  
arches, cyma trim

door way.  
stone sill, quarter round  
mouldings,  
recessed moulded ~~door~~  
replacement doors

#1 repl. sash + 5??

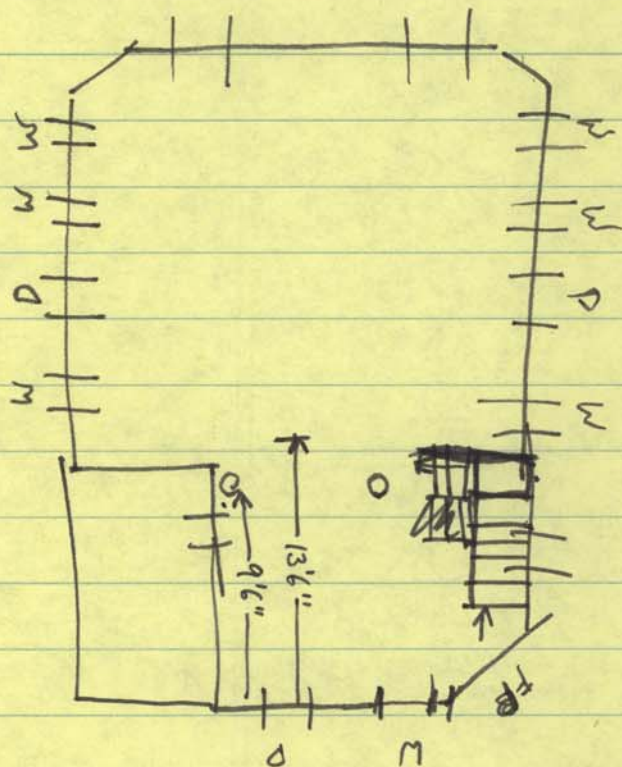
Interior:

large 2-story square room with a balcony second story east on the south end reached by a double staircase rising on either side of front entrance. offices are located on the balcony.

Changes include (probably) in the 1880s or 90s the installation of the stair and balcony floor. Installation recently of central heating + air cond. (ducts are visible under ceiling of mezzanine. 1 stair (west side) been blocked)

Front entrance is flanked by 2 plain stone columns supporting a beam which holds the balcony up.

Columns are 9'6" from front wall - c 1 foot in diameter

Stair is closed 2-flights, 1 landing. newel is small moulded with a square post + a ball atop it. has a moulded rail rail across mezzanine has turned bal. c 1890's moulded rail. square moulded support posts.

stair has. nosed treads risers = 7" Treads = 9½"
