Edge Hill

EDGE HILL (76-85) London Drive, Prince William County

# EDGE HILL (76-85), PRINCE WILLIAM COUNTY

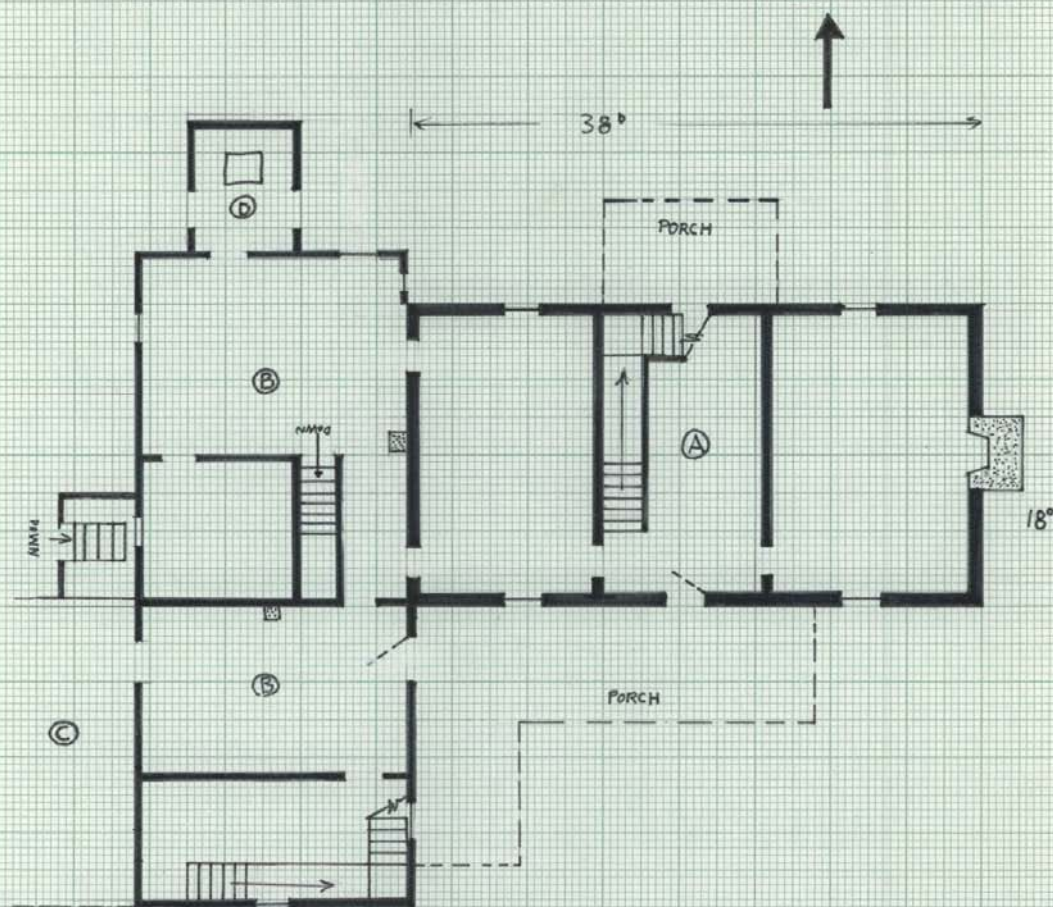
## Details of plan.

1. Front doors (2) <sup>missing.</sup> Both swing to the right. Have transom and sidelights. Sills here are 10" wide.
2. Fireplace; mantel missing. Opening made smaller twice.
3. Heavy timber framing with corner braces visible. Studs later reinforced. Furring strips replaced for new lath.
