Boundary survey. Milton C Forster Estate
Brentsville May. District.
Ross + Frame. engr.

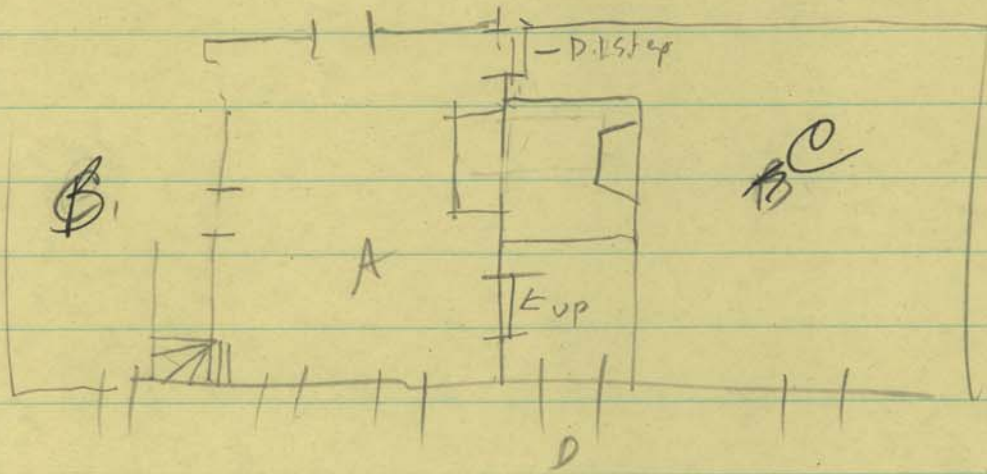
narrow oak floor
 plain pine trim
 replacement 1/2 d. oak
 window; stair to left of main room.
 Federal-style mantel
 moulded shelf; dentils, fluted pilasters

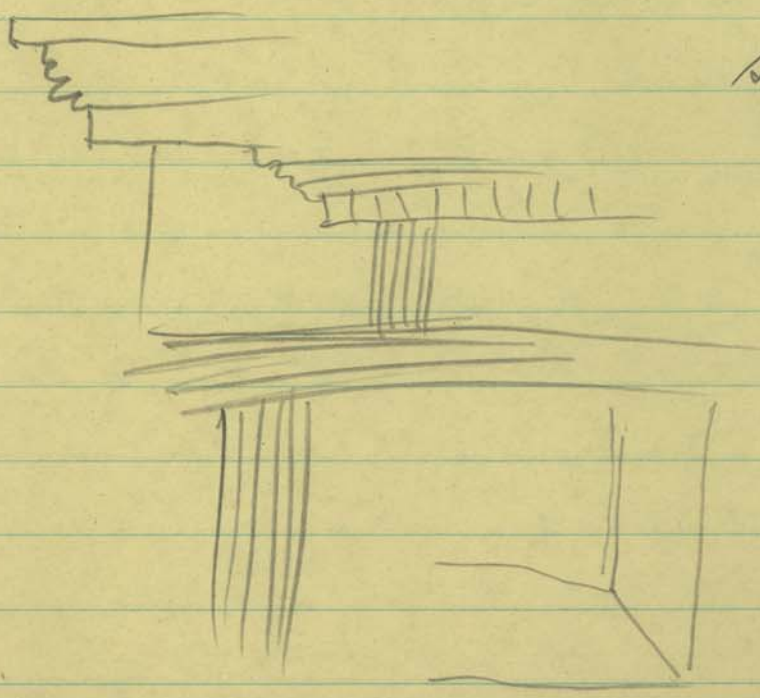
stone hearth. rep. w brick.
 stone surround + lintel
 stairs rebuilt.
 5-panel raised panels
 low to stair
 H-hinges. paneled part
 over door.
 wrought latch - repro?
 quarter-round
 moulding

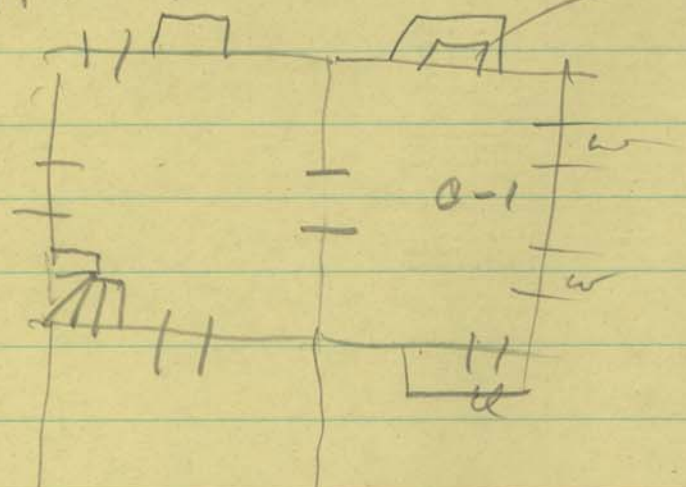
moulded shelf.

Replacement oak floor
