HISTORIC STRUCTURE REPORT

THE BARNES HOUSE

Independent Hill vicinity
Prince William County, Virginia

OCTOBER 2004

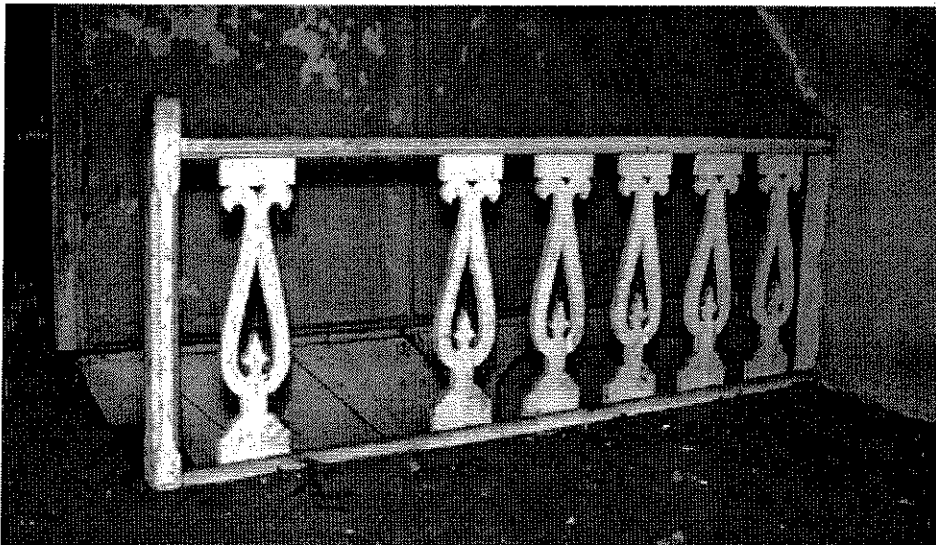
The short section of balustrade with cut-out balusters at the top of the stairs appears to date from around 1870 (Figure 3). A typical detail of Italianate style buildings of that time period, such balustrades often follow models found in carpentry pattern books of the era.

Figure 3: The Second Story Cut-Out Balustrade appears to date from about 1870

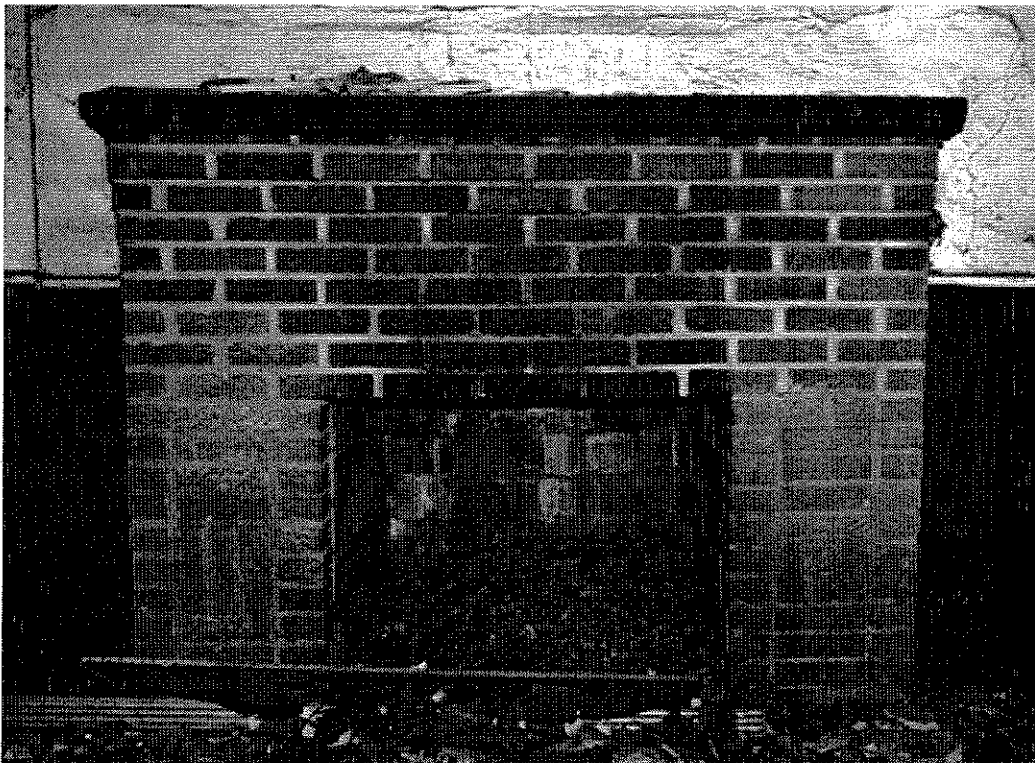
The former mantelpiece in the smaller of the first floor rooms (brushed red brick, seen in photos and in the debris at the former site) was installed at some point in the twentieth century, probably around 1950-1960. The knotty-pine interior paneling in both first story rooms dates from around 1960. Additionally, around this time, concrete was poured into the spaces beneath the first floor hearths where there is usually a box of sand.

Figure 5: The brick mantelpiece (now gone) and knotty pine paneling dated from around 1960

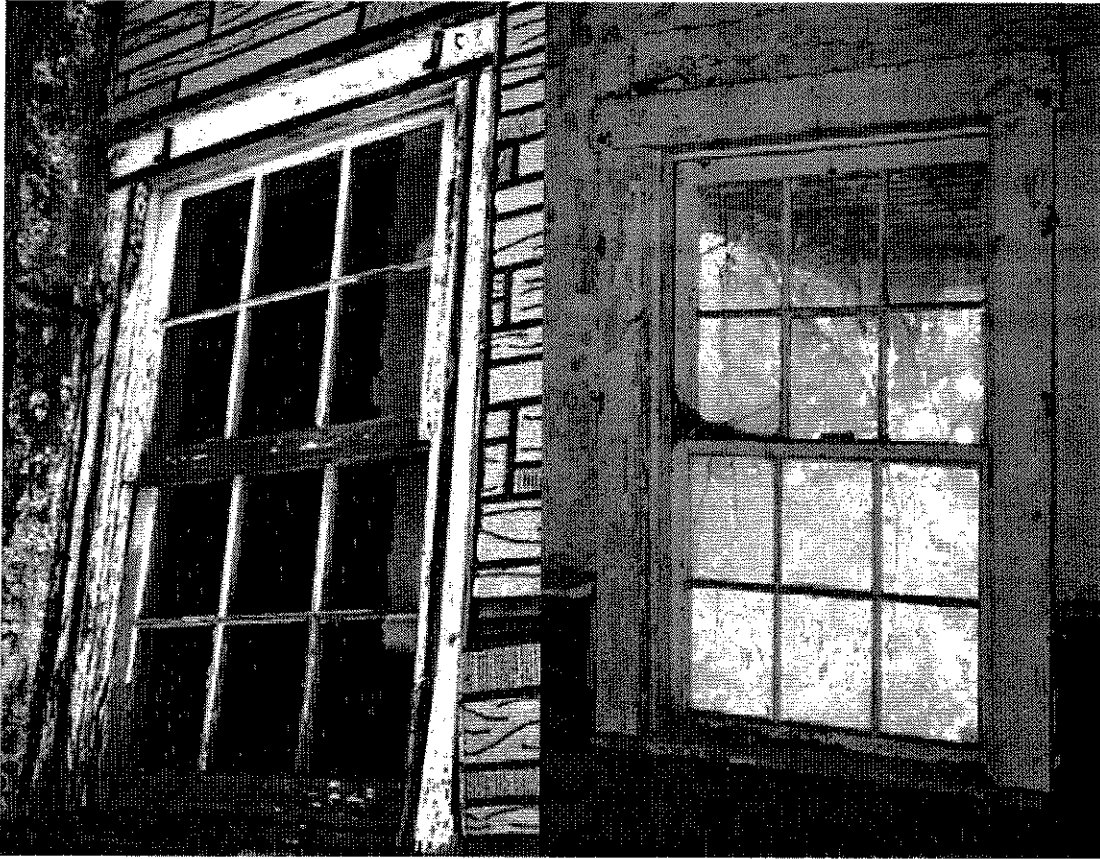
The window sashes that are still in place at the Barnes House appear to be twentieth century replacements, although they are correct to the period of the house in their 6-pane-per-sash construction. However, in comparing the various Tidewater house examples sited above, the proportions of the Barnes House door and window openings appear to be distinctively different from the eighteenth century examples. These early examples tend to have taller windows, often with 9 or more panes per sash in the first floor, and often only two panes wide in the attic level. The proportions at the Barnes House, which are closer to square, may be an indication of Greek Revival influence, and this may support the possibility of a later construction date, after about 1837 (when the Greek Revival style was introduced).

Figures 6 & 7: Exterior and Interior Views of typical 6/6 window sash, taken prior to the house

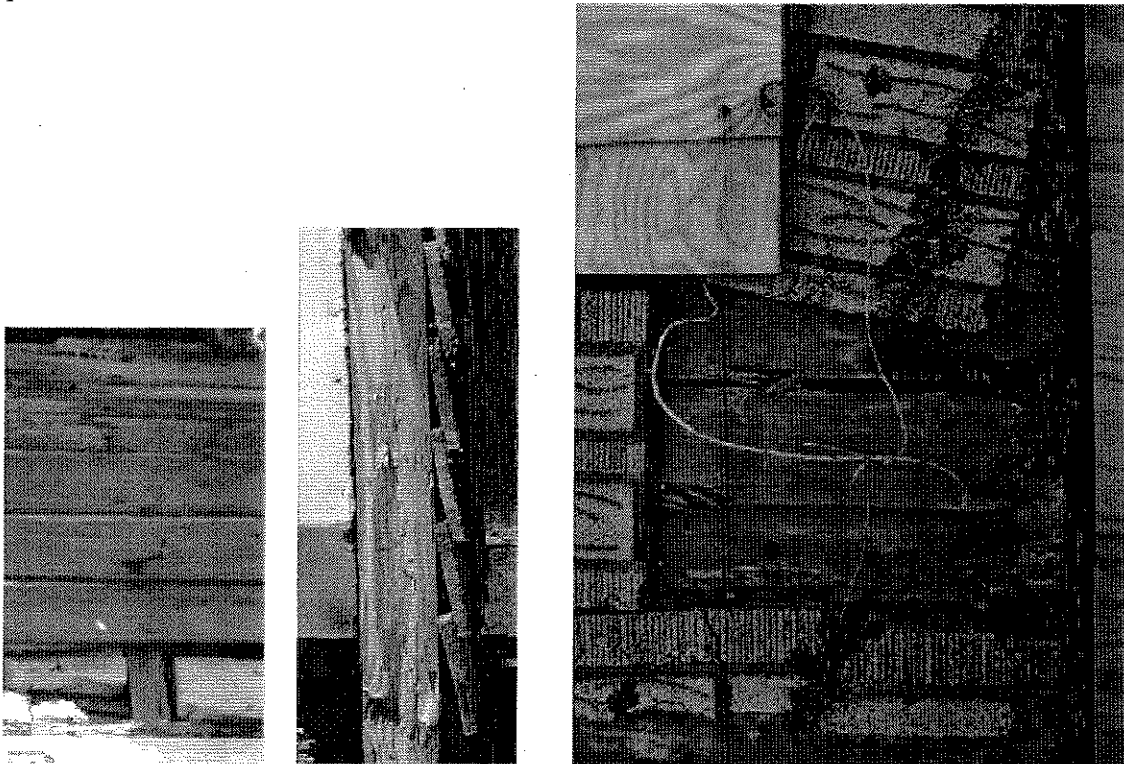
Figures 16-18: Three layers of siding. The view on the left is of the small area of the original beaded 4-inch-wide weatherboarding that was hidden in the attic of the catslide addition until recently. The center view shows the lapped plain boards used when the house was re-sided around 1900. The view on the right shows some shifting sections of Inselstone siding nailed over a section of this second layer of siding.

The entire house was covered with a layer of "Inselstone" siding (a variation on "Inselbrick" siding, a product manufactured by the Mastic Corporation of South Bend, Indiana beginning in 1935, but in this case, a later variation made to resemble random-coursed sandstone). The product was made of sheets of pressed fiber insulation board with black bituminous coatings, with a colored gravel finish as is normally used on asphalt roof shingles. The colored gravel finish is arranged to look like thin layers of stone. This siding was common through the Mid-Atlantic Area and Midwest in the middle decades of the twentieth century, used to cover deteriorated wood siding and to eliminate the need for painting exterior wall surfaces. The Inselstone siding is old, broken in many places, missing on one entire wall (where the addition was removed), and difficult to repair (it is very difficult to find matching pieces). It also may be retaining moisture and contributing to deterioration of older materials beneath it, and it may be a fire hazard and may contain asbestos.

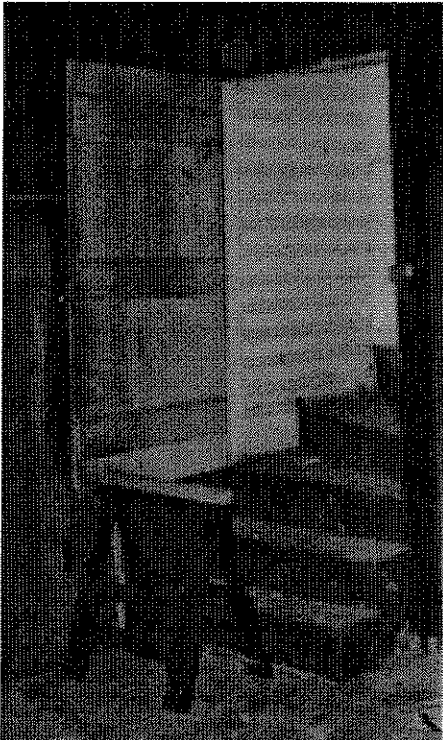
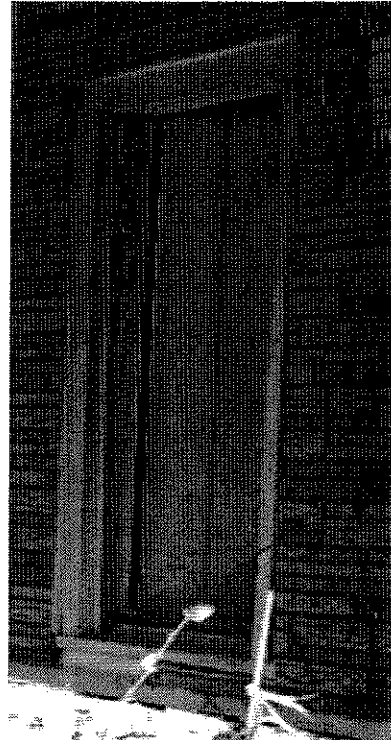
*Figures 21 & 22:
The plank doors at
the front entrance
and in the opening
to the enclosed stair
are excellent
examples of the style
and craftsmanship
that accompanied
the Tidewater frame
tradition. They are
constructed of
beaded vertical
boards with
horizontal braces on
the back.
Fortunately, they
are in good
condition and can be
repaired and
retained. The house
formerly had several
others just like these
two.*

The house has intact plank doors, which are in good condition, at two doorways: at the front door to the smaller first story room and at the door to the enclosed stair. The doors are hung with wrought iron hinges of two or three knuckles each, with wrought nails, some of which have rose heads. The doors likewise have wrought iron latches and other hardware components typical of the period before the Civil War, with about four vertical planks per door, secured by three beveled horizontal battens. The proportions of the two front door openings and the door to the stair enclosure are consistent with an earlier (pre-1860) construction date, rather than a later one.

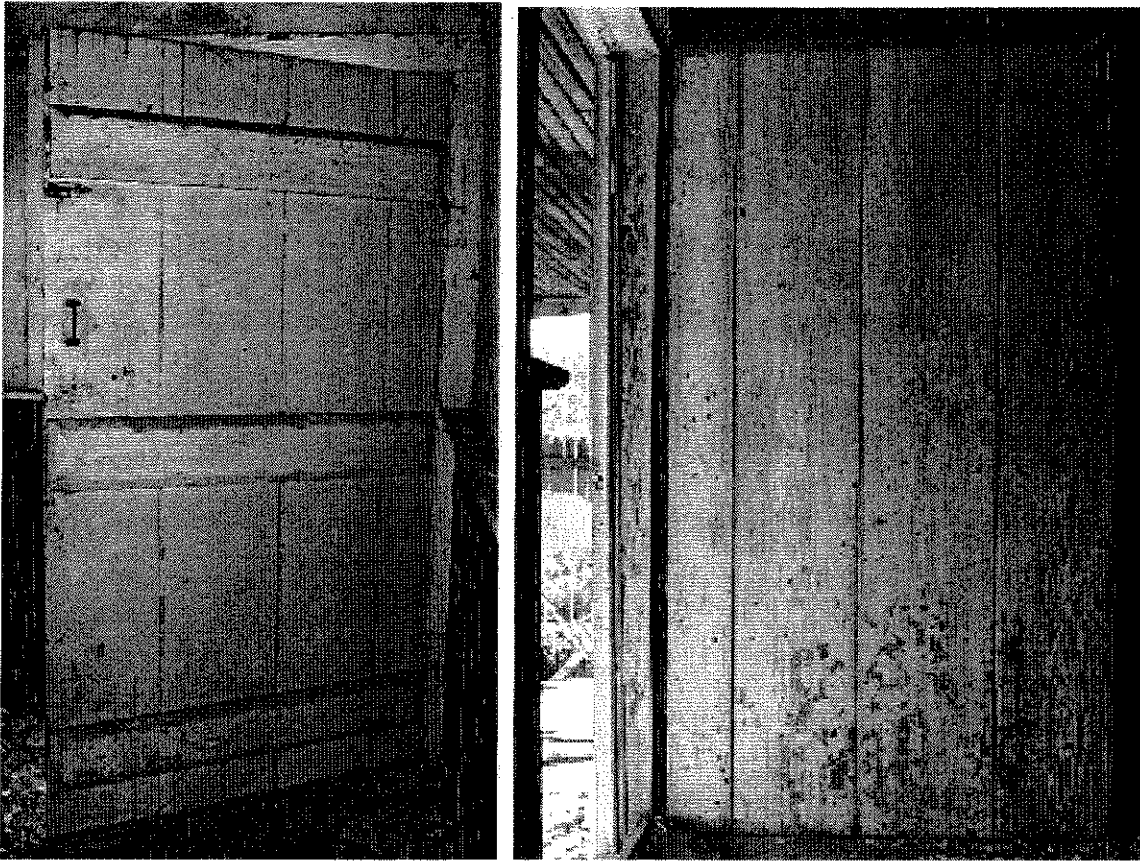
Figures 23 & 24: These views of the front door, taken just before the house was moved, show the beading, the beveled cross-braces, and the hardware on the front door to the smaller first floor room.

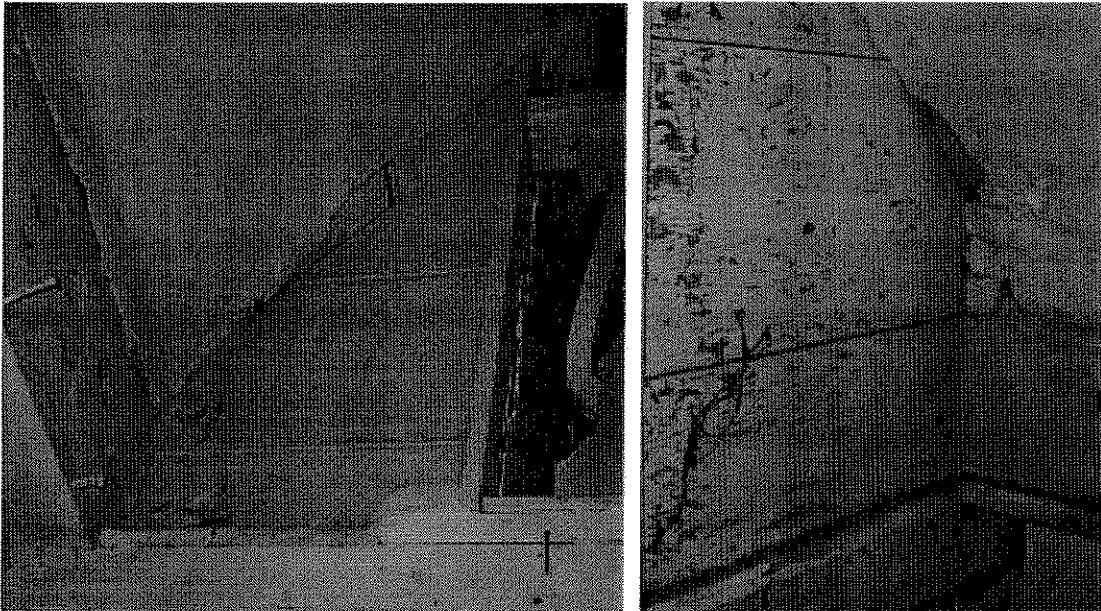
The second story plaster was applied wet over metal mesh lath. It is most likely composed mainly of gypsum. It was installed at some point between about 1920 and about 1950. The metal mesh lath was nailed directly on to beaded horizontal wall boards. The earlier boards appear to be relatively intact under the plaster. The second story plaster is intact in some areas and damaged by water in others, with some large sections missing. However, it would be appropriate to remove it to expose and restore the earlier wall treatment design, the beaded boards (see Recommendations).

Figures 26 & 27: Small areas of the beaded sheathing wall treatment in the second story are exposed, especially in the area immediately above the winder part of the stairs.
