STATE Virginia  
 COUNTY Prince William  
 TOWN OR VICINITY Woolsey  
 STREET NO.  
 HABS SURVEY NO.  
 AIA

2. NAME The Retreat  
 SEE SPACE BELOW FOR MAP OR DIRECTIONS

HISTORICAL SIGNIFICANCE & DESCRIPTION  
 The Retreat is one of the very  
 earliest houses in this area,  
 it has received no care in the  
 last 75 years - poor condition,  
 CONTINUE IN SPACE BELOW

14. NAME, ADDRESS AND TITLE OF RECORDER  
 W.B. Morton III  
 213 S. Pitt Street  
 Alexandria, Virginia  
 DATE OF RECORD August 5, '50

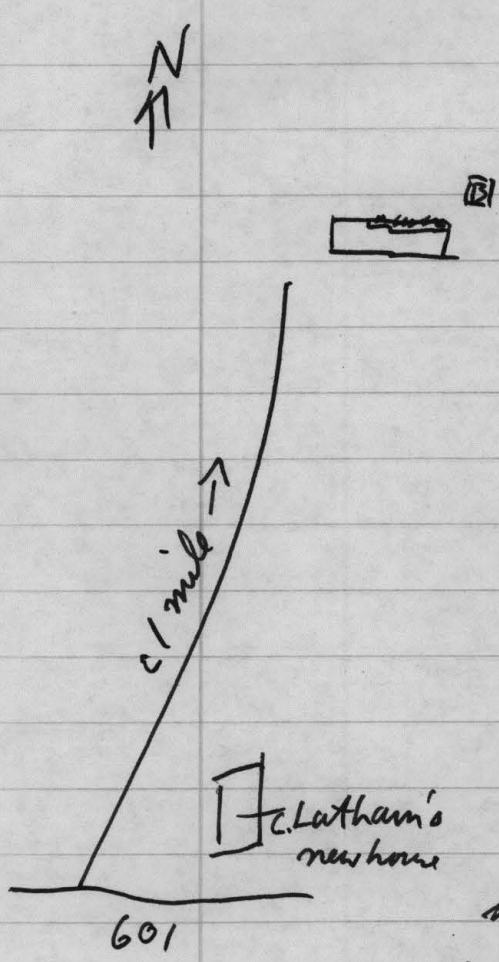
Sheet 10/28

B. is a small (c 10x10) stone structure behind & to the <sup>east</sup> right of main house. ~~over~~ The structure, possibly a meat house, has a metal covered pent roof of a later vintage than the stone found. & walls. It is in very bad condition. The walls which are about 12" thick are whitewashed inside. There appear to be 2 entrances, one to the south, facing the house and one to the west, facing the barn & probably other former buildings.

sm. stone str.  
w/ pent roof.  
v. bad cond.  
a meat house? but  
walls whitewashed
