VIRGINIA
 DIVISION C HISTORIC LANDMARK 3
 HISTORIC DISTRICT/BRIEF
 SURVEY FORM

City/Town/Village/Hamlet _____ County Prince William
 Street address or route number 14823 Dumfries Road U.S.G.S. Quad Independent Hill
 Historic name Barnes House Common name Barnes House
 Present use Storage (vacant) Building Style Vernacular Hall - Parlor
 Original use Dwelling Building Date(s) Early-to-mid 19th century

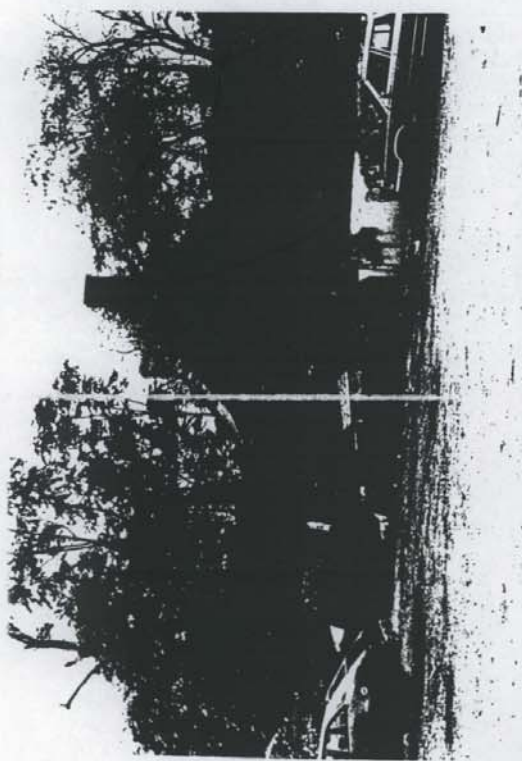
8. Primary Porch
 style Victorian
 stories 1
 levels 1 bays 5
 materials Wood
 description and decorative details
Turned posts, scroll-sawn brackets.

9. General supplementary description and decoration:
2 front doors, 6/6 windows, 2 brick exterior end chimneys with small windows on either side in gable peaks.

10. Major additions and alterations:
Rear shed-roofed addition with one brick exterior chimney.

12. Landscape Features:
Trailers and used car parts surround the Barnes House.
