Ben Leonard Int photos

Site Form

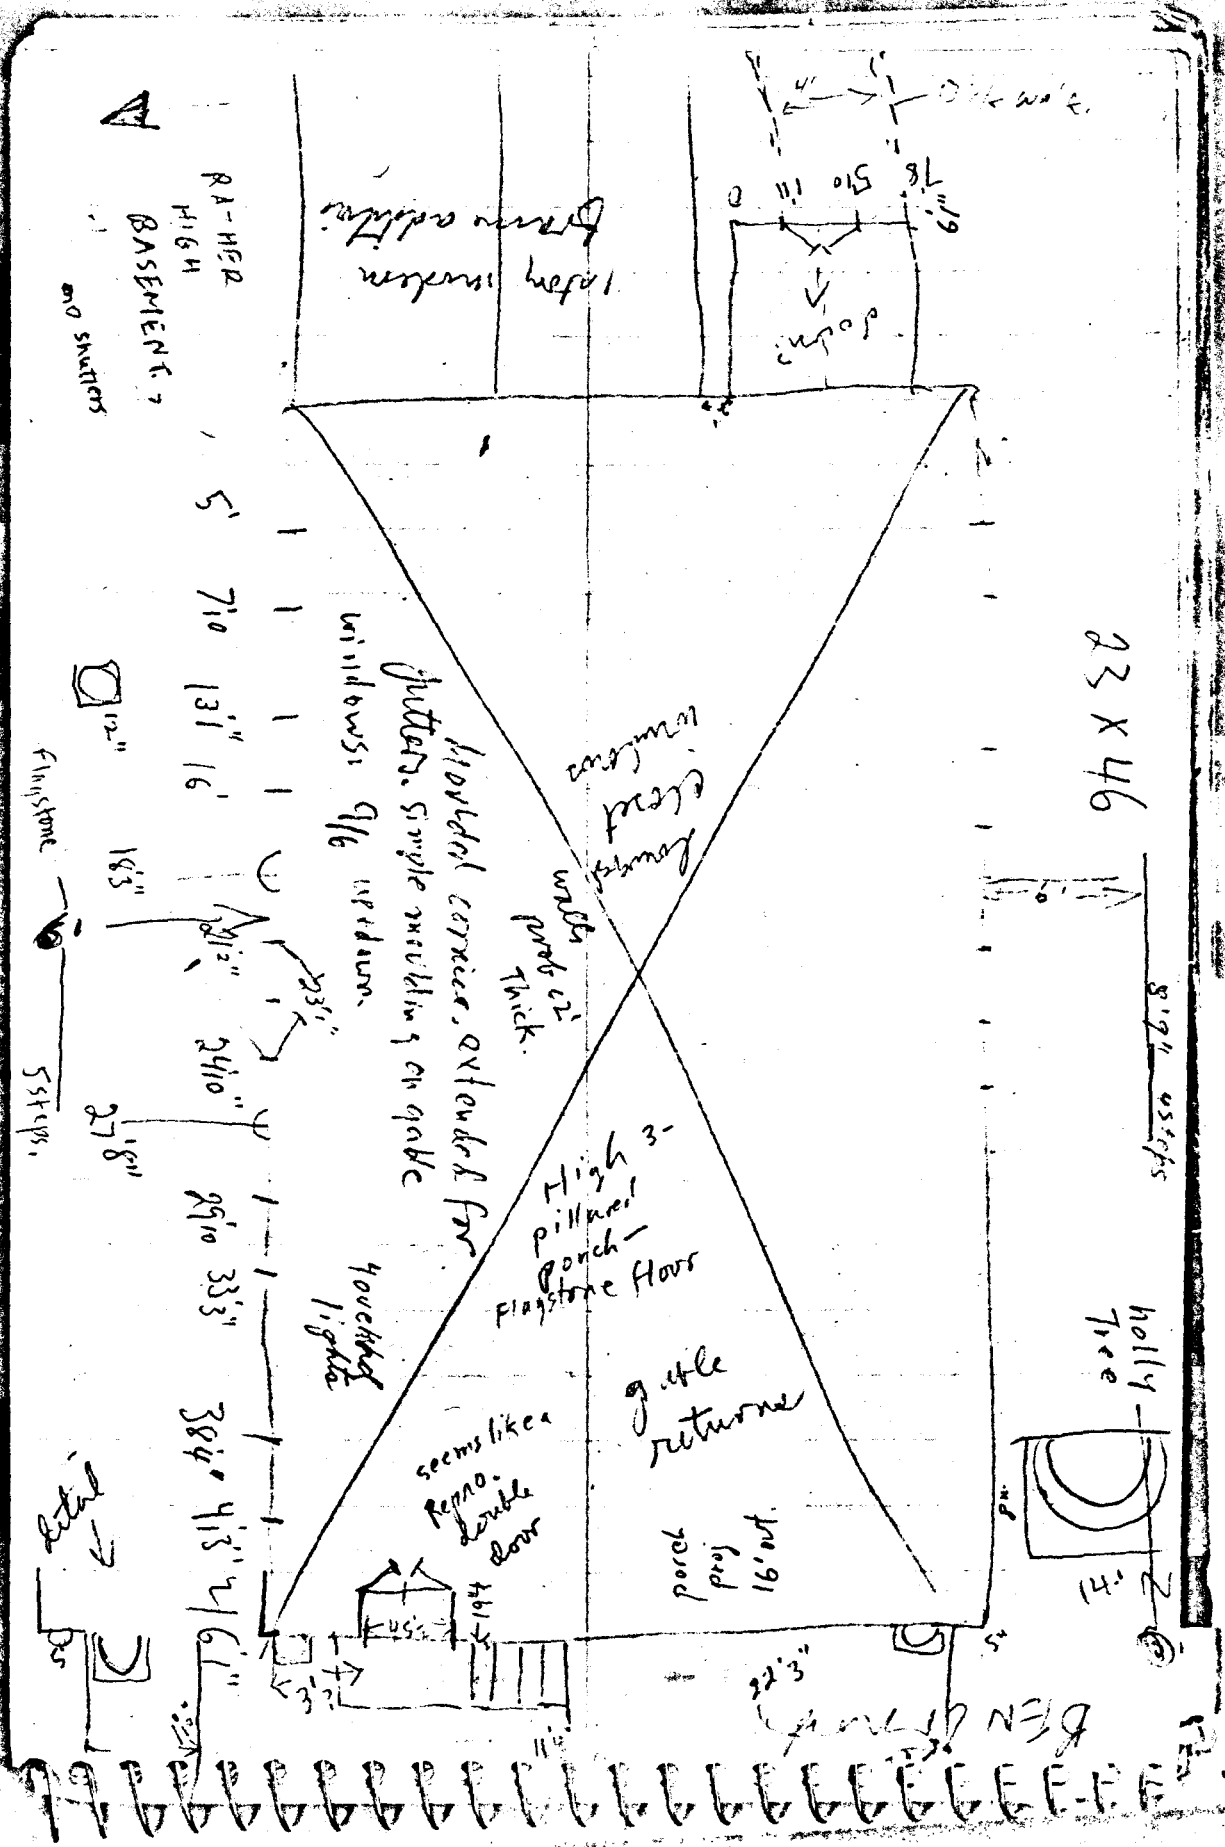
RA-HIGH
BASEMENT

AND SHUTTERS

shoulder cornice, extended for
gutters. Simple mullins on gable
windows 9/16

High 3-
pillared
porch -
Flagstone floor

parch
proj
16' out.

seems like a
Remo.
double
door

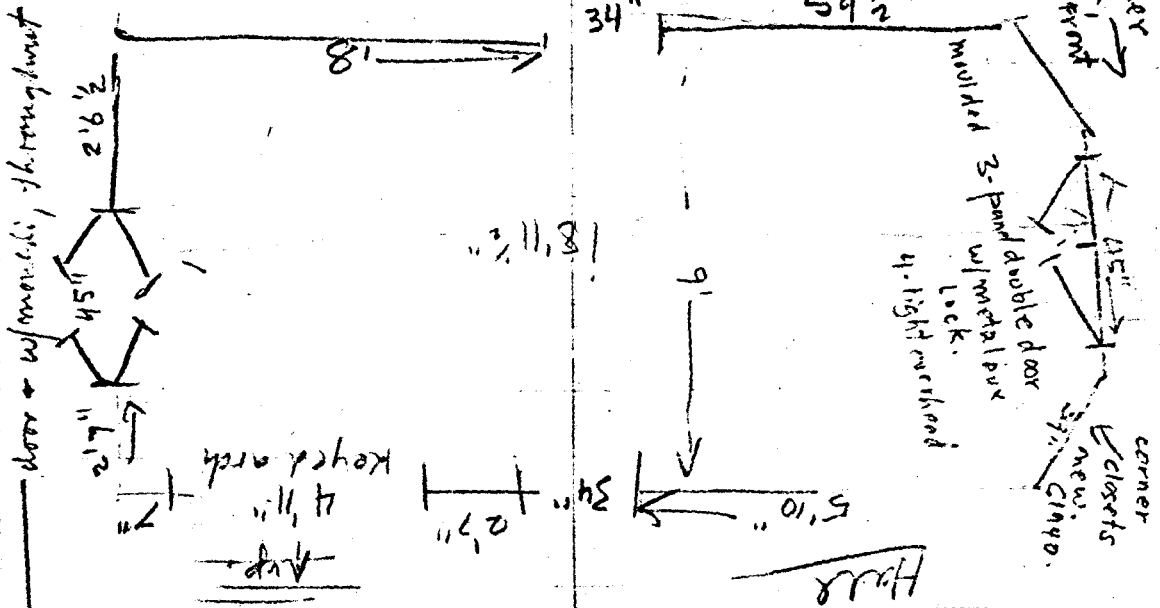
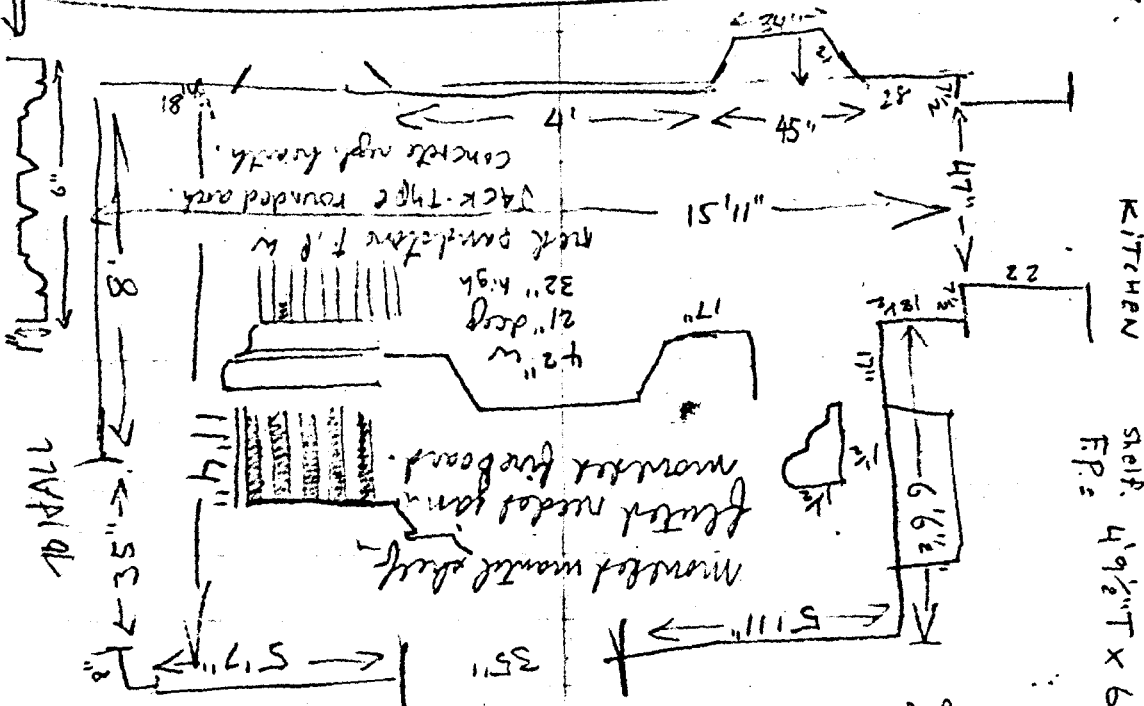
walls = 024-23" thick

1st floor east room
DINING RM.
ceiling 9'8 1/2"
wait high warm ceiling (concrete panels) try to w/ chair rail
wallpapered & look like wood paneling

KITCHEN
Shelf 4'9 1/2" T x 6'9" W
FP

arch. moulded, about 6 coats of paint.

pink paint on wall paper

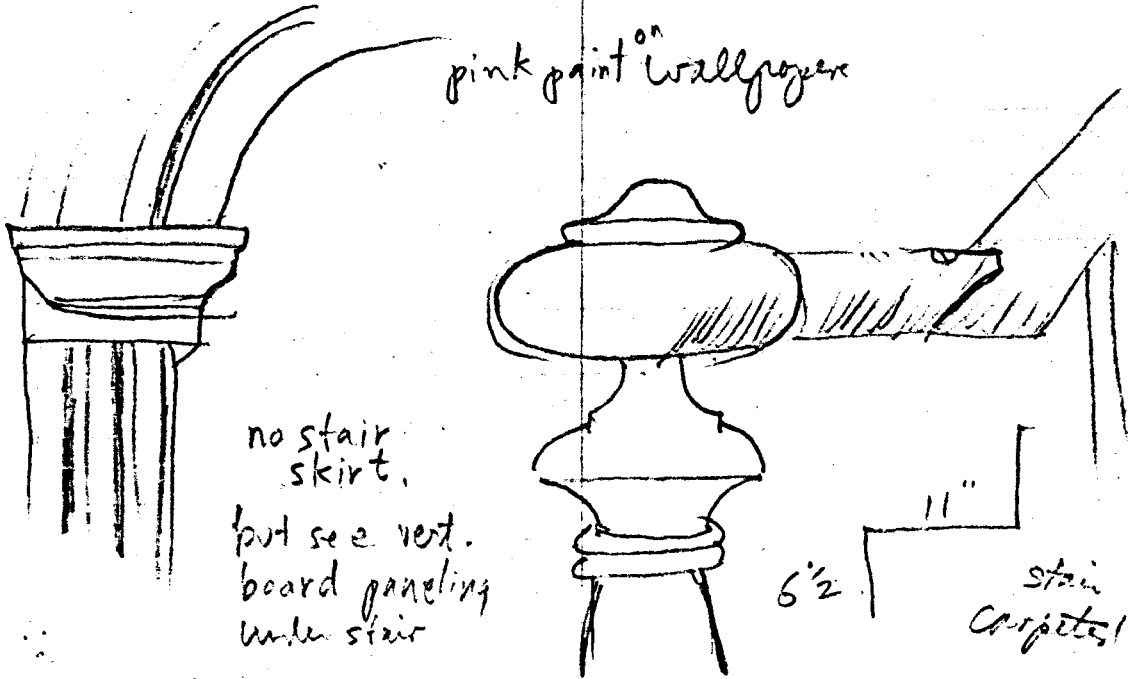
no stair skirt,
but see vert.
board paneling
under stair

stair
carpet!

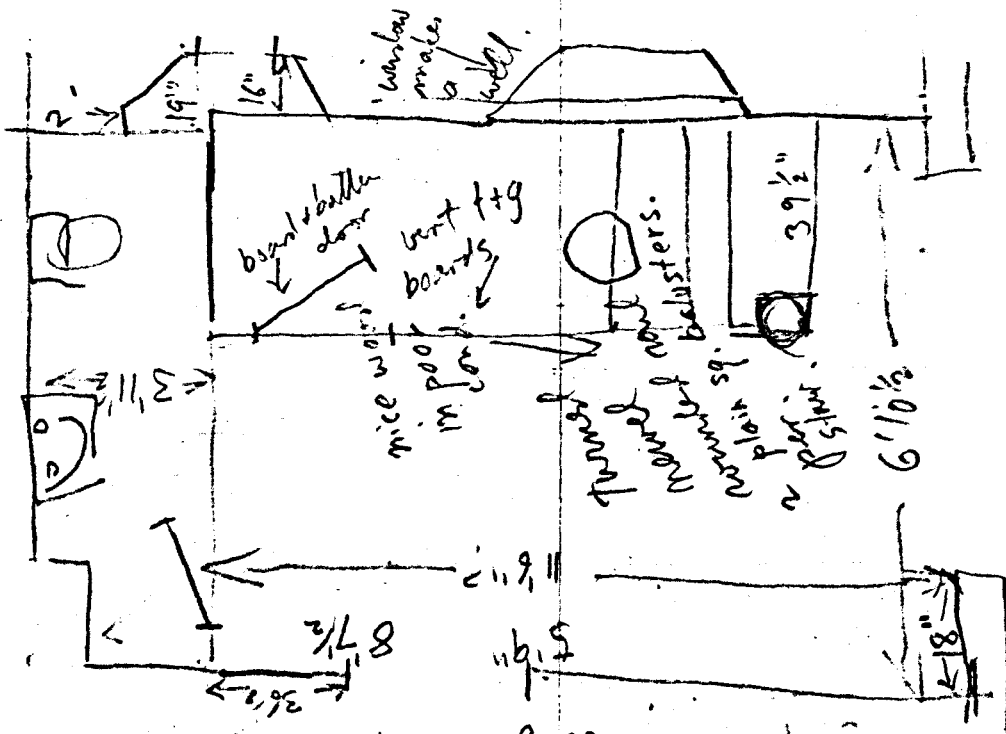
Living Room

blue wallpaper

New door but a copy of the other
45"

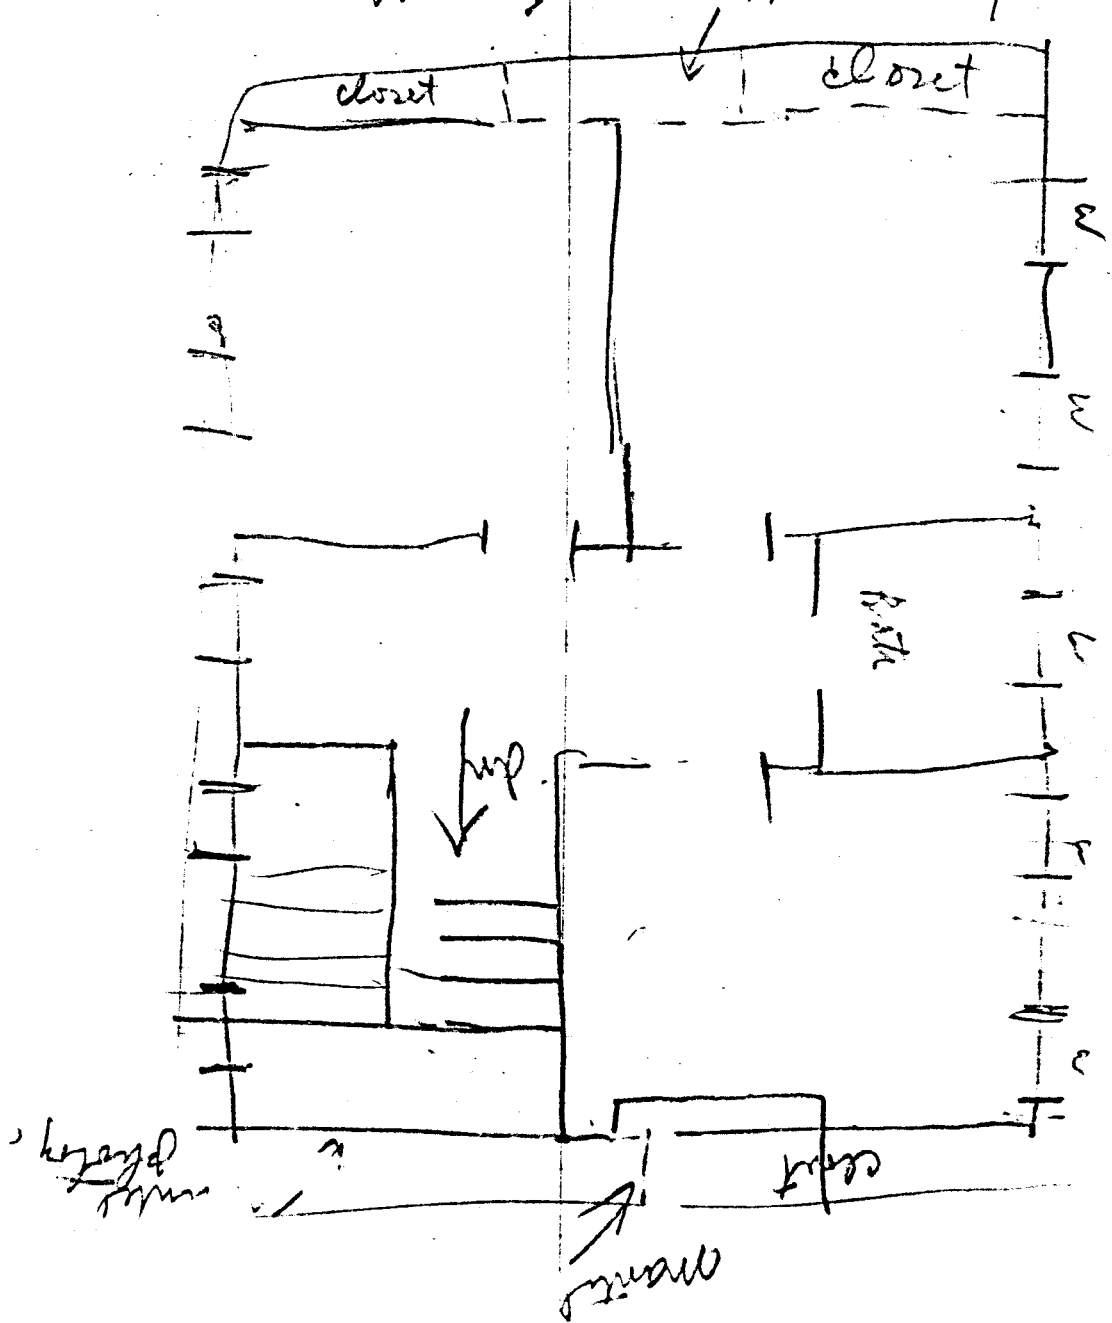
meat house +

— new roof.

walls plastered once +

white washed.

mud mortar

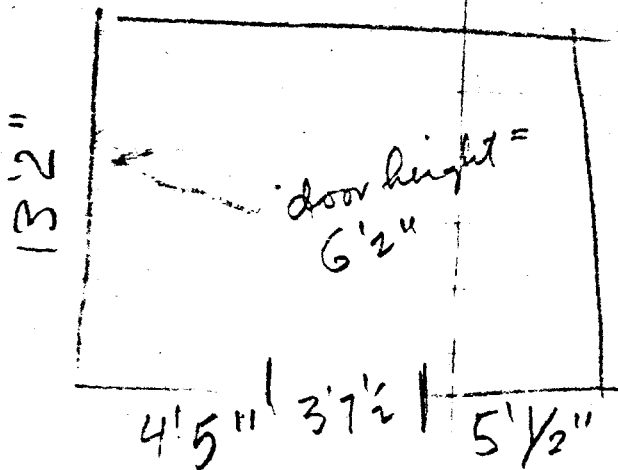
dairy

mortar has been repaired 2 times

walls = 27-23"

stone + dirt floor

also a new roof.
