VIRGINIA HISTORIC LANDMARKS COMMISSION

SURVEY FORM

Historic name	Common name Ben Lomond Stone Accessory Building
County/Town/City Prince William County	
Street address or route number Westover Baptist Church Parcel, Sudley Manor Dr., Manassas, Va.	
USGS Quad Gainesville	Date or period 1st Qtr. 19th C.
Original owner Benjamin T. Chinn	Architect/builder/craftsmen
Original use Overseer's House?, Slave Qtr.?	
Present owner Westover Baptist Church	Source of name Mtn. Nr. Loch Lomond in Scotland.
Present owner address c/o Rev. Alfred Philley	Source of date Architectural, Archeological evidence
9425 Westmoreland Ave., Manassas, VA 22110	Stories 1 story
Present use Not in use.	Foundation and wall const'n Stone foundation, walls.
Acreage c6 acres.

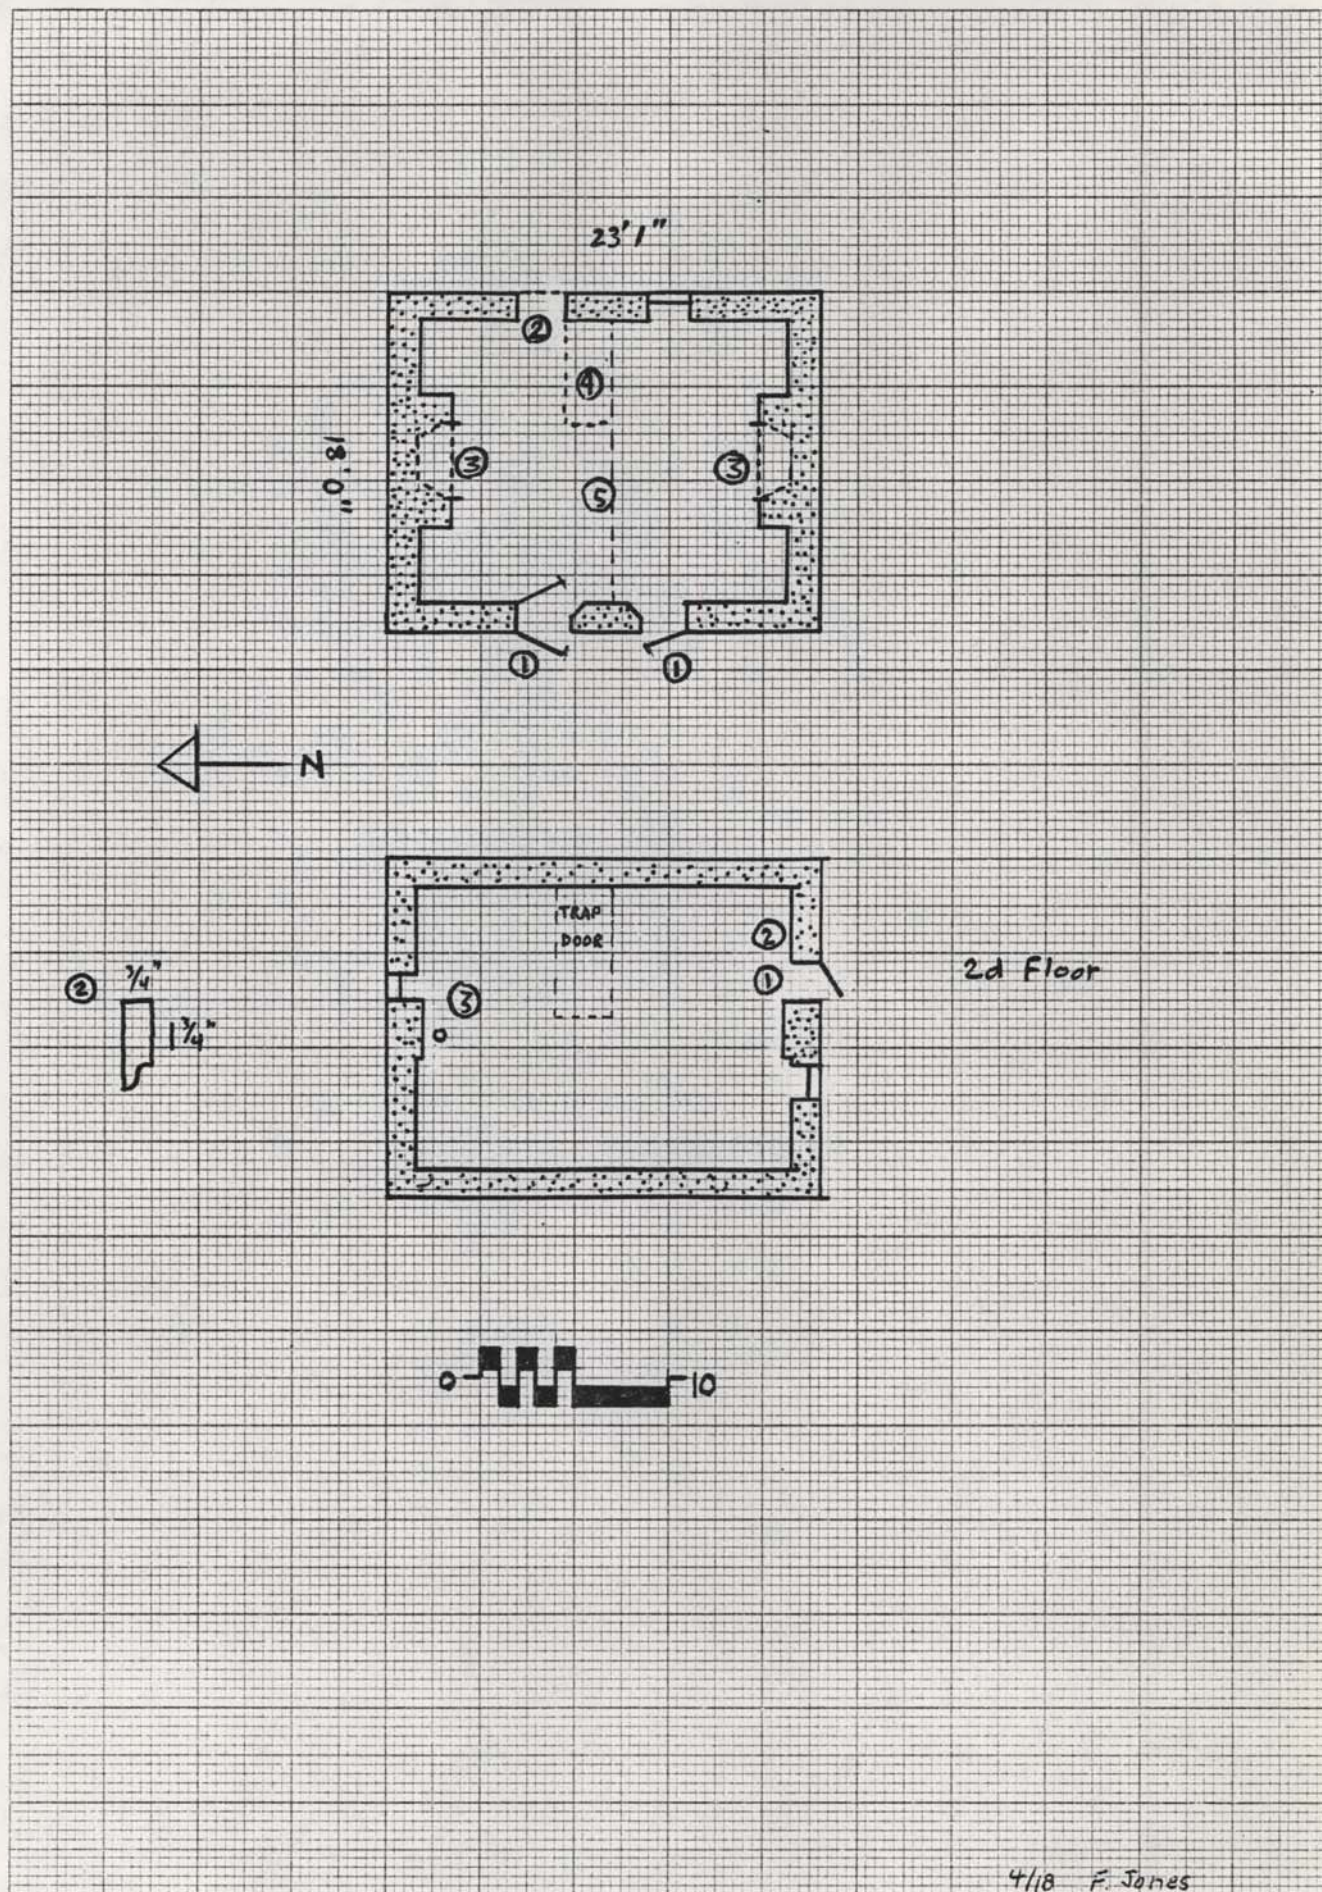
Plan (Indicate locations of rooms, doorways, windows, alterations, etc.)

Notes to Plan:

FIRST FLOOR

- 1) Pair of entrances; one boarded up, the other a replacement door.
- 2) Window converted to door.
- 3) Fireplaces blocked.
- 4) Trap door to 2d floor.
- 5) Signs on joist and along wall of 1"-thick board partition dividing 1st floor into two equal rooms.

SECOND FLOOR

- 1) Small (25" x 42½") door.
- 2) Fragment of cyma moulding around interior door frame. See sketch.
- 3) No fireplaces in 2d floor, but stove hole.
