VIRGINIA
DIVISION OF HISTORIC LANDMARKS
HISTORIC DISTRICT/BRIEF
SURVEY FORM

City/Town/Village/Hamlet Brentsville County Prince William County
 Street address or route number 12350 Barbee Street U.S.G.S. Quad Nokesville
 Historic name _____ Common name Clover Springs Farm

Present use Residence Building Style Vernacular I-House
 Original use Residence Building Date(s) ca. 1890-1920

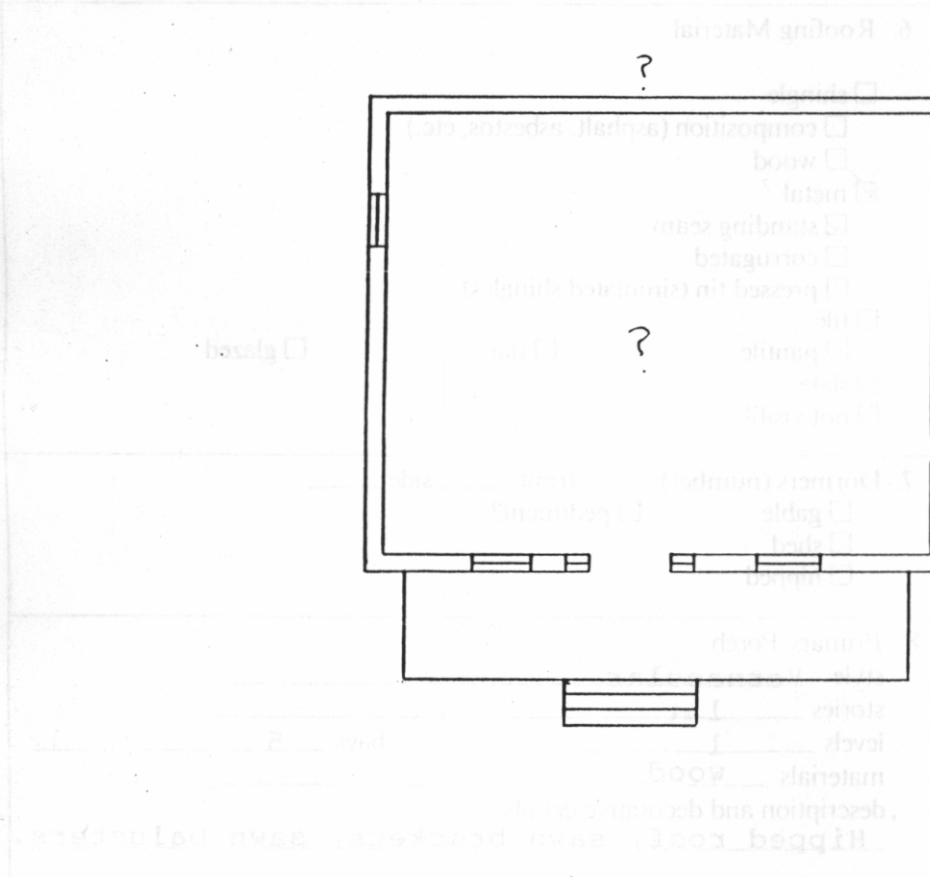
Drawing of Plan

8. Primary Porch
 style Vernacular
 stories 1
 levels 1 bays 5
 materials wood
 ,description and decorative details
Hipped roof, sawn brackets, sawn balusters.

9. General supplementary description and decoration: 1/1 sash win-
dows with louvered blinds. Transom and side-
lights around entrance. Red sandstone foundatio
Four-panel front door.

10. Major additions and alterations:
West-end brick chimney added. Aluminum
siding added. Blinds added.

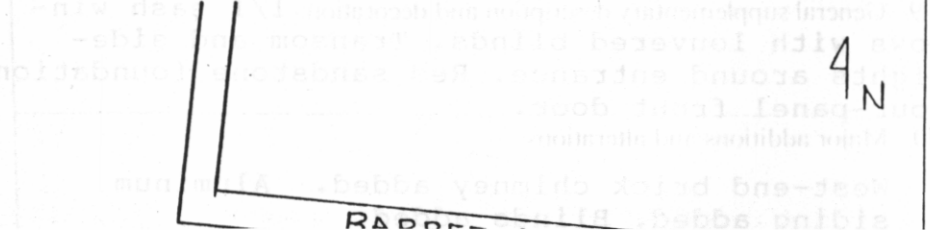
Sketch of Site Plan

11. Outbuildings:
Gable-roofed garage covered with metal brick patterned siding.

12. Landscape Features:
Wood rail fence, mature oak trees and various shrubs.
