Blooms

Blooms Interior

Thurs. 23 Oct 1980

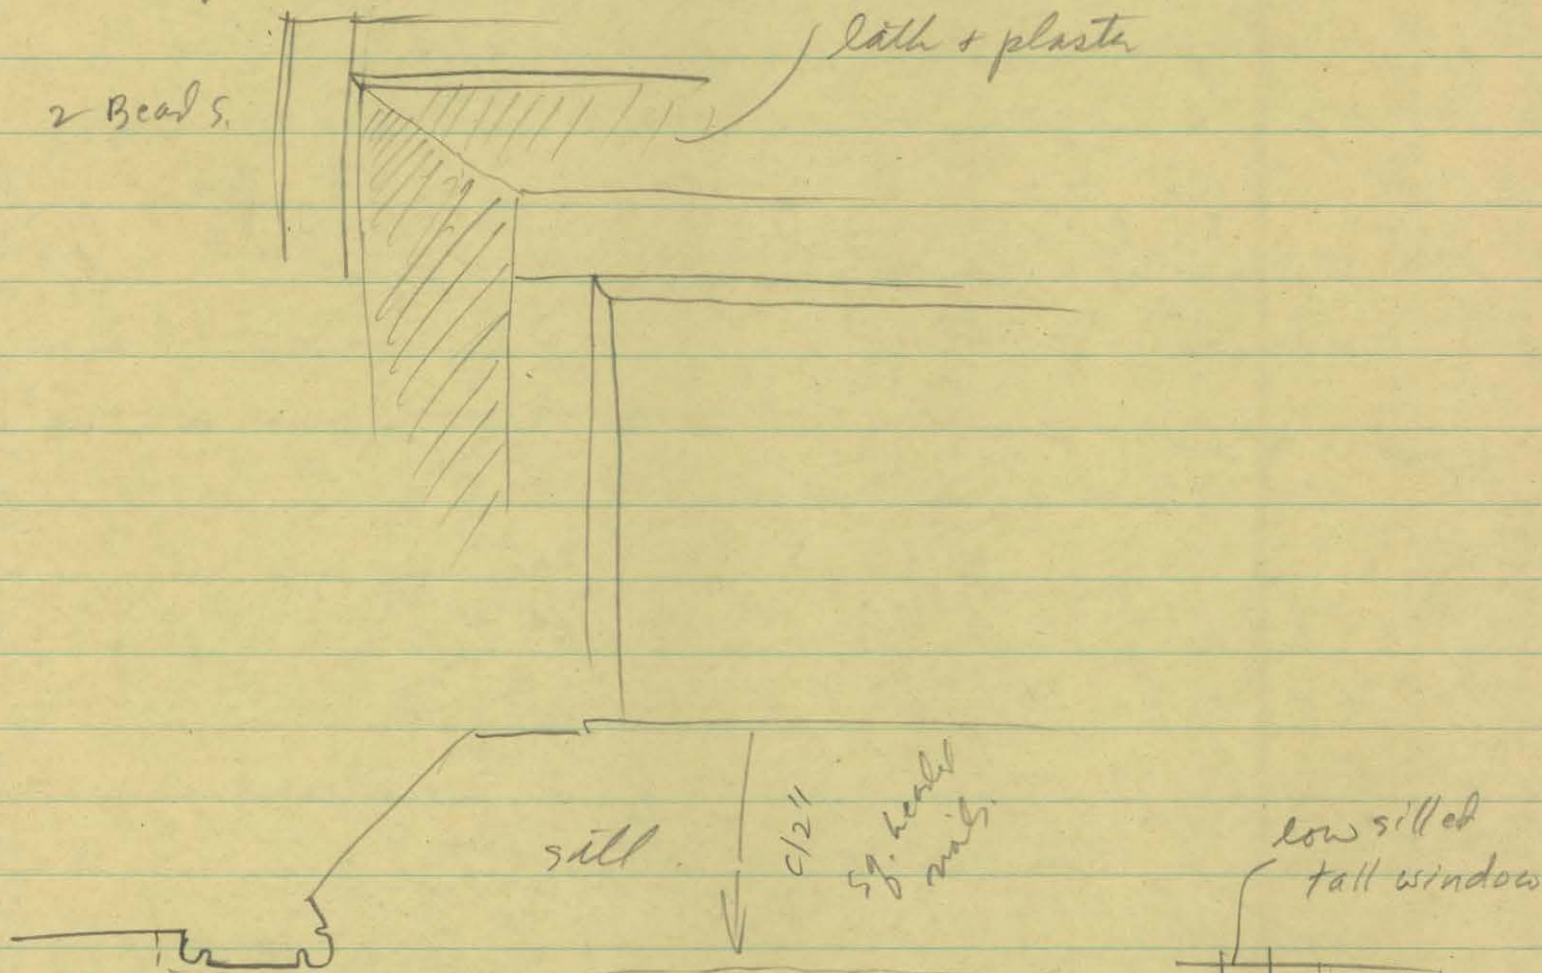
2d fl. trim in Hall w. (west side)

2 Bead S.

lath + plaster

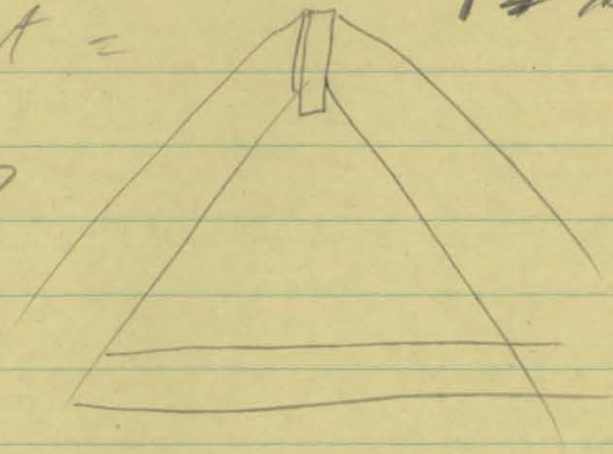
roof old part =

ridge pole roof?

lath present  
in attic  
small hearth?

collar braces  
close to ridge +  
late horiz  
supports  
lower than that

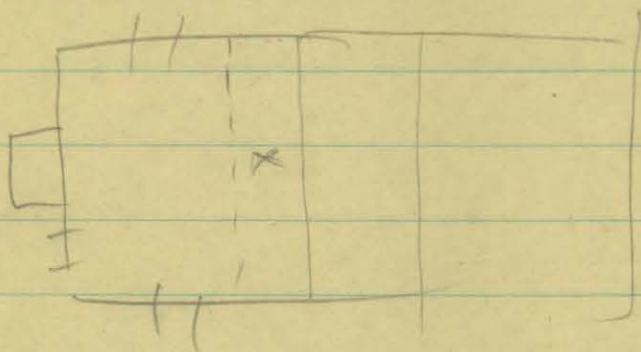
sign of an old heav timber in center of  
hall on west wall. c4x7 or 5x7.

Hall part 2d fl may have been moved  
c 1 1/2 ft. to the south.

Making hall narrower.

Which explains why trim is or is not  
present and baseboards

x may be where stair to attic rose.
