W.R. GOSSOM'S STORE (GRISTMILL & HICKORY GROVE POST
OFFICE (76-104) LOGMILL RD. & LONDON DRIVE,
HICKORY GROVE, PRINCE WILLIAM COUNTY.

W. R. GOSSOM'S STORE/GRISTMILL & HICKORY GROVE POST OFFICE (76-87), PRINCE WILLIAM COUNTY

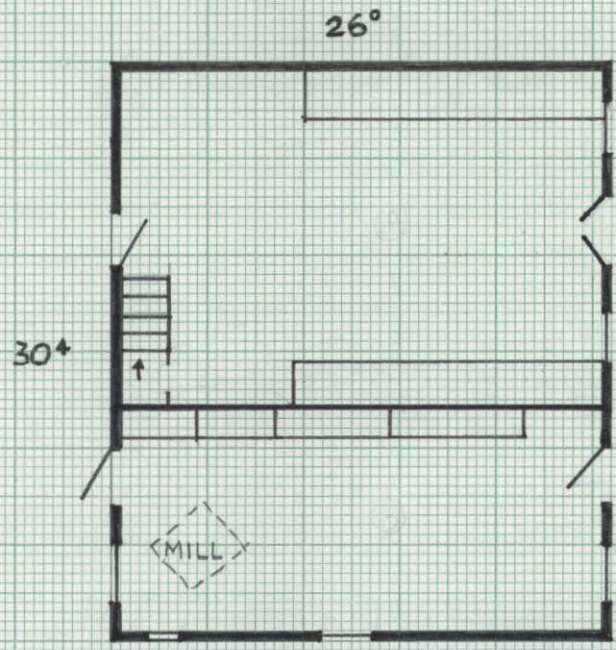
EXTERIOR 1 1/2 story Frame structure w/ clapboard exterior.
1-story addition with shed roof contains milling eqpt.
Stone foundation; no basement. Metal roof.
~~Floor, store side = poured concrete over stones.~~
" ~~mill side = wood.~~
7' deep concrete porch across front.

Ext. Very weathered but traces of white paint remain.
Trim was green. Walls, east & west & south have ~~had~~ clapboards.
Wall on north is vert tongue & groove siding.

Condition. Very bad.
