VIRGINIA HISTORIC LANDMARKS COMMISSION

SURVEY FORM

Street address or route number 209 Commerce Street, Occoquan, VA 22191

A.L. Harris House

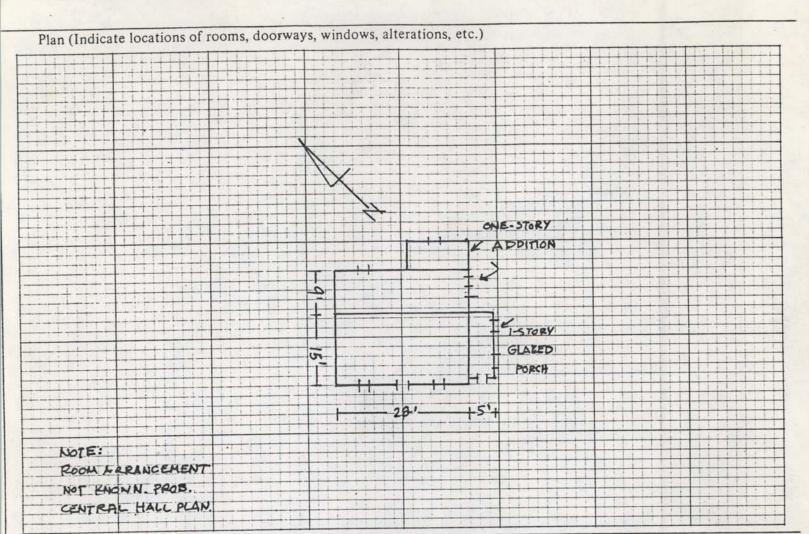
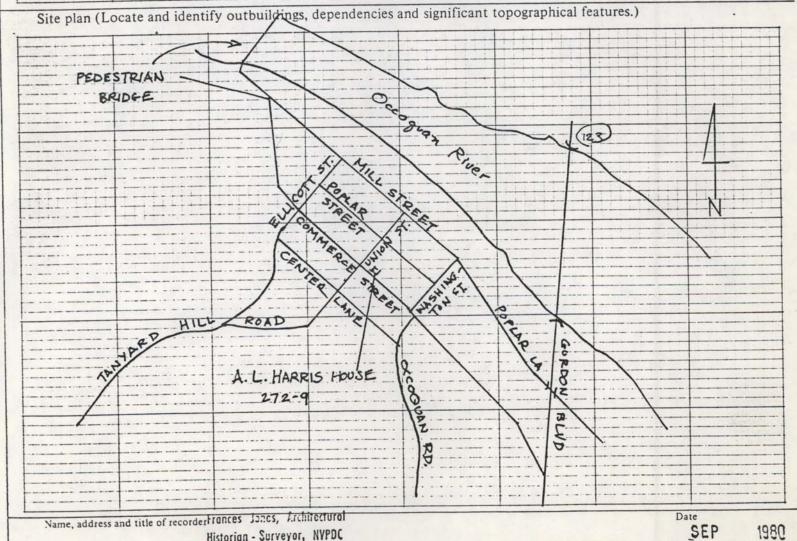
State condition of structure and environs House and environs are in good condition.

This three-bay, frame, I-type house has an asphalt shingle-covered gable roof pierced by two brick interior stove flue chimneys, one at either end. The exterior is clad with weatherboard siding. The 6.6 sliding sash windows are shuttered (in part) and are surrounded by plain box trim painted dark green. There is a one-story, shed-roofed addition containing a kitchen on the rear, or northeast side. Attached to the one-story rear addition is another small onestory shed or enclosed porch. On the south end is a one-story, hip-roofed enclosed porch.
