VIRGINIA HISTORIC LANDMARKS COMMISSION

SURVEY FORM

Historic name Haymarket Post Office

Street address or route number 15020 Washington Street, Haymarket, VA 22069

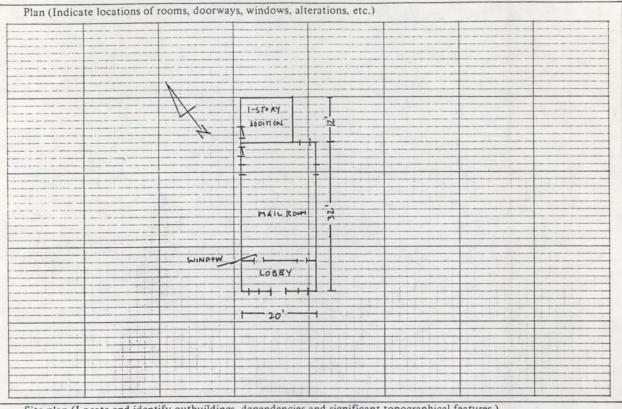
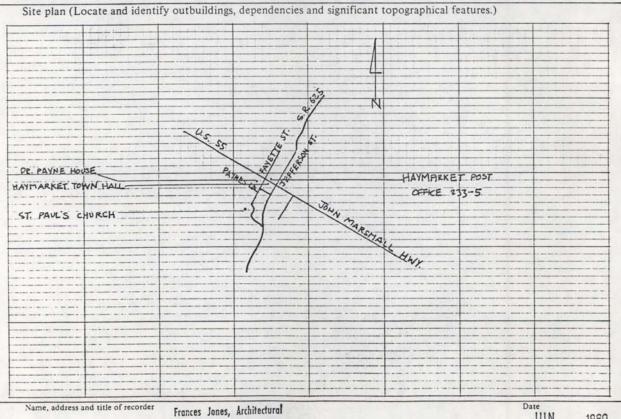
State condition of structure and environs Building and environs in fair condition.

A small, weatherboarded, 2-story, gable-ended structure, built, probably in the early 1900's, as a commercial building. The exterior is covered with rough-sawn weatherboard and is painted white with dark green trim. Rafters are exposed, and there is a plain vergeboard. The building has cornerboards and plain box trim. Regular size 2/2 sliding sash except on first floor front where there are oversize 2/2 stationary windows. The front entrance is a double door with glass panels in the upper half. There is a three-pane overhead. A covered porch may once have spanned the front.
