# National Register of Historic Places Registration Form

historic name Chopawamsic RDA - Camp (2) Mawavi Historic District  
 other names/site number Prince William Forest Park

Name of related multiple property listing:  
ECW Architecture at Prince William Forest Park, 1933-42

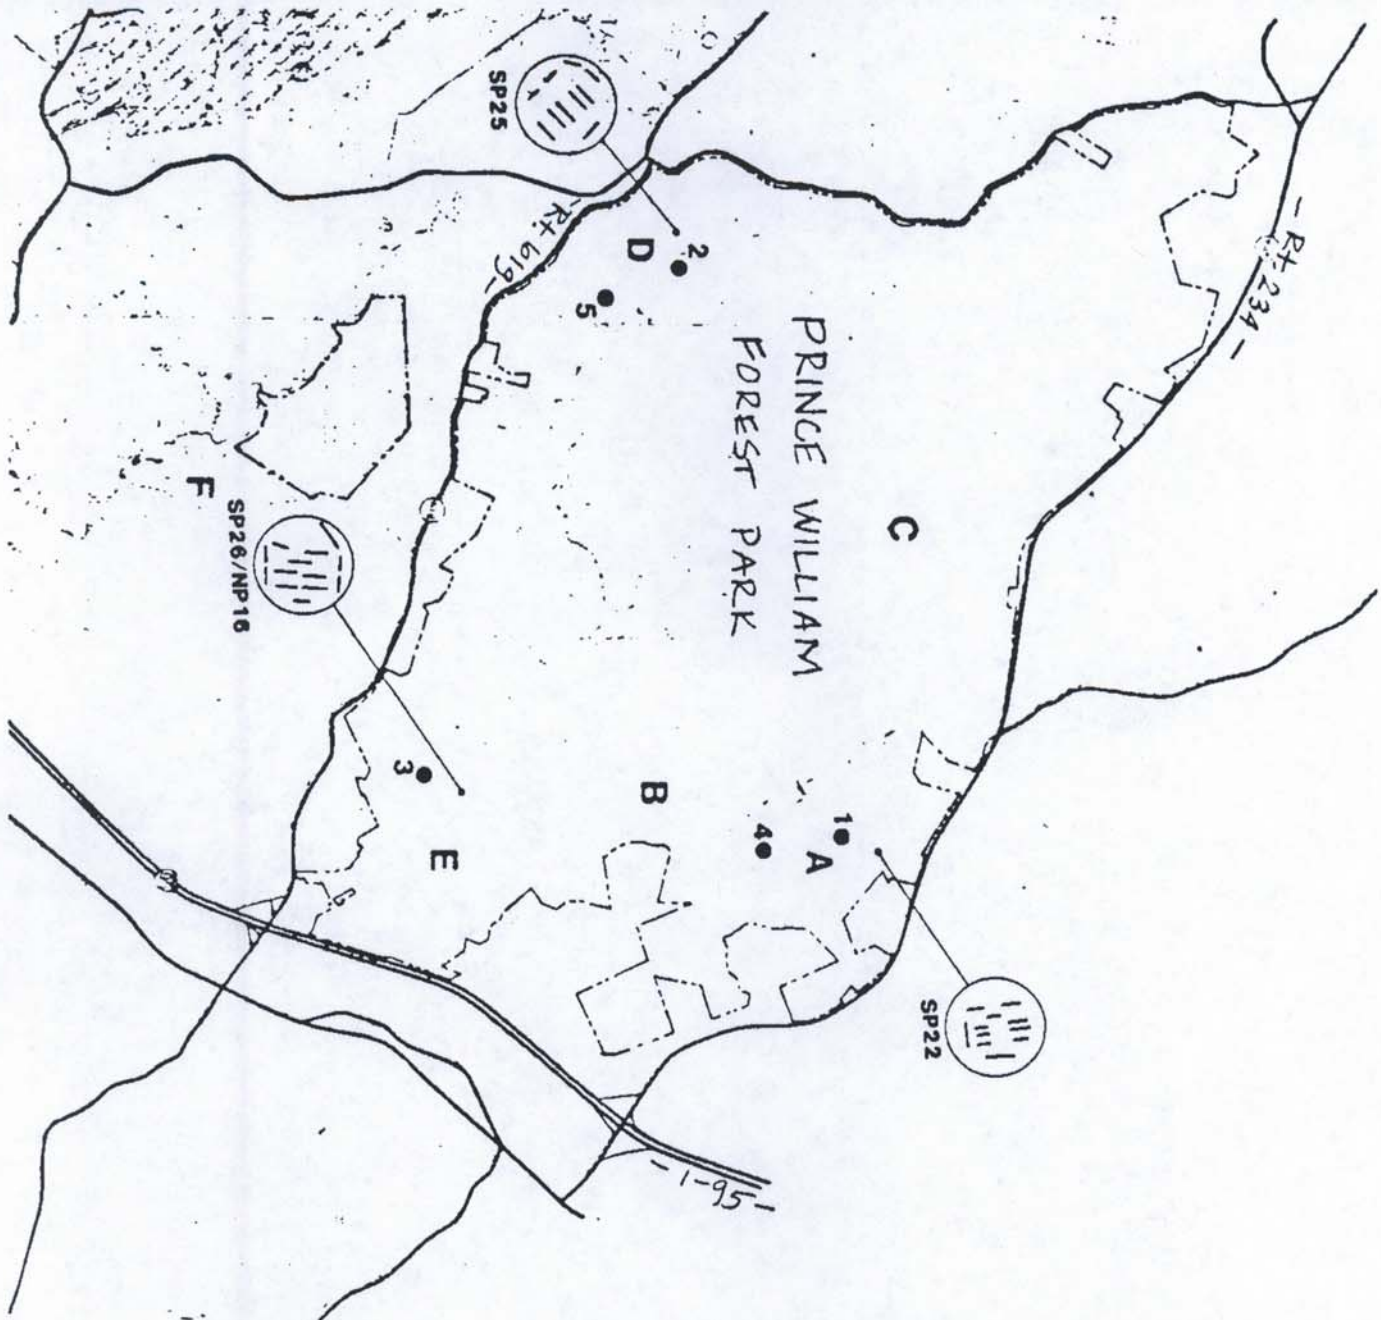
MAP 1: CCC and CABIN CAMP SITES  
 (from The Hinterland, Parker)

- A** Negro Organized Camps
  - B** Negro Day Use
  - C** Negro Pioneer Unit
  - D** White Organized Camps
  - E** White Day Use
  - F** White Pioneer Unit
  - G** Mothers and Tois' Area
- 
- 1** Cabin Camp 1  
(Camp Lichman)
  - 2** Cabin Camp 2  
(Center Camp, Mawawi)
  - 3** Cabin Camp 3  
(Camp Orchard)
  - 4** Cabin Camp 4  
(Camp Pleasant/Camp Goodwill)
  - 5** Cabin Camp 5  
(Happyland)

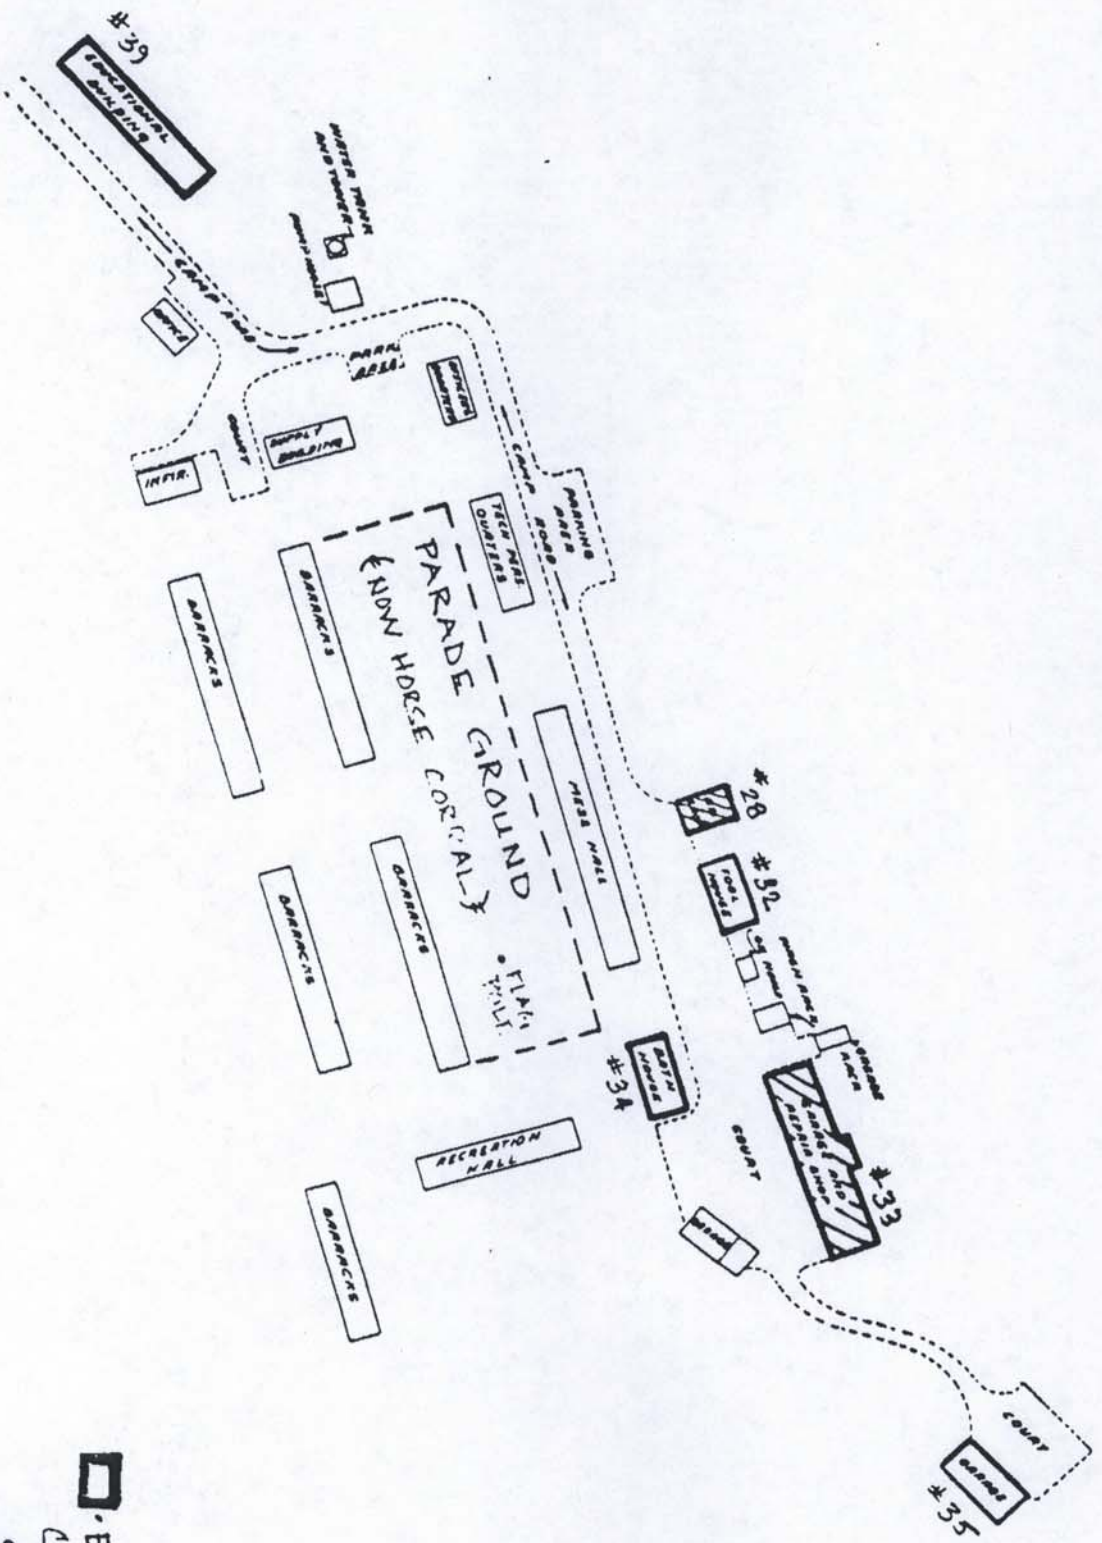
MAP 2: SP-26 SITE PLAN, begun 1934  
 Now located in maintenance area  
 (from The Hinterland, Parker)

EXSTANT &  
 CONTRIBUTING

CCC CAMP NO. 16  
 CHORONATHSIC AREA  
 QUANTICO, VA  
 SCALE 1" = 50'

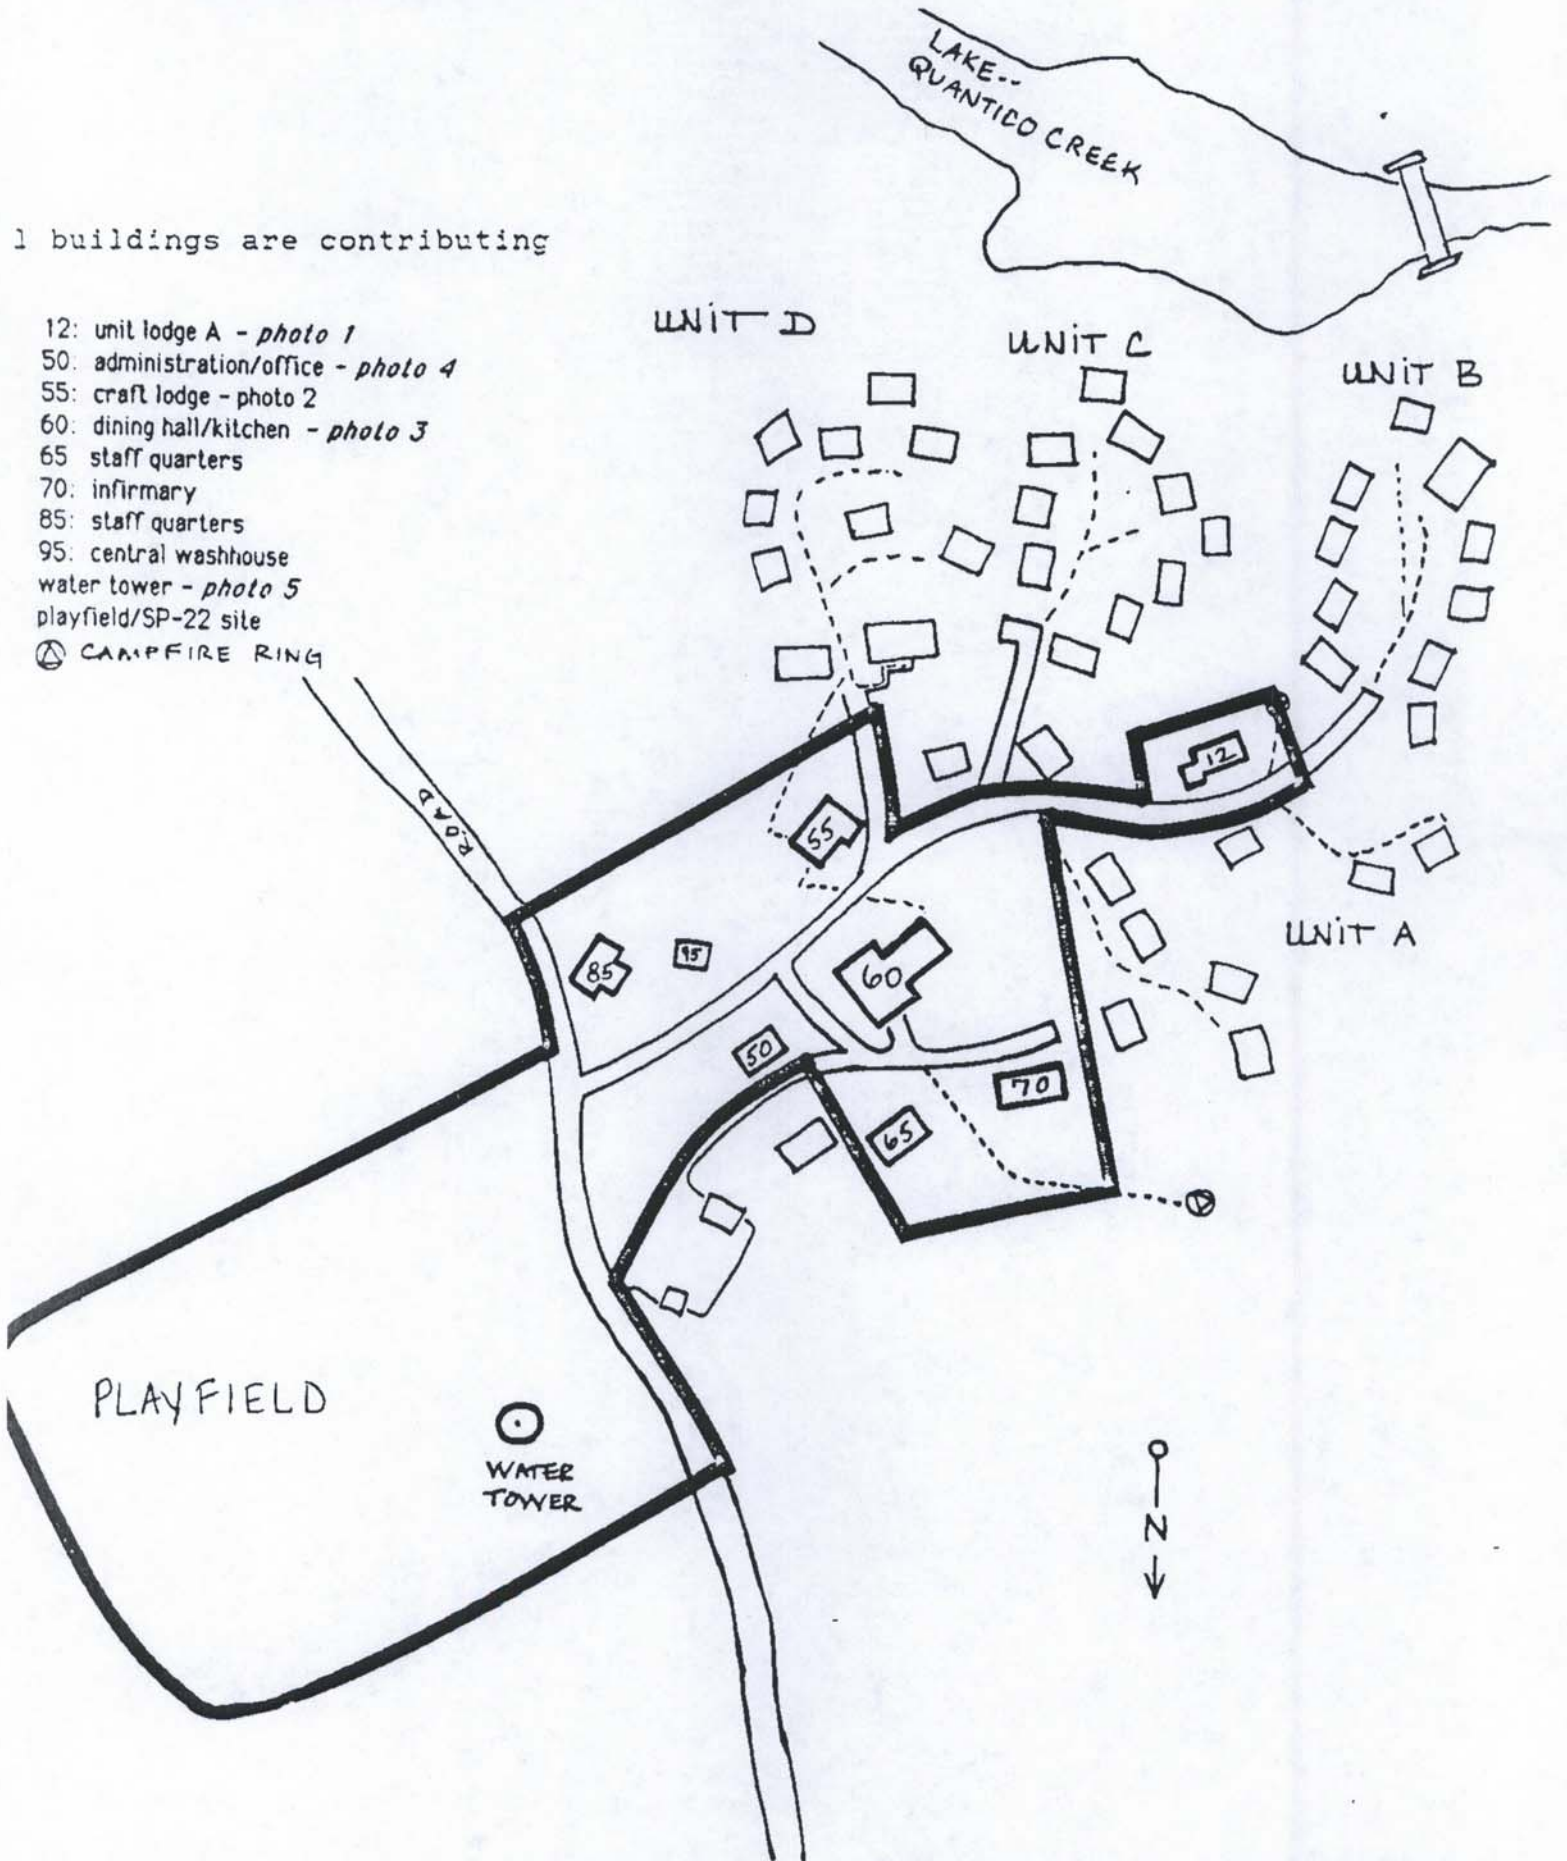
**MAP 5: PROPOSED CAMP (1) GOODWILL  
HISTORIC DISTRICT**

1 buildings are contributing

- 12: unit lodge A - *photo 1*
- 50: administration/office - *photo 4*
- 55: craft lodge - *photo 2*
- 60: dining hall/kitchen - *photo 3*
- 65: staff quarters
- 70: infirmary
- 85: staff quarters
- 95: central washhouse
- water tower - *photo 5*
- playfield/SP-22 site
- ⊙ CAMPFIRE RING

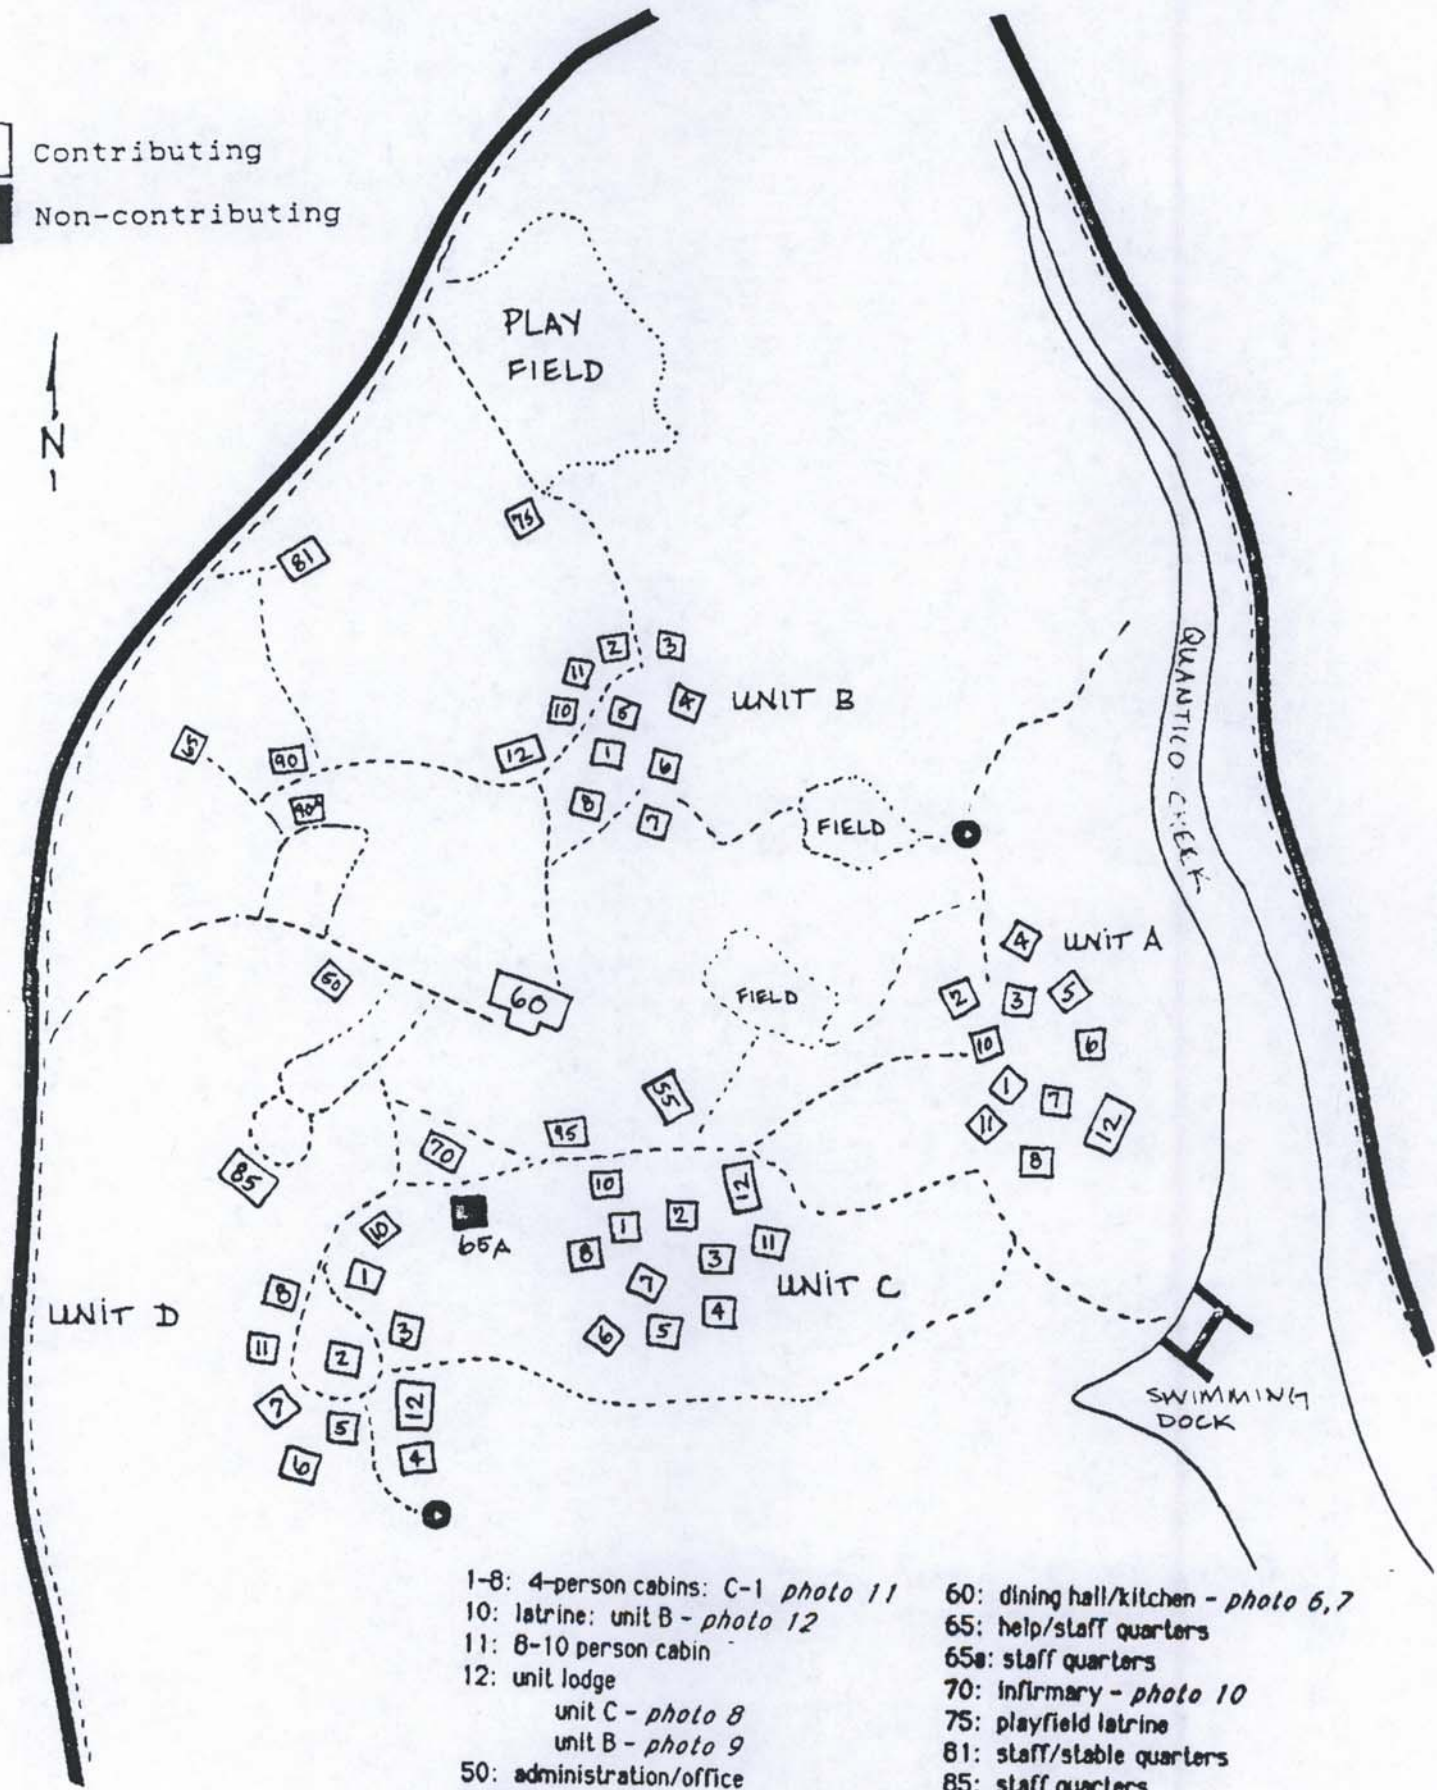
MAP 6: PROPOSED CAMP (2) MAWAVI  
HISTORIC DISTRICT

□ Contributing  
■ Non-contributing

- 1-8: 4-person cabins: C-1 photo 11
  - 10: latrine: unit B - photo 12
  - 11: 8-10 person cabin
  - 12: unit lodge  
unit C - photo 8  
unit B - photo 9
  - 50: administration/office
  - 51: boathouse
  - 55: craft shop
  - 60: dining hall/kitchen - photo 6,7
  - 65: help/staff quarters
  - 65a: staff quarters
  - 70: infirmary - photo 10
  - 75: playfield latrine
  - 81: staff/stable quarters
  - 85: staff quarters
  - 90-90a: storage
  - 95: central washhouse - photo 13
  - Dam 2/5: photo 14
- ⊙ CAMPFIRE RING

Chopawamsic/PWFP is a product of the coordinated efforts of the NPS's Branch of Plans and Design in Washington, and the NPS Branch of Planning and State Cooperation, Region 1, in Richmond. Between 1936 and 1938, CCC enrollees and WPA laborers constructed the 36 cabins, five latrines, four unit lodges, four helps'/staff quarters, two storage buildings, office/administration building, craft shop, dining hall, infirmary, washhouse, campfire circle, and an impounding/diversion dam blocking the South Branch of the Quantico Creek (map 6).

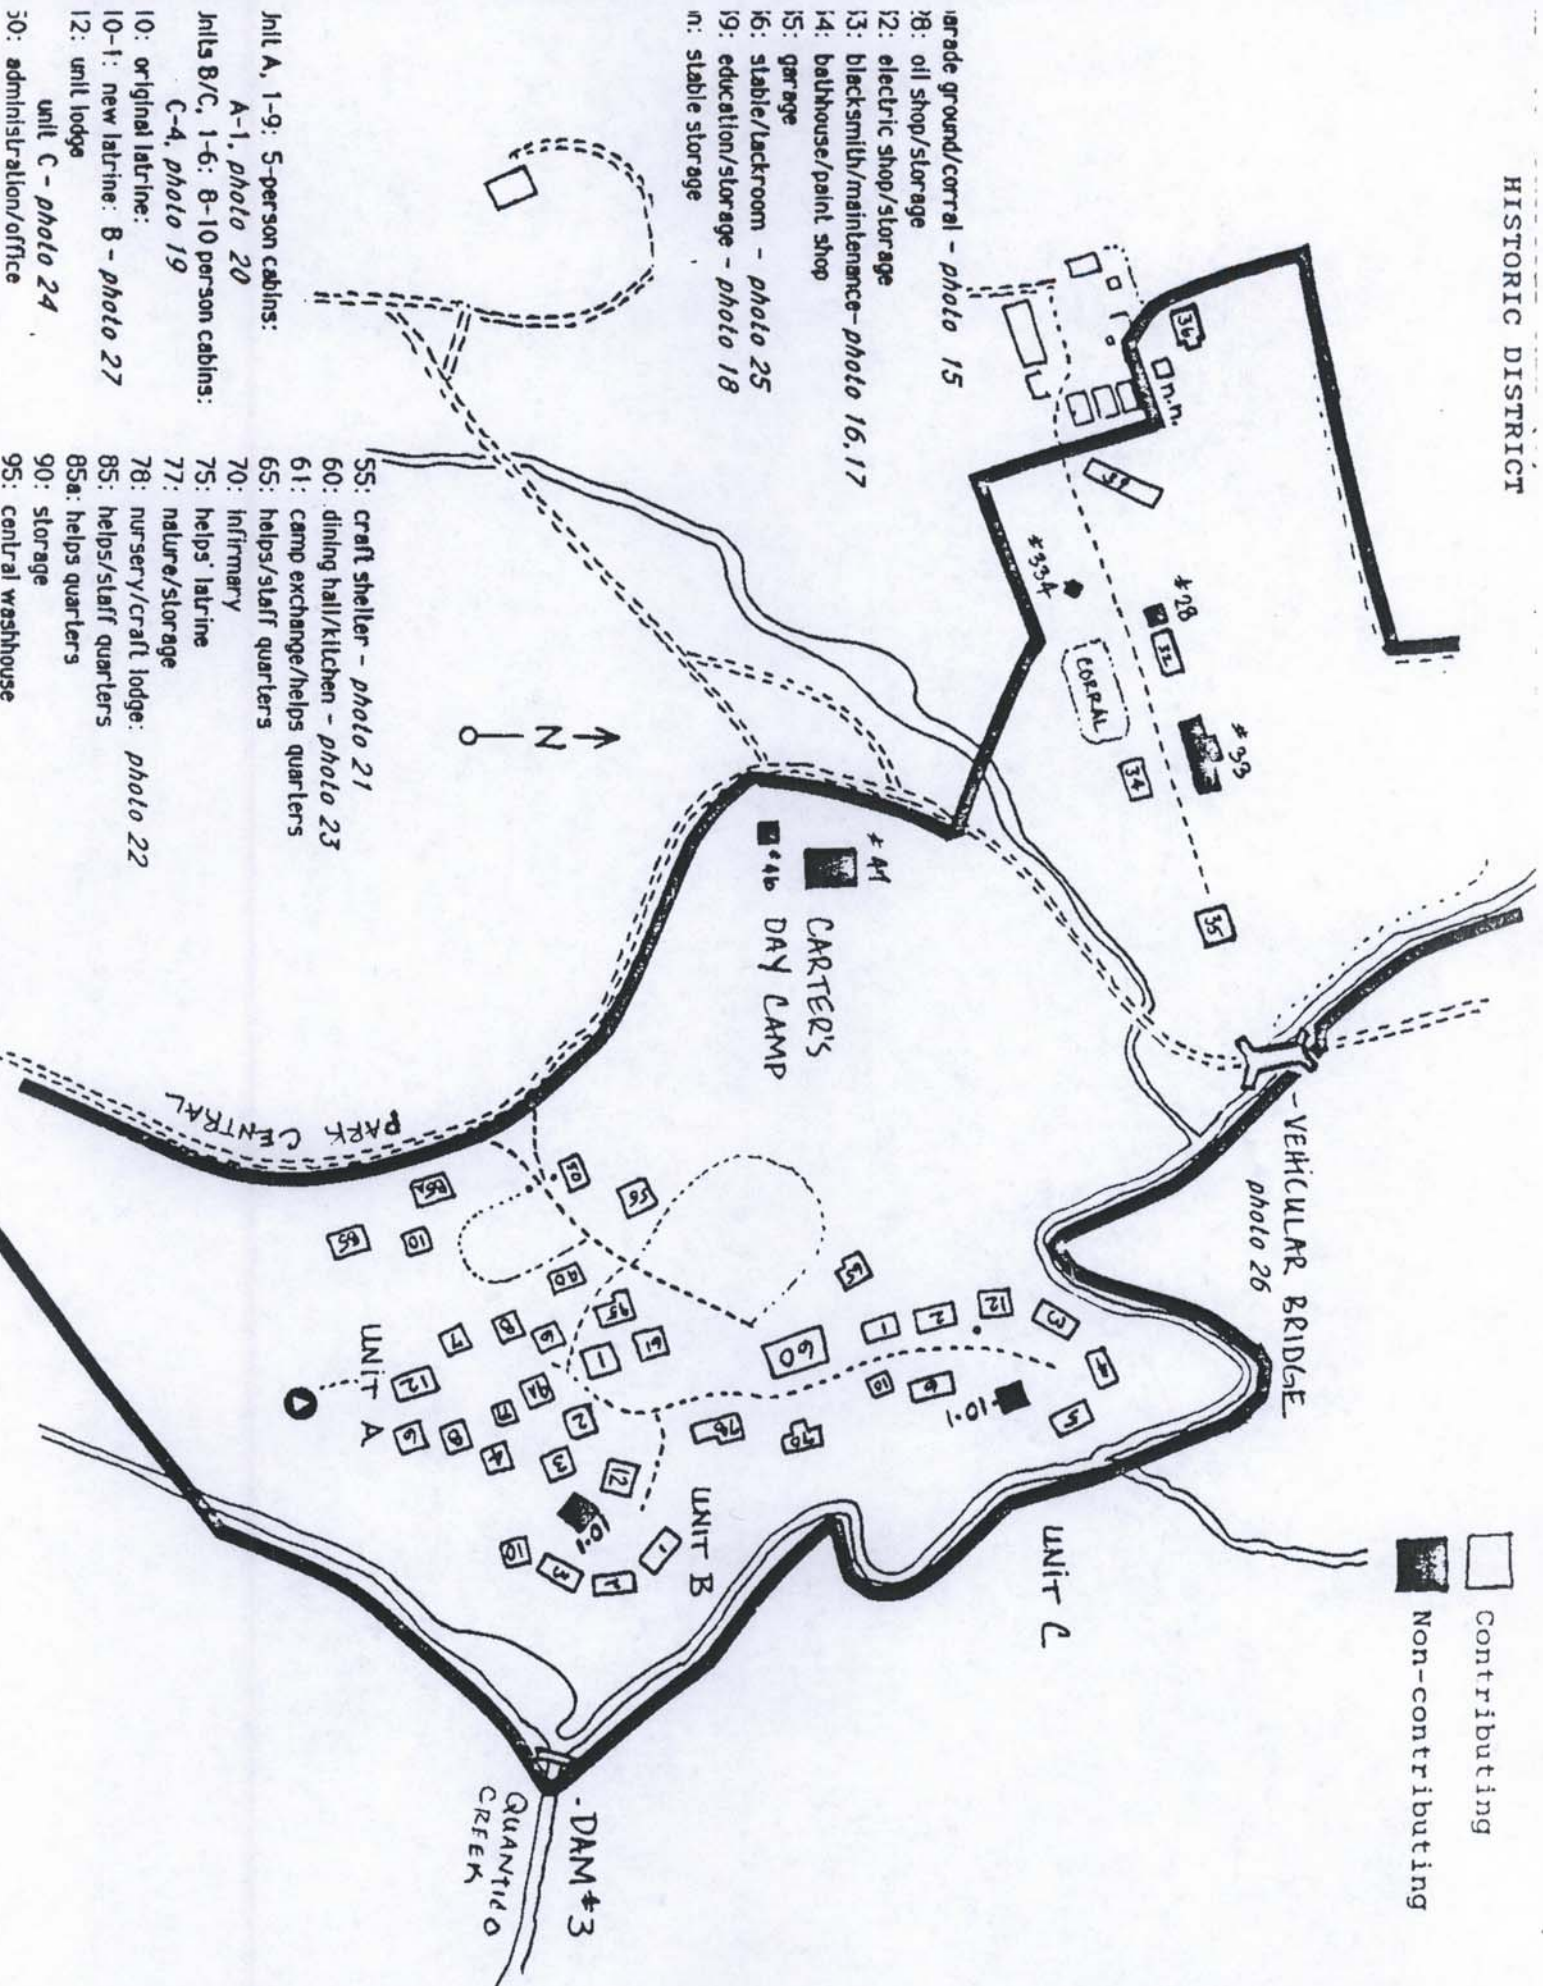
HISTORIC DISTRICT

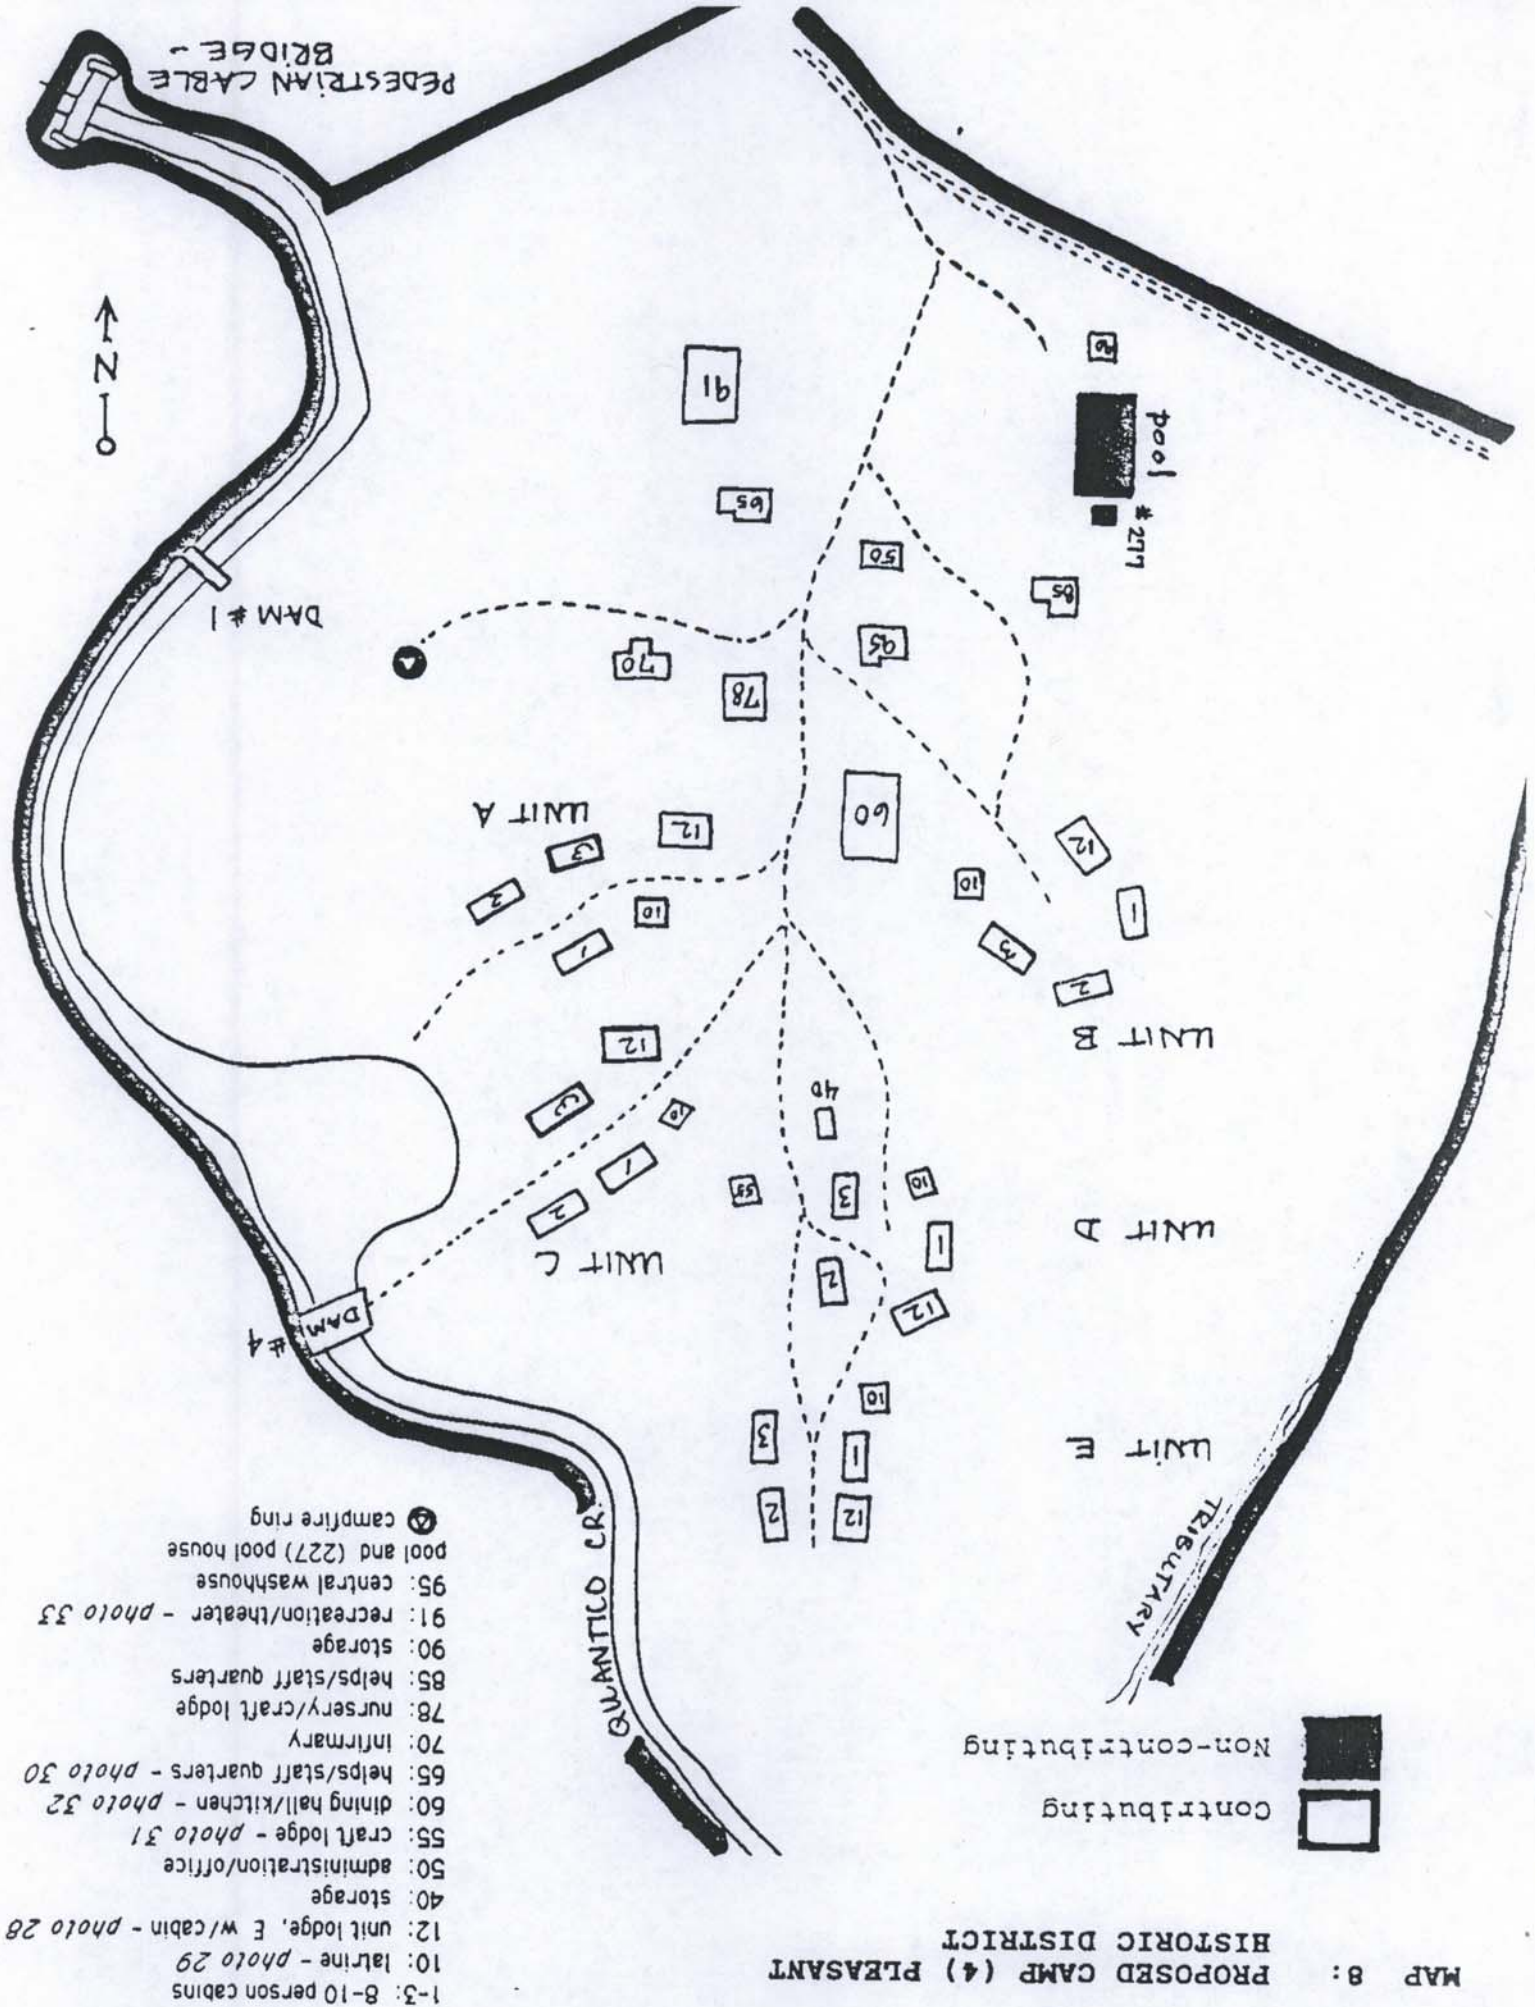
MAP 8 : PROPOSED CAMP (4) PLEASANT HISTORIC DISTRICT

- 1-3: 8-10 person cabins
- 10: latrine - photo 29
- 12: unit lodge, E w/cabin - photo 28
- 40: storage
- 50: administration/office
- 55: craft lodge - photo 31
- 60: dining hall/kitchen - photo 32
- 65: helps/staff quarters - photo 30
- 70: infirmary
- 78: nursery/craft lodge
- 85: helps/staff quarters
- 90: storage
- 91: recreation/theater - photo 33
- 95: central washhouse
- pool and (227) pool house
- ⊙ campfire ring

- Contributing
- Non-contributing

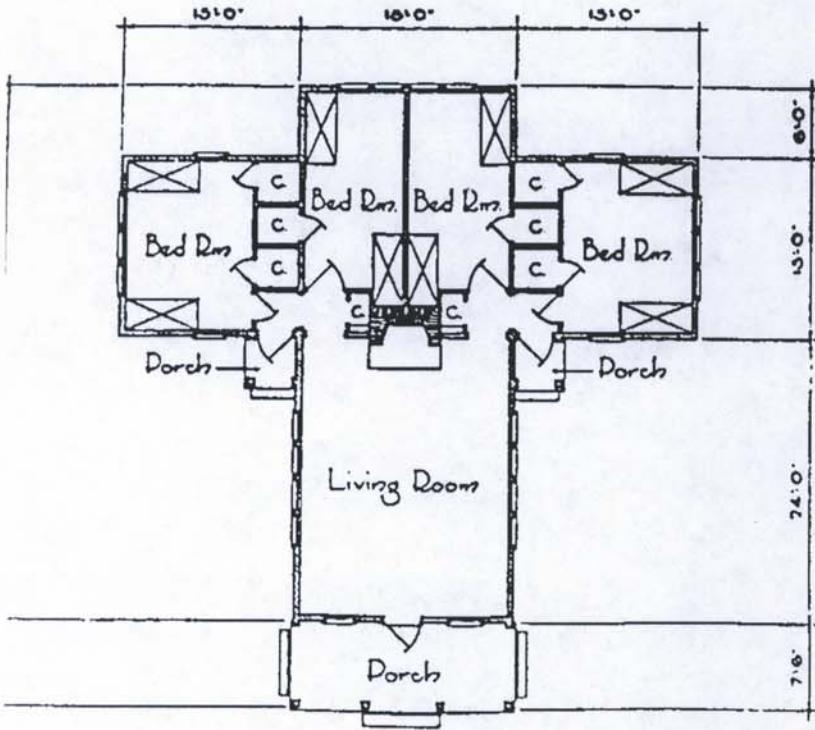
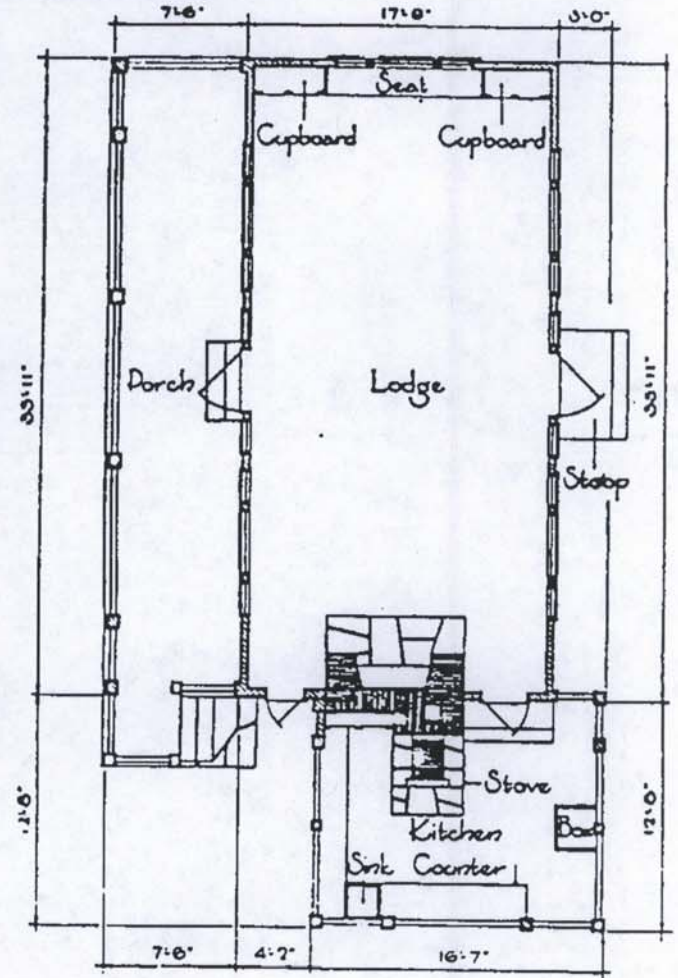
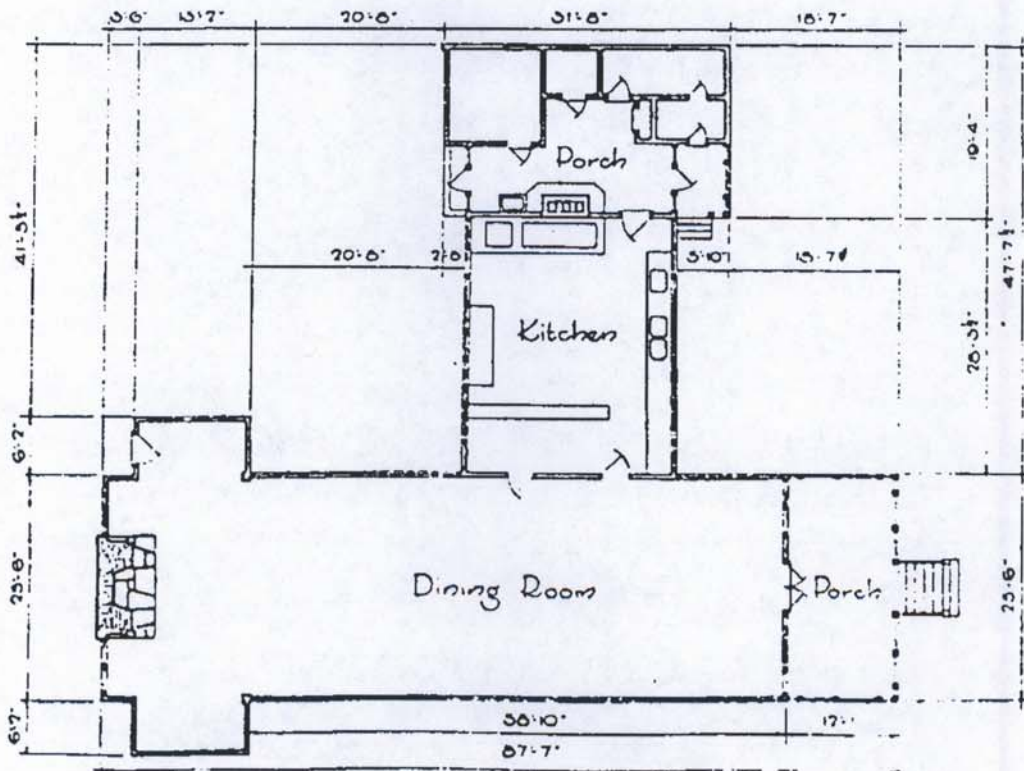
ILLUSTRATION 1: PLANS FOR CAMP (2) MAWAVI  
 (from Park and Recreation Structures, Good)

top left: staff quarters  
 top right: unit lodge  
 bottom: dining hall/kitchen

Five structures at Chopawamsic's Camp (2) Mawavi appear in Good's Park and Recreation Structures (1935, reissued in 1938) as model facilities: the kitchen/dining hall, unit lodge, administration building, infirmary, and staff quarters (illustrations 1-2). The unit lodge and staff quarters were also issued as model plans in the Portfolio of Buildings for Organized Camps in 1937. The dining hall (1936, photos 6-7) is a substantial 3,690 square feet, organized on a T-plan with the largest arm devoted to the dining room that features a stone hearth and entrance porch. The kitchen area adjoins the dining room on the service side, and on the other by a storage/pantry set of spaces. There is a clear division of spaces, and the eating area is ventilated by nearly continuous bands of windows. It represents "more than the minimum requirements" due to features like bay windows flanking the fireplace and large porch, non-essentials that nonetheless contribute to the buildings' attractiveness.<sup>18</sup> It was constructed at a cost of \$5,883, and served as a model (flopped over) for the one built at Camp (1) Goodwill a year later for \$3,165.<sup>19</sup>

The unit lodge (1936, photos 8-9) type here offers more than adequate features, including the full rear porch--sometimes added as a "superfluity in a hillside location that offers a view. It is one item which may be omitted without hampering the use of the building," although all four units of Camp (2) Mawavi have them; each cost about \$245.<sup>20</sup> The slightly banked ridge siting, low-pitched gable roofs, and texture of the hefty exterior stone chimneys, vertical casement windows, and full porches make this building type one of the most cohesively rustic and romantic in the park.
