Ranch house

--- "RANCH HOUSE" ---

Research made by  
Susan Rogers Morton,  
Haymarket, Virginia.

October 22, 1937

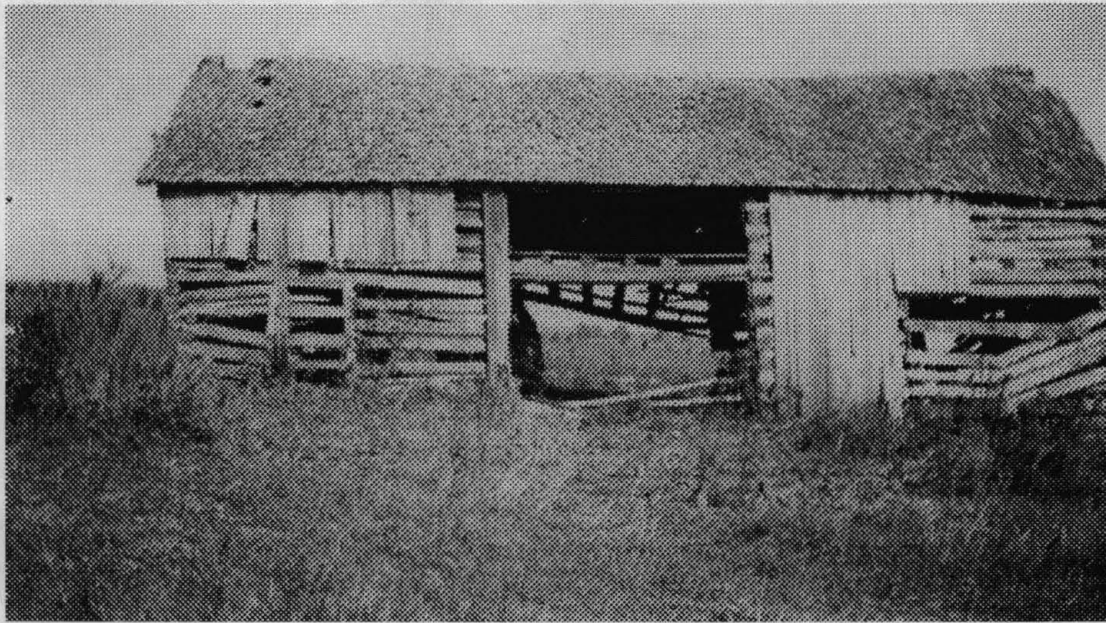
/VHI/P/22/0129.jpg

The interesting thing about it is the form in which it was built, being a double cabin with a covered span between them that a large team could pass through. There is one chimney and there seems to have been no way of heating the cabin except by a fire in the north.

It is in such a ruinous condition that it is difficult to describe it. The logs are all mortised, and were formerly daubed with stone and brick, mud chinked. There is one room in each cabin, and a loft reached by a ladder, the same in both parts of the house. There was once a large stone place, and wide hearth, but it is torn apart, and the chimney is partly fallen. There are the rotting remains of several outbuildings, and the yard is dotted with clumps of matrimony vine and rose bushes.
