VIRGINIA HISTORIC LANDMARKS COMMISSION

SURVEY FORM

Common name Rhodes House

RHODES HOUSE (76-108), PRINCE WILLIAM COUNTY

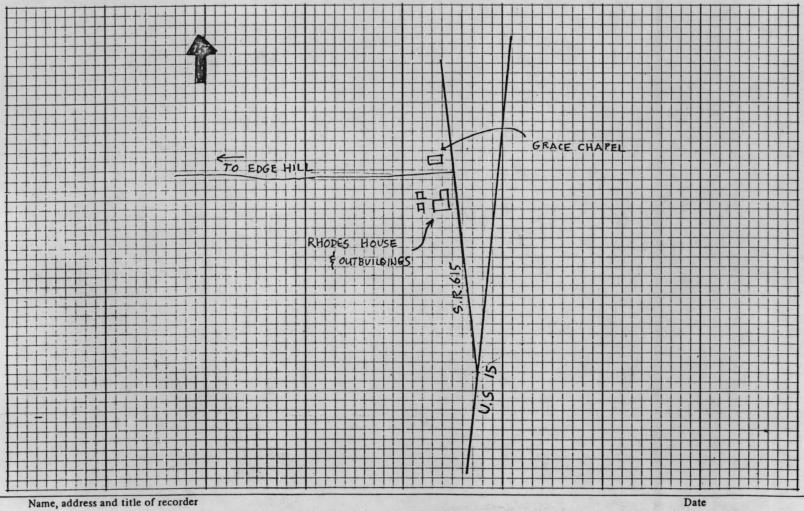
Site plan (Locate and identify outbuildings, dependencies and significant topographical features.)

There are two small outbuildings adjacent to rear of house, and lined up along driveway. One has a gable roof and wooden shingles; the other a shed roof with wooden shingles and a brick stove chimney. Both have board and batten siding.

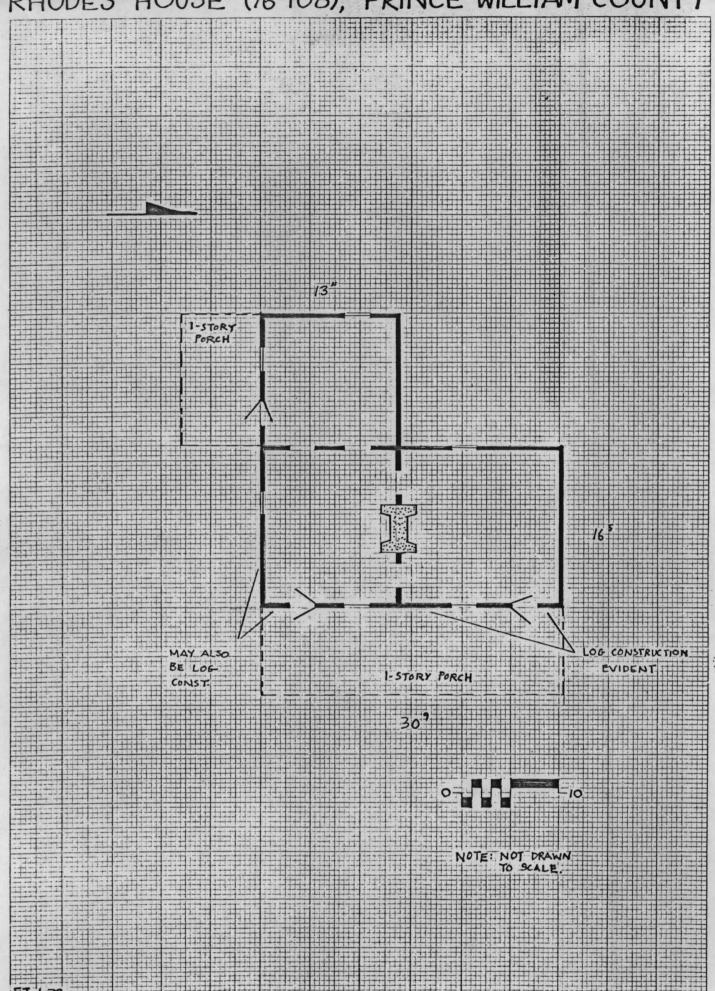
State condition of structure and environs House is in fair condition. Outbuildings need some work.

Siding is wide (5" to 8"-lap) weatherboarding painted white except where unpainted. Whitewashed logs with mud chinking on front right, and board and batten vertical siding on front left.

Chimneys: both brick, one (stove chimney) pierces roof of el, the other (fireplace stack) at center of main house. Both either repaired or replacements.
