Looks like two separate living units, one new stair. large residence, ca

4 rentals
former dwelling + apt.
wood fr.
stone found.
plaster, drywall walls

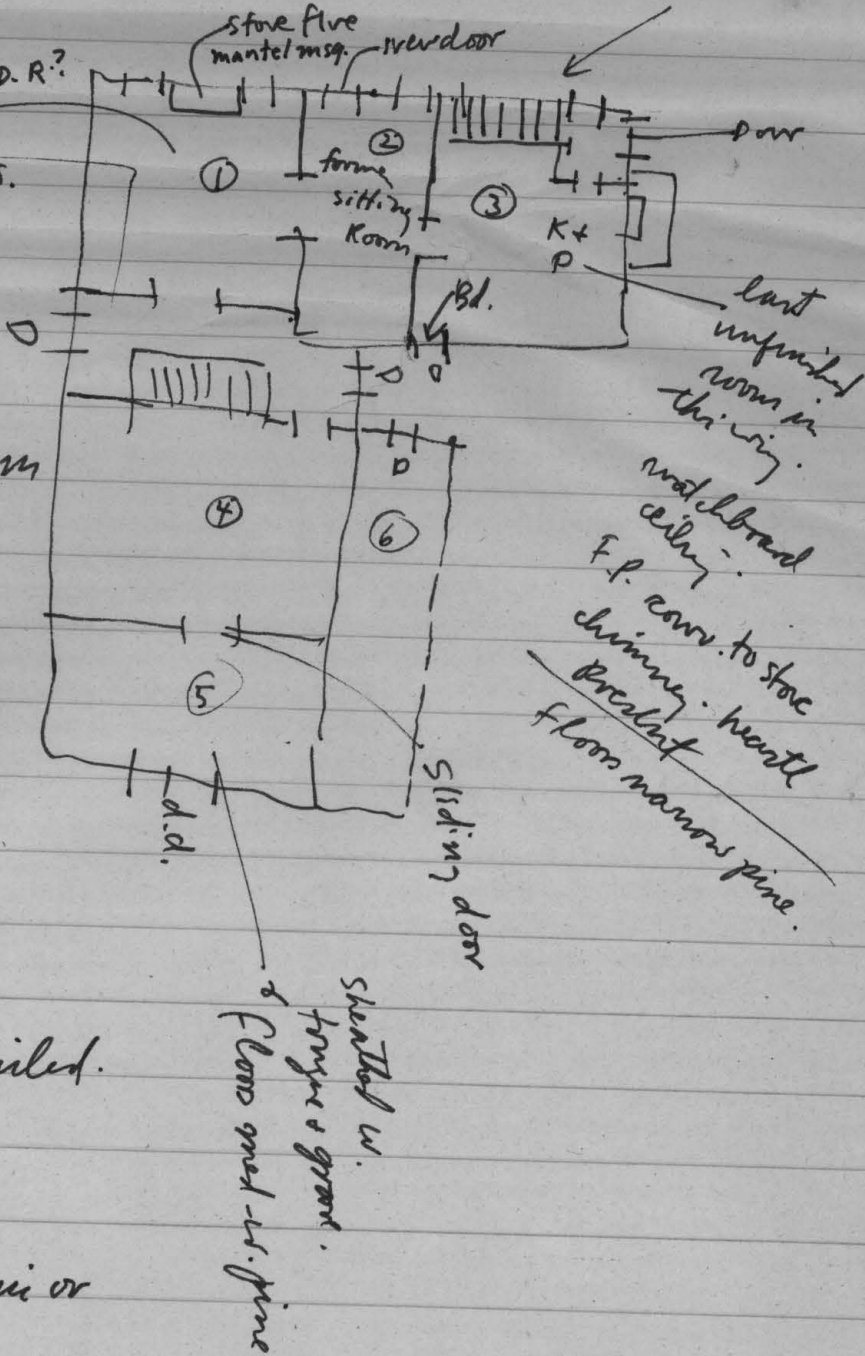
TRIM in ①, ② & ③ + upstairs. is handmade box trim with a beveled edge.

Trim in 4 is symmetrically-m / corner blocks

Trim in 6 is plain box w/ overhang
Cms. ↑

studs are sawn, 16' long joints are shaped logs rafters are sawn + square-nailed.

doors are mostly 4-panel moulded doors w/ ceramic or metal knobs.

lock at front door ⑤ is old box lock w/ door at ⑤ is batten door in ③ is vest bd. + batten.

last unfinished room in this wing. wood board ceiling F.P. conv. to stove chimney: heart breakst floor narrow pine.

Sliding door

shredded w. finger + grain. Floor grad w. pine

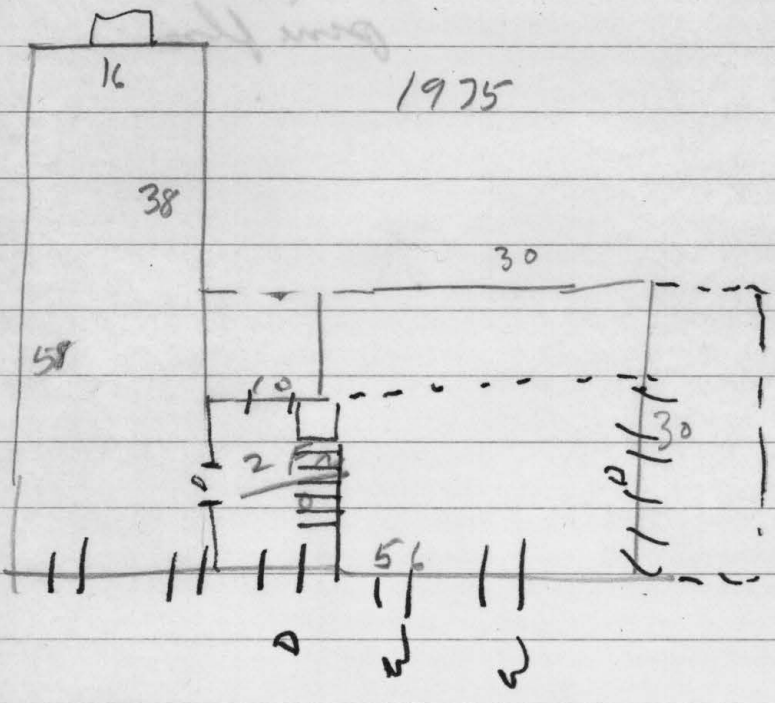
front porch - sq. posts w chamfered corners
shutter pins all around.
